Swan and Canning Rivers Foreshore Assessment and Management Strategy

March 2008

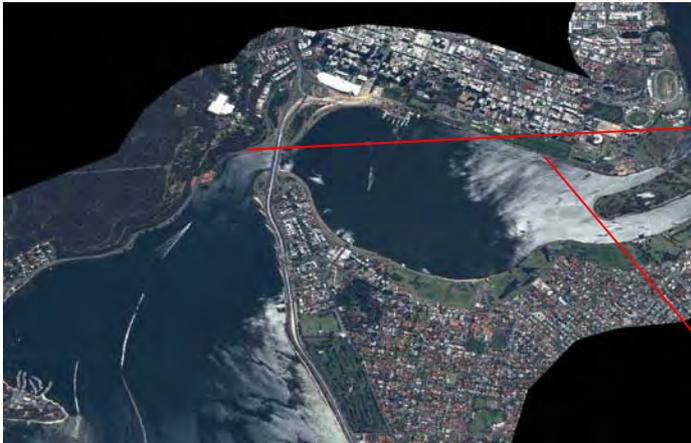
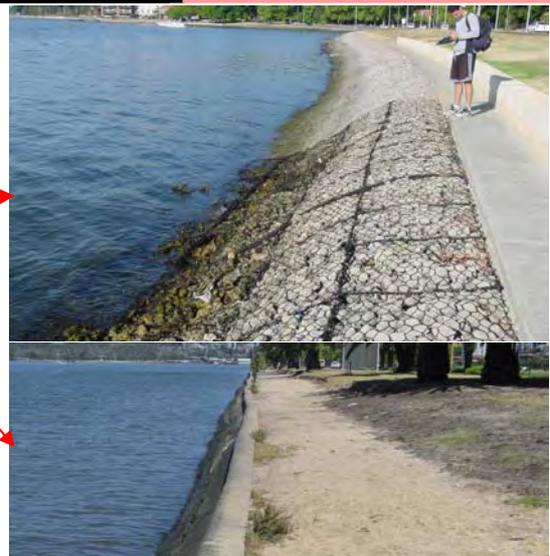
Description: This length of shore is intensively walled and is wholly artificial due to reclamation works. Shore protection types vary from vertical walls to inclined gabion baskets. The walling between the UWA Boat Club and approaching the Narrows from the west sustains the location of Mounts Bay Road, a dual use path and the Brewery site. Stresses acting on the walling vary along its length with localised bed movements and occasional wave overtopping. Some sections of walling are in disrepair due to installation of inadequate structures.

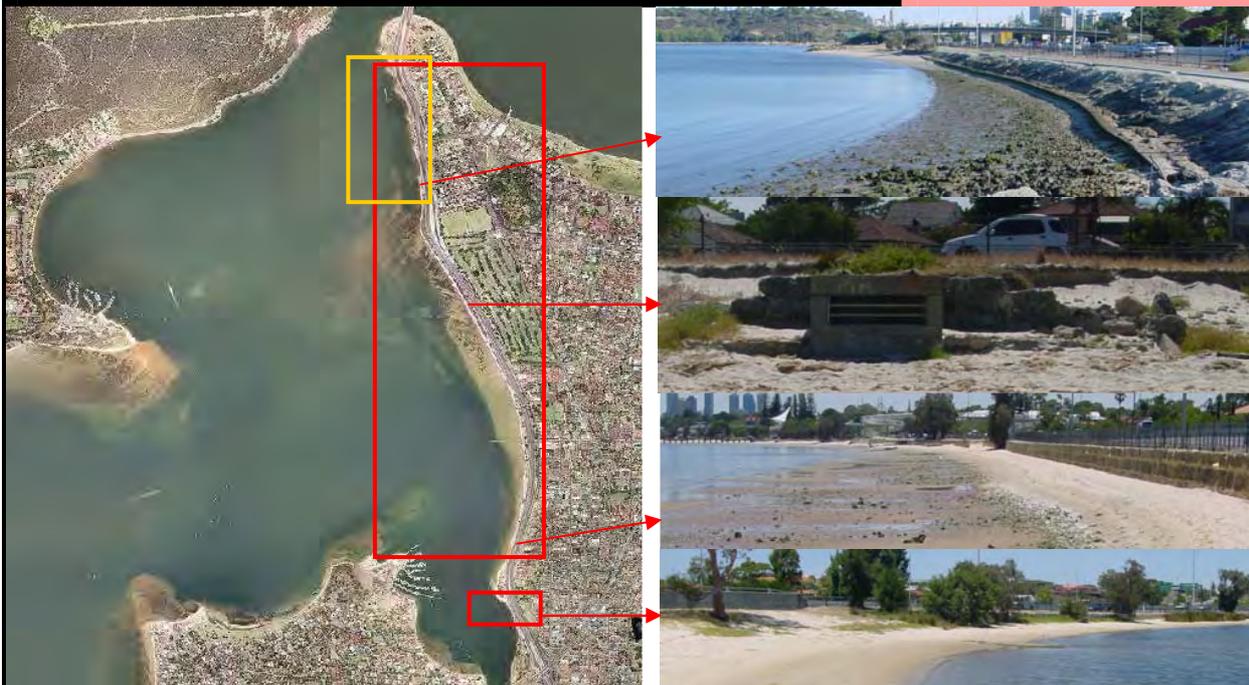
Description: Extensive reclamation of the Como Foreshore was conducted to construct the Kwinana Freeway (1956-60). A large portion of the original reclamation has subsequently eroded, providing a minimal buffer to wave action. The low elevation freeway is susceptible to inundation during both coastal flooding and severe wave events (red boxes in diagram above). The inundation creates a traffic and pedestrian safety concern, as well as potential damage to infrastructure. The region north of Richardson Street has had a series of groynes and walls constructed that affects longshore sediment transport patterns (yellow box). There is now a net northwards transport with loss of sediment from the beaches to the south.

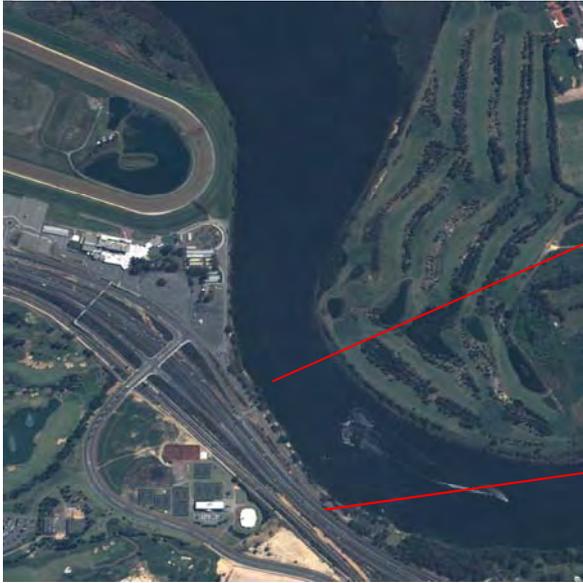
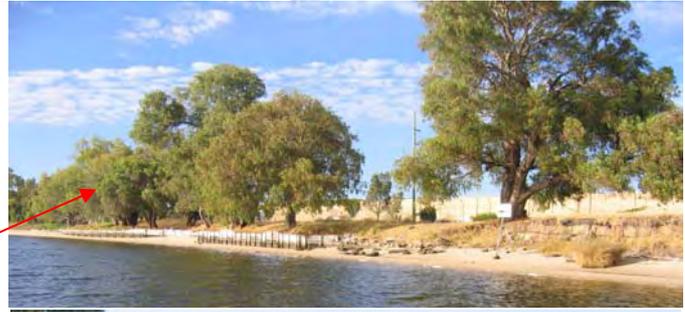
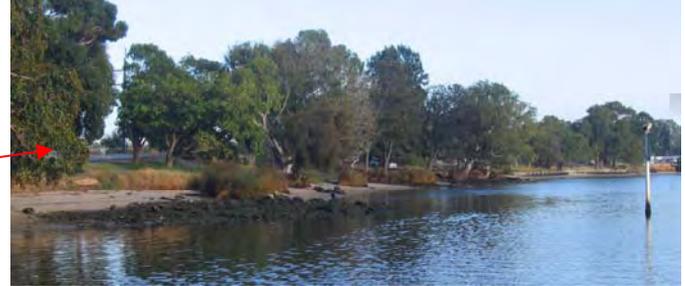
Description: Balbuk Way left bank is in a water ski area, formerly named Goodwood Parade. The bank sediment is a sandy loam that is generally unconsolidated on the lower bank. The low elevation banks increase in grade and elevation with distance downstream of the boat ramp to Belmont racecourse.

During 2006-07 the City of Belmont partnered with the Swan River Trust and Town of Victoria Park to remove the failing log walling at the ramp and replace it with limestone walling and revetments. Foreshore revegetation works are scheduled for areas adjacent to the hard engineering works.

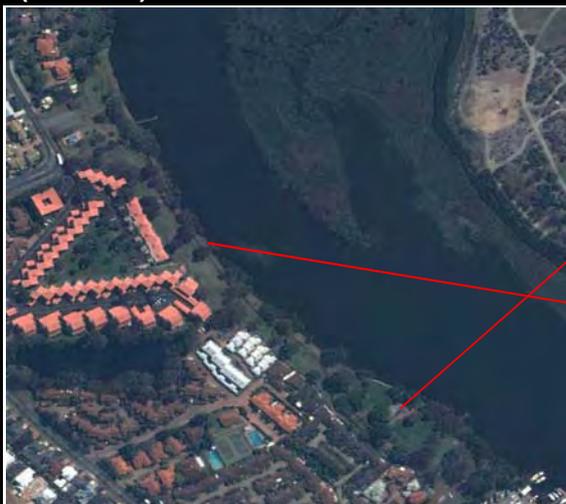
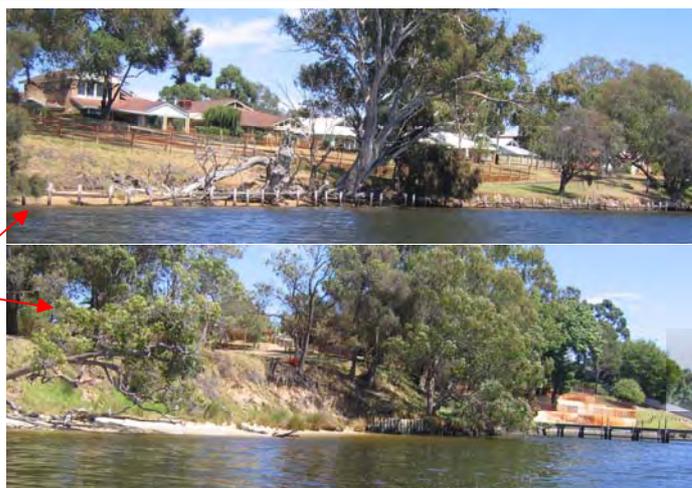
Description: This foreshore is on the Maylands Peninsula and contains the historic Tranby House and Bath Street Reserve. The site is on the outside of a bend with deep water adjacent to the banks. The banks are a sandy loam with areas of brick debris present (dumped material retained as it might increase stability). The bank elevations vary along the site, with significant scarping (3-4 m height) in many areas. The scarping is a public safety concern with general retreat occurring towards the dual use path.

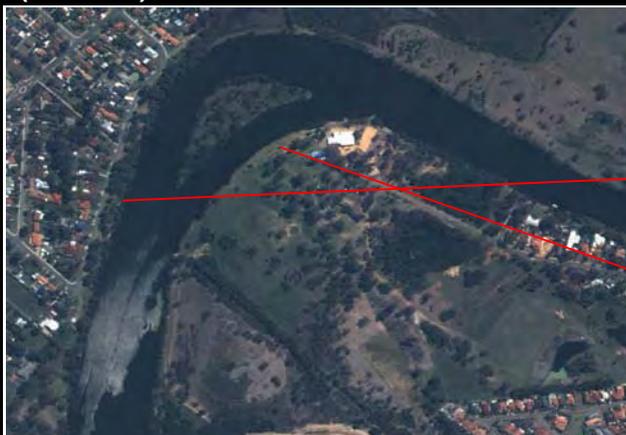
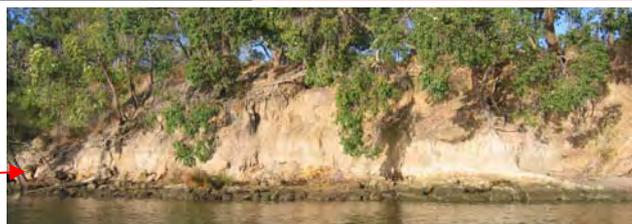
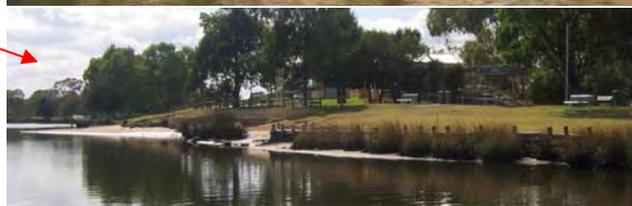
Description: The section of shoreline on the outside of the bend adjacent to Ashfield Parade has been a site of ongoing erosion. There are houses, Ashfield Parade and a dual use path in proximity to the scarping bank. The outer bank has a high clay content in its lower section. The high erosion scarps have been a concern for public safety for decades. The channel which separates Ron Courtney Island (RCI) from Garvey Park was excavated in 1969 in an effort to alleviate the erosive forces due to the river flow. The artificial channel was originally sustained by log walling that has experienced a significant loss of function or condition in many areas.

A revegetation plan is required across Garvey Park to address foreshore retreat.

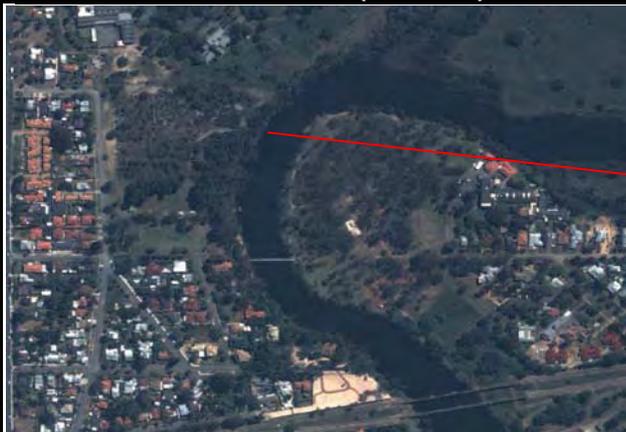
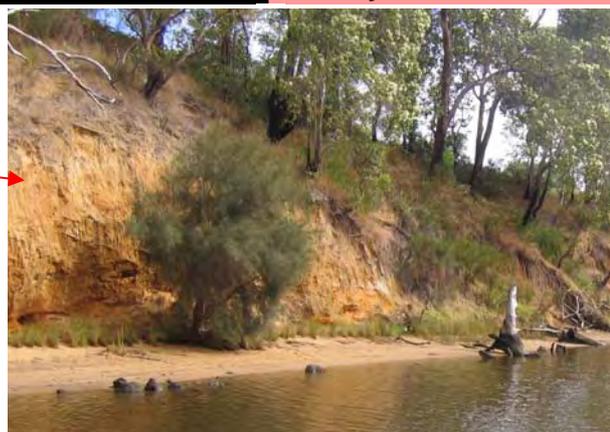
Description: The section of shoreline on the outside of the bend adjacent to Success Hill Reserve has been a site of ongoing erosion. There are private houses and a recreation reserve near the scarping bank. The bank sediments are sandy clays with high erosion scarps along its length. Following undercutting and subsequent collapse, the bank is relatively stable until the river currents remove the collapsed sediment from the base of the bank.

Managed migration is recommended for the steep scarped banks of Success Hill, with fencing placed for public safety. Minor nourishment, combined with revegetation and flow mitigation structures at the base, may act to slow the rate of material removed at the base of the scarp, reducing undercutting and the potential rate of scarp erosion. However, this would need to be repeated and could not be sustained through flood conditions.

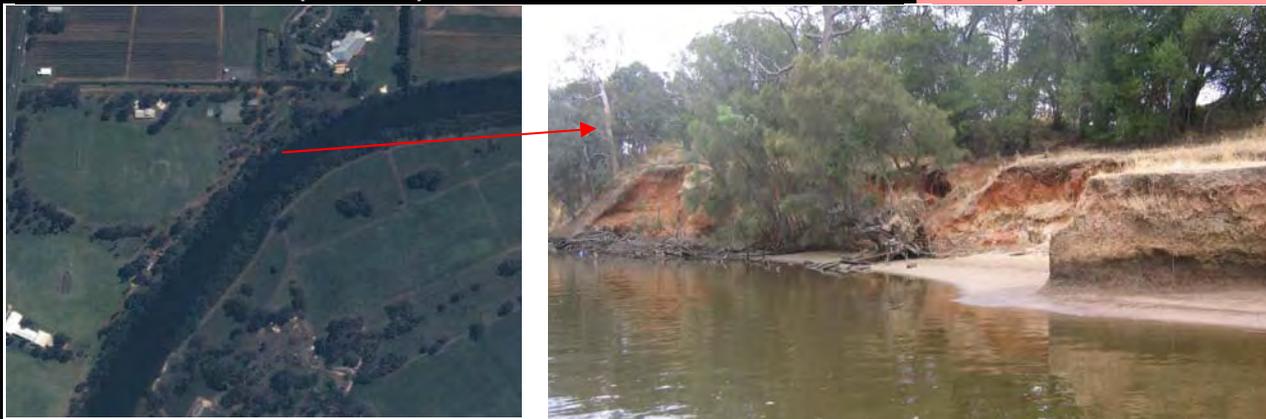
Description: The section of shoreline on the outside of the bend adjacent to Lilac Hill Reserve has been a site of ongoing erosion. There is limited recreation use in the vicinity of the scarp. The bank sediments are sandy loams overlying clay with high erosion scarps along its length. Following undercutting and subsequent collapse, the bank is relatively stable until the river currents remove the collapsed sediment from the base of the bank.

Managed retreat is recommended for the steep scarped banks of Lilac Hill, with fencing placed for public safety. Pedestrian access along the right bank should be directed to avoid the scarped and undermined section of bank.

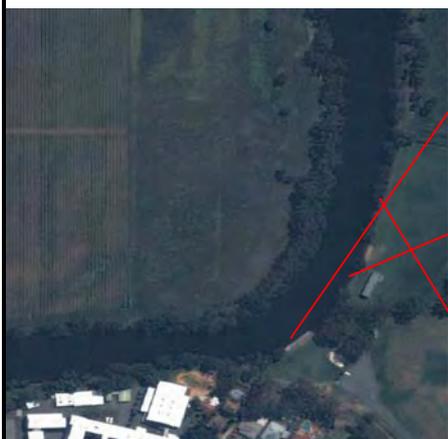
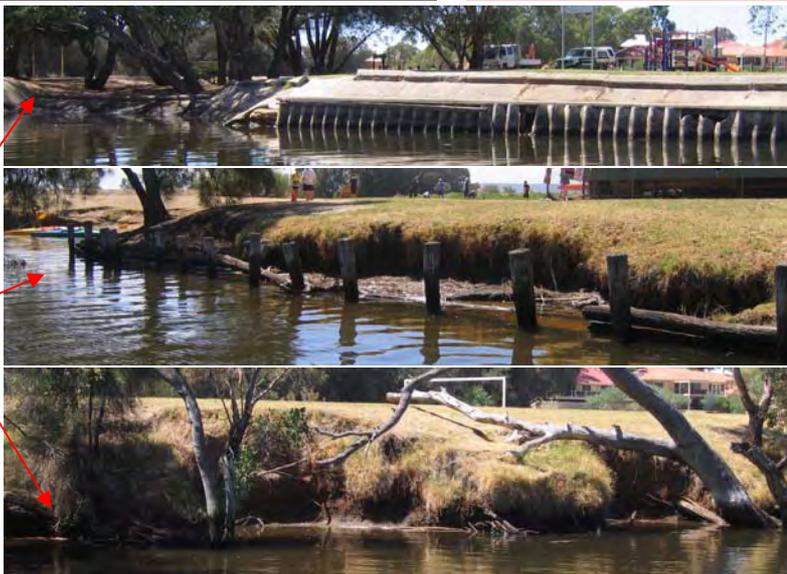
Description: Woodbridge Riverside Park contains West Midland Pools, a kayak club, car park and a walking trail upstream from the site. The site is a significant recreation area for the public and students of Governor Stirling High School. West Midland Pool was a location of historic aquatic recreation. The site contains walling of concrete sheet piling, and until 2004, it also contained two jetties for recreation. The walling is in disrepair and public safety would be improved if some maintenance or rebuilding work was conducted on the walling.

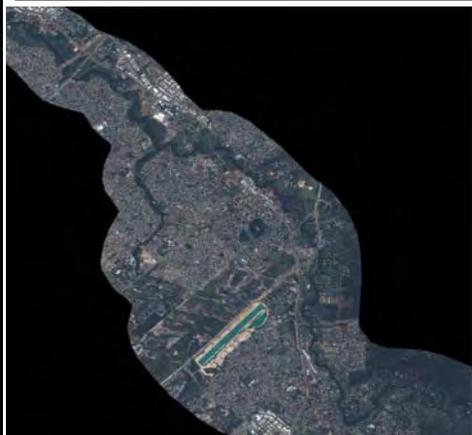
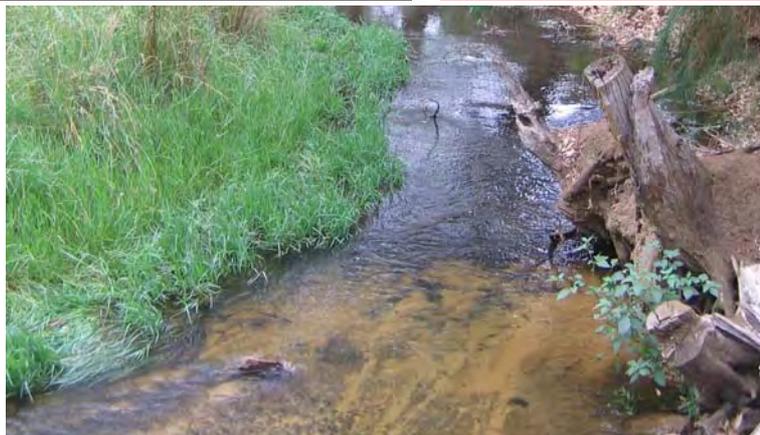
Description: The Canning and Southern Rivers between the scarp and Bickley Brook are located within agricultural zones and conservation areas. There is a mix of infrastructure, significant environmental sites and areas of recreational amenity.
