**Biodiversity and  
Conservation Science**

# Preliminary assessment of plastic infrastructure in the Swan Canning Riverpark

June 2024

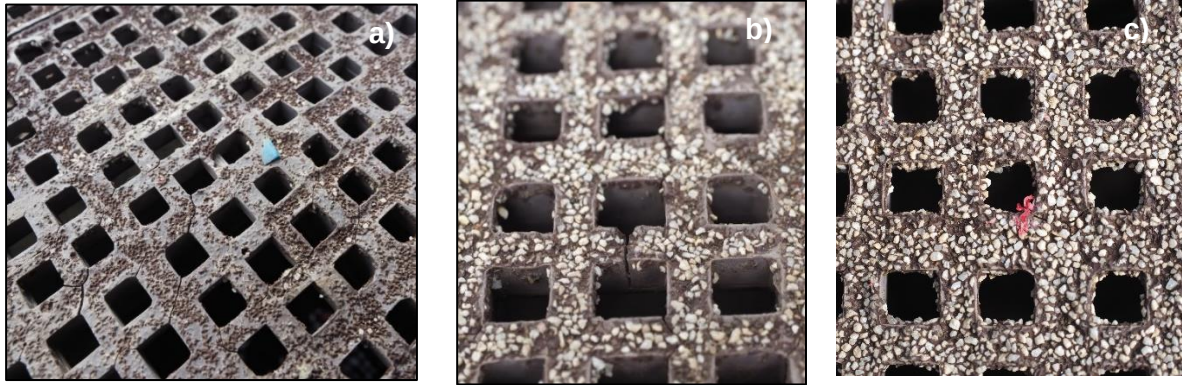
Figure 11. Moderate to severe cracking (a & b) and captured microplastics (c) on the fibre reinforced plastic grated decking used for the canoe launch at the Middle Swan Reserve.

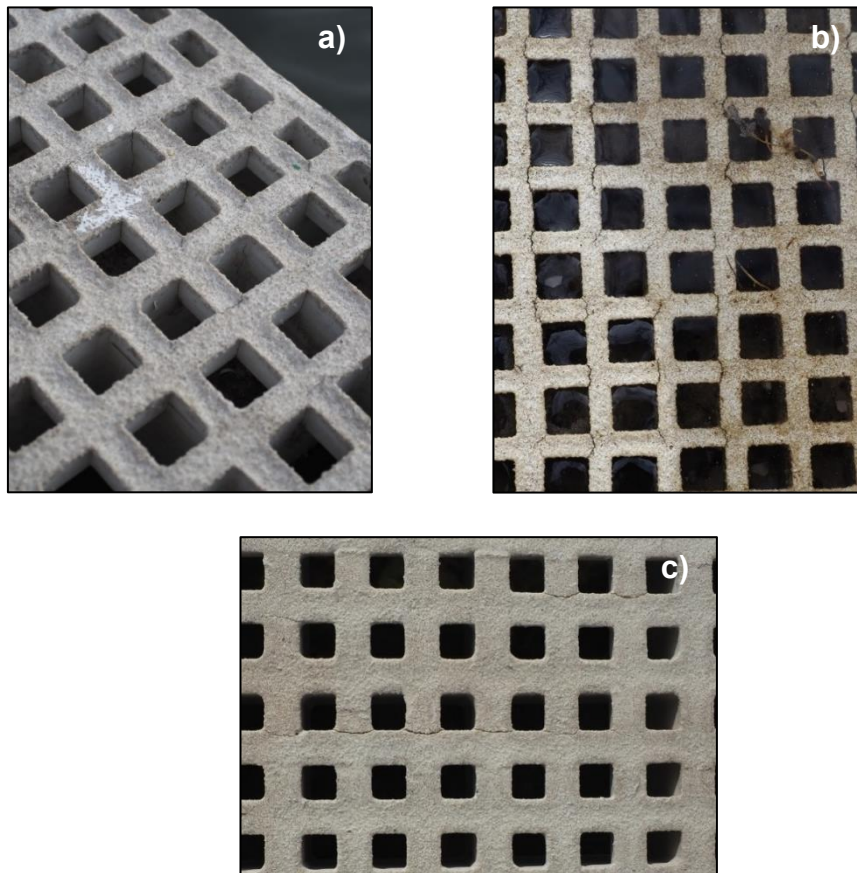
Figure 12. Fibre reinforced plastic (FRP) standard mesh with grit at Deep water Point finger jetty (a) and boat ramp (b) showing where cracking often occurs in grated decking; (c) cracking on FRP decking from quadrat 1 on the pontoon at South of Perth Yacht Club.

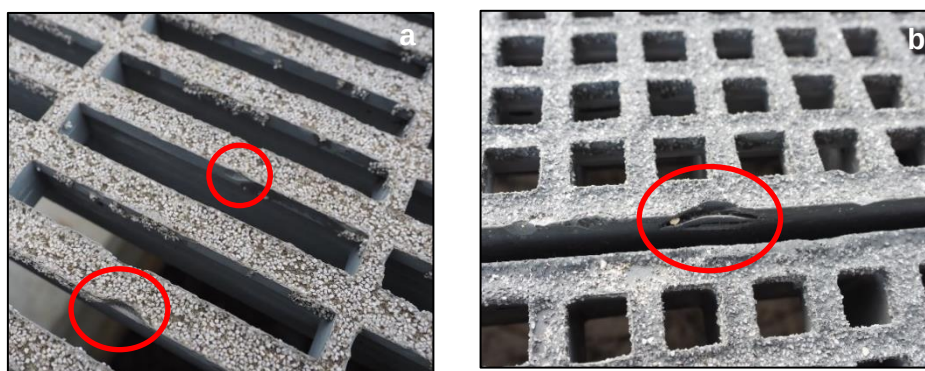
The mean score for chips in FRP decking was  $0.81$  ( $SE \pm 0.33$ ) (Figure 10b & Figure 13). Chips were evident in almost all FRP grated decking at all sites, except the jetty at the Swan Yacht Club (Figure 10b). Cracks often led to chipping on the edges of structures such as along the grating at the Kent Street Weir Bridge (Figure 13a) and the beach access ramp at John Tonkin Reserve where FRP panels were joined at different angles (Figure 13b).

Figure 13. Chipping on grating at Kent Street Weir Bridge (a) and on edging of the beach access ramp at John Tonkin Reserve (b).

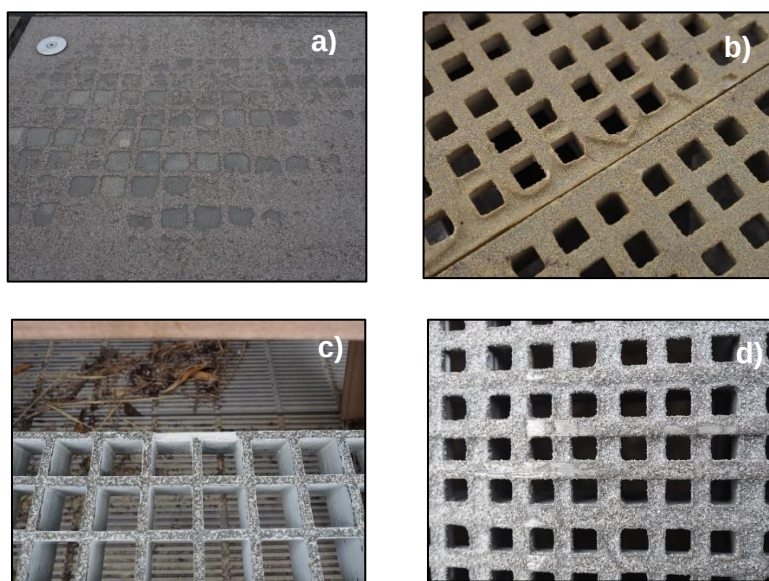
The surface of the solid top decking installed at Kent Street Weir showed material loss in about a third of the panels (10 / 33 panels) (Figure 13a & Figure 14a).

Figure 14. Material loss on the solid top section of the raised walkway at Kent Street Weir (a), the loading jetty at Aquarama Marina (b), an access staircase at Applecross boardwalk (c) and exposed fibres at Miller's Pool boardwalk (d).

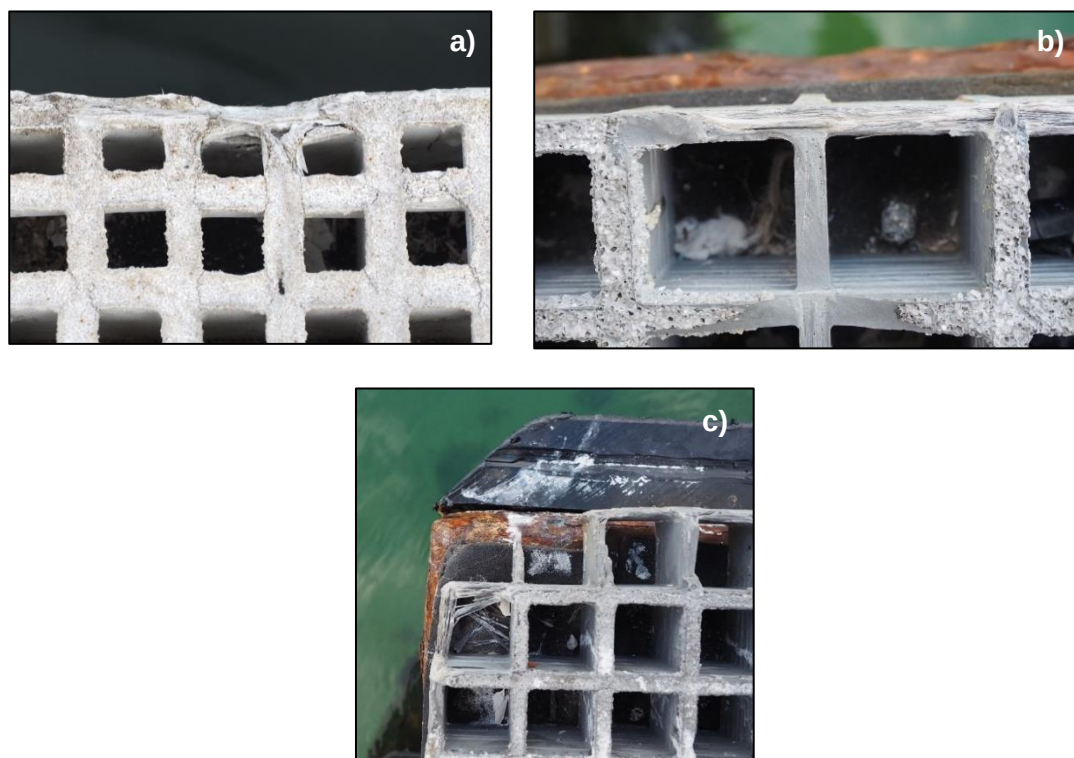
**Boat strike:** FRP decking on the water-facing sides of jetties were particularly susceptible to boat strikes (Figure 17). The centre of the decking on these structures was much less damaged and often showed less exposed fibres than the outside margins of the FRP panels (Figure 17).

**Structure type and finish:** More wear was evident on the edges of grated FRP decking with a larger grid size (e.g. standard grid versus micro-grid) (Figure 17). More wear was also

Figure 17. Examples of degradation from boat strikes on edges of grated fibre reinforced plastic decking at Deep Water Point finger jetty (a) and Leeuwin boat ramp finger jetty (b) and (c) end of Leeuwin boat ramp.

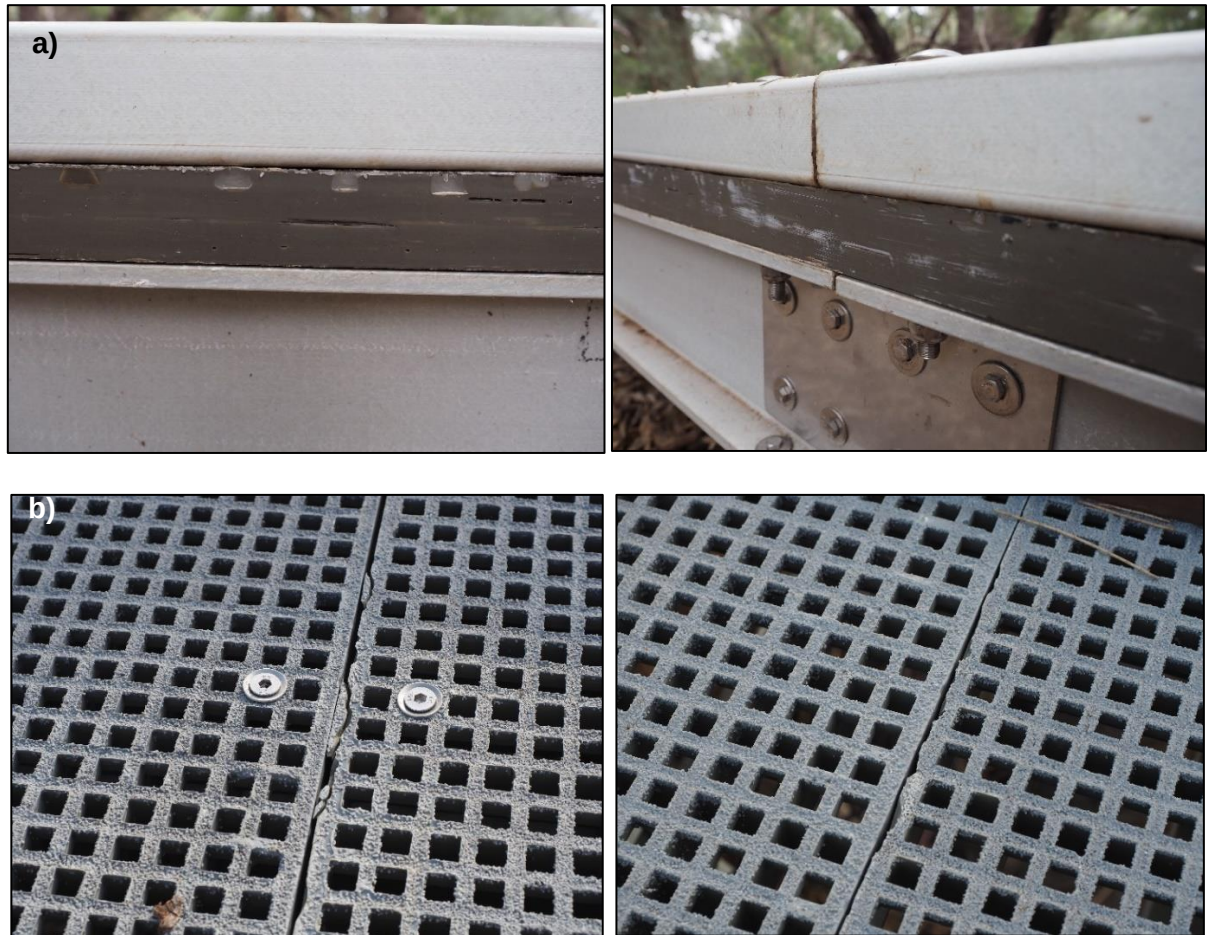
**Installation:** Scuffing on the edges of newer structures may have been caused from installation and transport of materials to site (Figure 18a).

Figure 18. (a) Fibre reinforced plastic (FRP) kick rail (top), FRP mini mesh edging (middle dark grey layer) and FRP substructure (bottom layer) along board walk at Thornlie nature reserve; (b) FRP decking joints at Melville bird view platform.

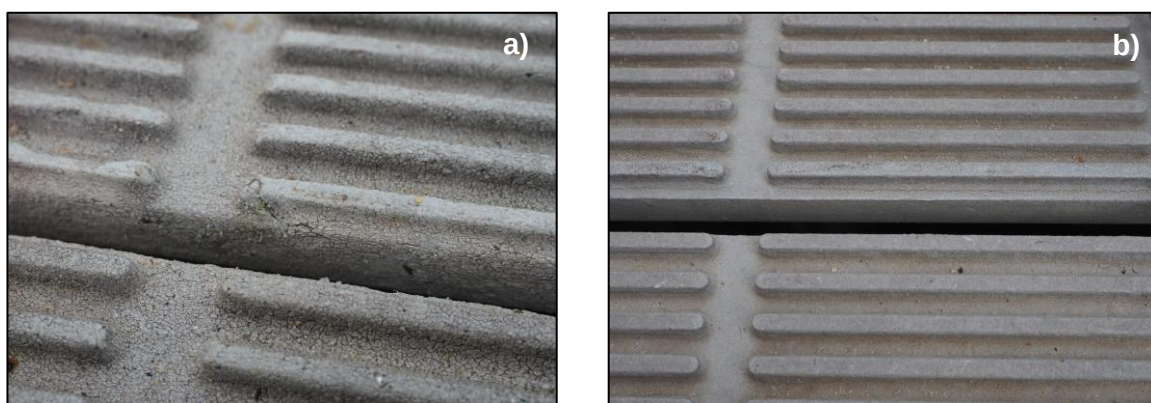
Overall, cracking was not a major issue resulting from degradation of recycled plastic decking, as most structures showed negligible cracking.

Figure 19. Cracking of recycled plastic decking observed at the Mount Henry jetty (a) and the Applecross boardwalk (b).

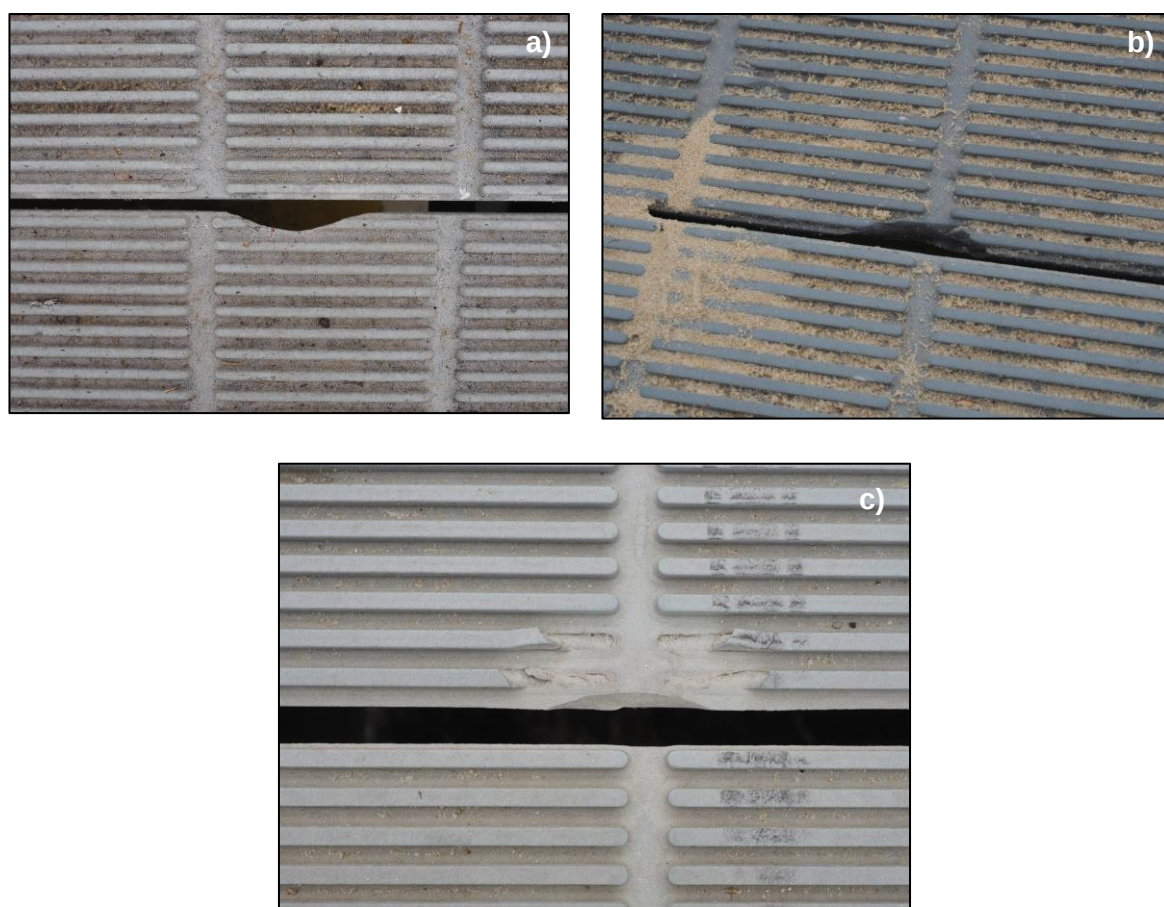
Figure 20. Chipping present on recycled plastic decking at the Mount Henry jetty (a), Pollard Park jetty (b) and the Applecross Boardwalk (c).

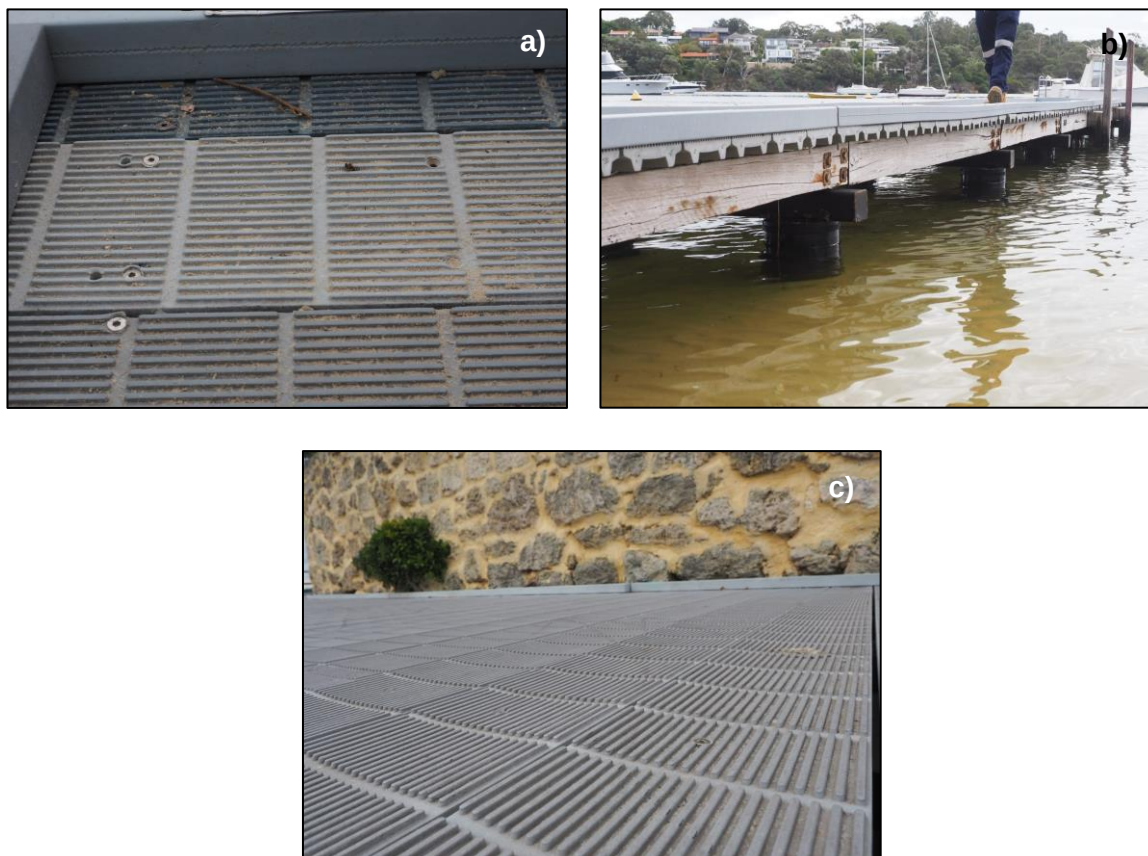
Figure 21. Deformation of recycled plastic decking observed at Pollard Park jetty (a, b) and Applecross boardwalk (c).

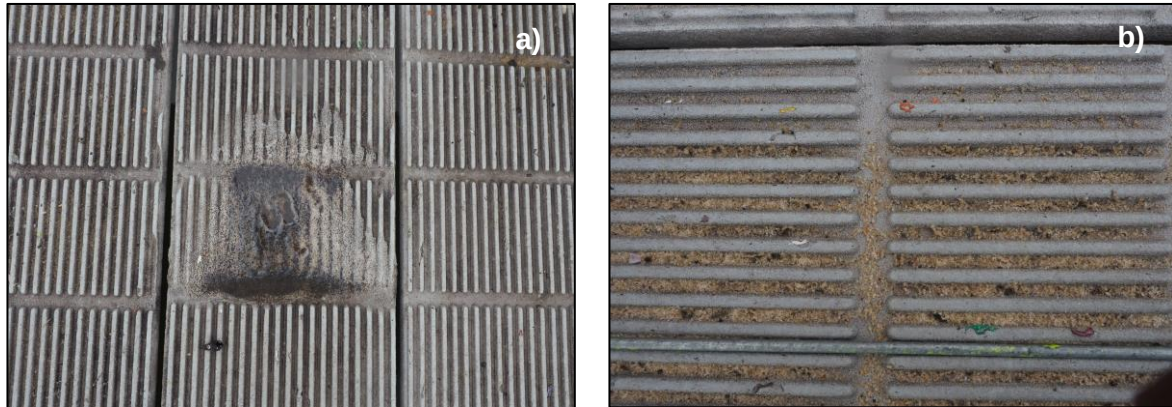
Figure 22. Material loss observed on recycled plastic decking at the Mount Henry jetty (a – chemical or fire damage, b – exposed plastics of different colours).

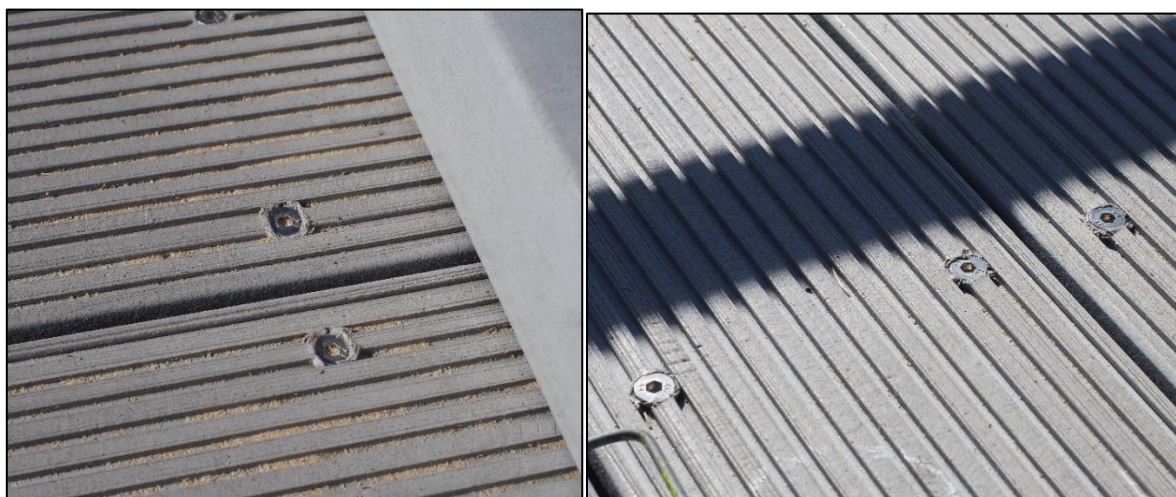
Figure 24. Poor installation of screws to install recycled plastic decking at Rockwood Street (Esplanade) jetty.

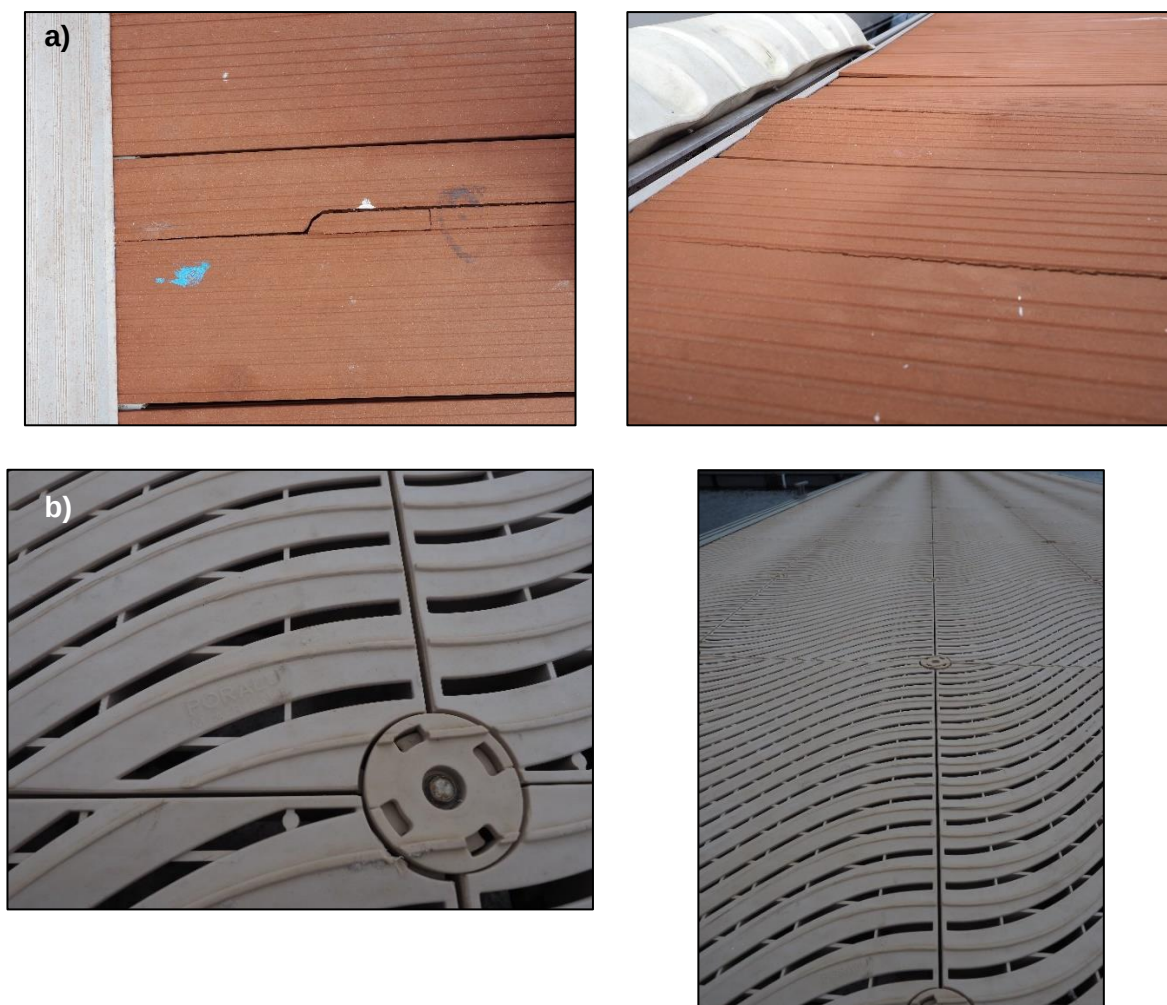
Figure 26. Other types of plastic decking observed including composite plastic at the South of Perth Yacht Club (a) and hard plastic decking (most likely polypropylene) at the Perth Flying Squadron Yacht Club (b).

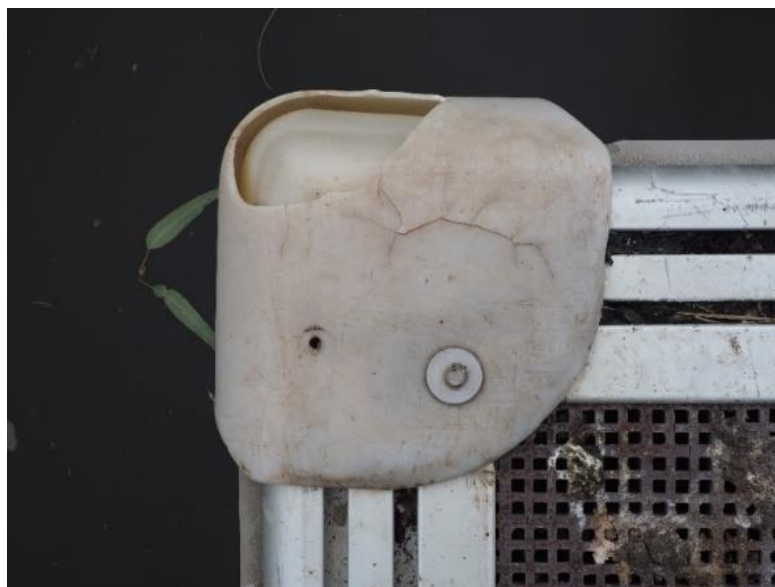
Figure 31. Damaged rigid capping used on corners of the pontoon at Middle Swan Reserve.

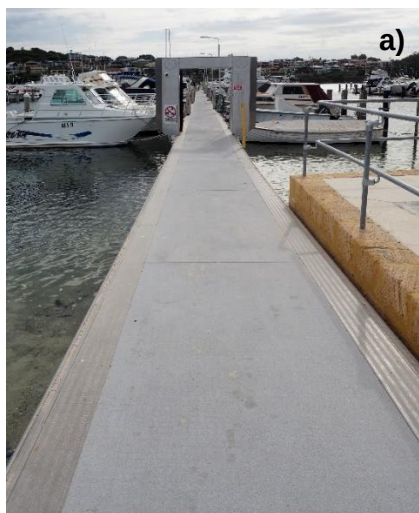
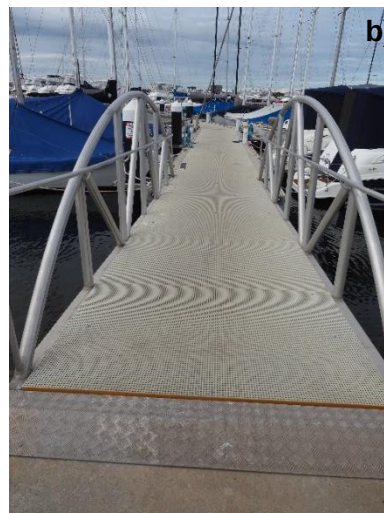
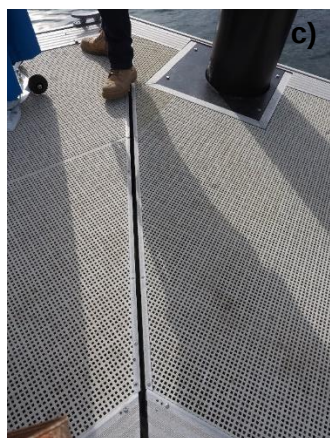
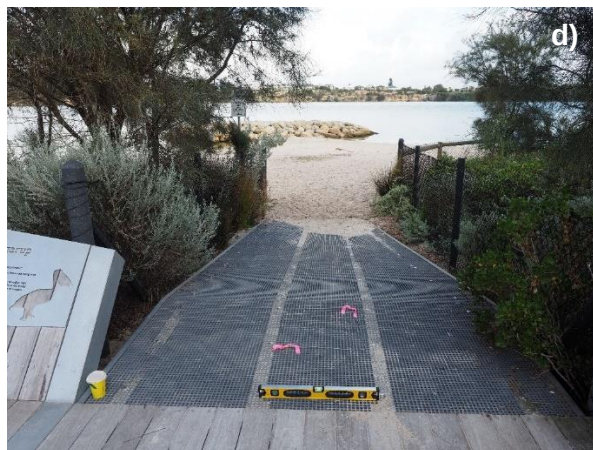
Figure 33. Aluminum edging used on Jetty 2 at the Swan Yacht Club (a), South of Perth Yacht Club (b), and Swan Yacht Club pontoon (c) protected fibre reinforced decking from wear in comparison to an example where edging is recommended (d - John Tonkin Reserve beach access ramp).

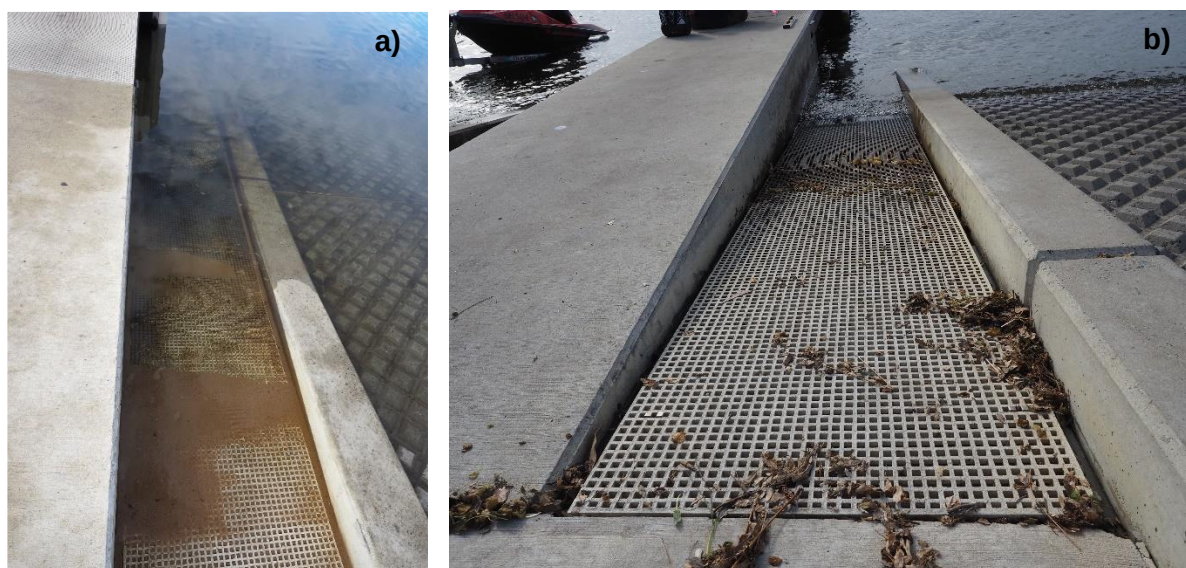
Figure 34. Examples of fibre reinforced plastic exposed to wet and dry cycling at Deep Water Point (a) and Point Walter boat ramps (b).

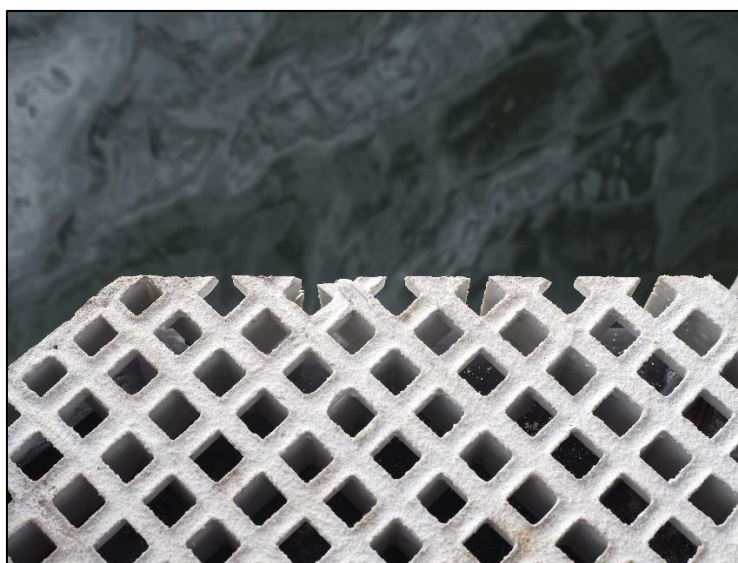
Figure 36. Fibre reinforced plastic decking cut on an angle and showing chipping at the end of Deep Water Point finger jetty.
