Department of **Biodiversity**, **Conservation and Attractions**

Tributary Foreshore Assessment Report: Helena River (Mandoon)

Last Updated: 31 January 2018

January 2018

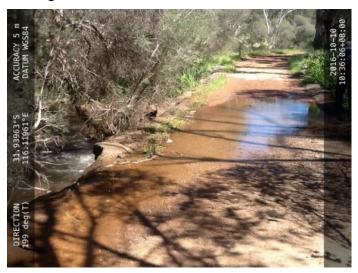
Figure 10: Localised flooding occurs above this small ford. Figure 11: Steep banks above the Pumpback Dam.

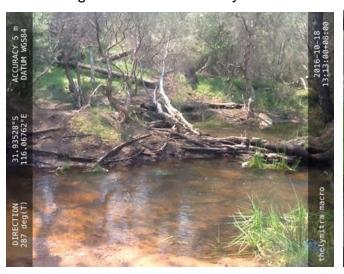
Figure 13: 1-2m medium sloped bank in Helena Valley. Figure 14: 1-2m steep sloped bank in Helena Valley.

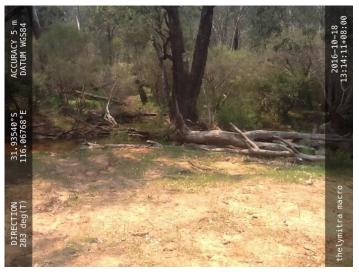
Figure 15: Exposed riverbank near Craignish Gauging Station.

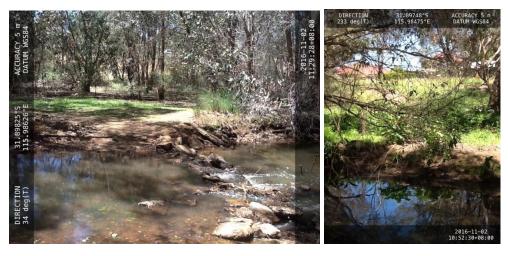
Figure 19: 0.5-1m medium slope bank in South Guildford. Figure 20: 0.5-1m steep slope bank in Woodbridge.

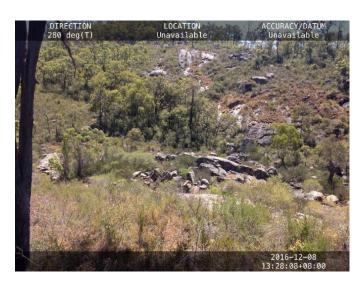
Figure 27: Poor condition vegetation immediately downstream of Mundaring Weir. Figure 28: Granite dominated area with good condition vegetation.

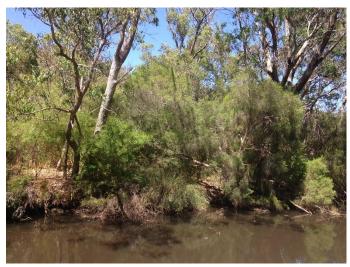
Figure 29: Remnant riparian vegetation in Beelu National Park. Figure 30: Understorey dominated by weedy grasses and herbs, Helena Valley.

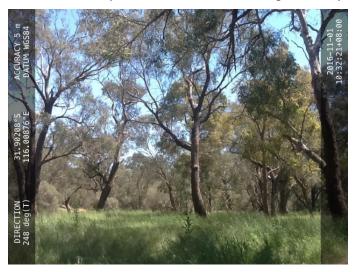
Figure 31: Connected upperstorey of Eucalyptus rudis in the floodplain in Midland. Figure 32: Understorey of arum lily and nasturtium in Guildford.

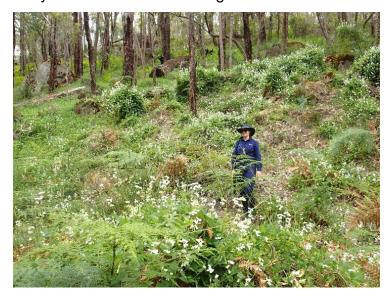
Figure 36: Dolichos pea infestation about 1km downstream of Mundaring Weir. Figure 37: Dense watsonia infestation above the Pumpbank Dam.

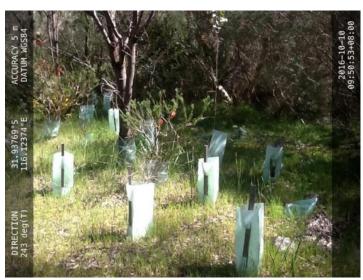
Figure 53: Coir logging in a pool downstream of Mundaring Weir Road. Figure 54: Small revegetation site requiring maintenance.

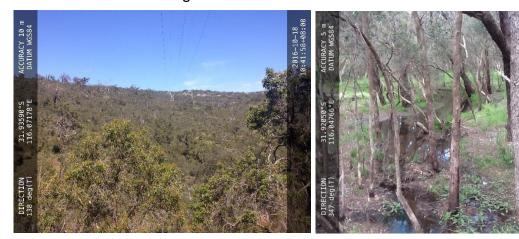
Figure 55: Watsonia has been controlled in the valley below the Pumpback Dam. Figure 56: Weed control and revegetation immediately upstream of Scott Street.

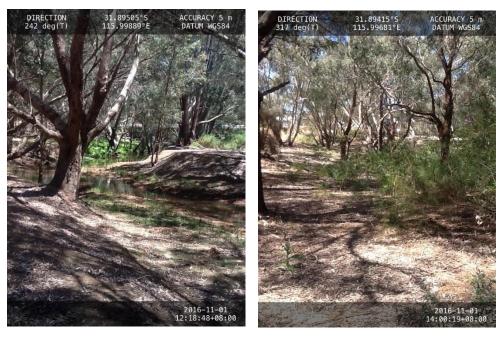
Figure 57: Revegetation site adjacent to the Men of the Trees property in Hazelmere. Figure 58: Revegetation site near Amherst Road in Woodbridge.

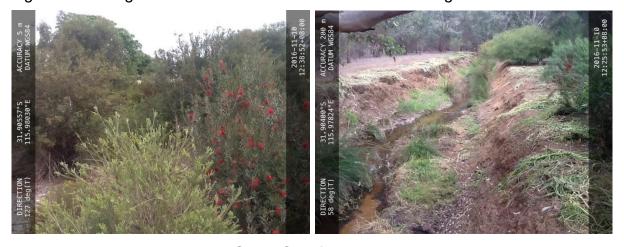
Figure 59: Revegetation site in South Guildford.

Figure 60: Recent weed control was evident in the lower part of the drain from Rosehill Estate.
