Department of **Biodiversity,
Conservation and Attractions**

Saint Leonards Creek Foreshore Condition Assessment

Version: 2

Last Updated: November 2020

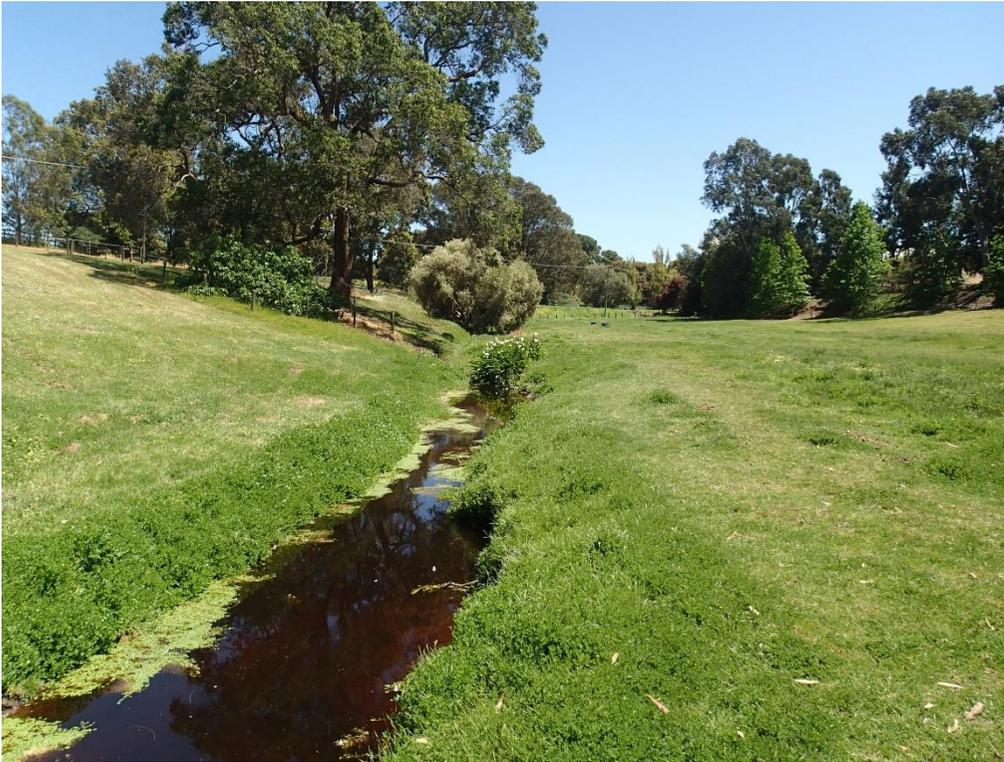
Vegetation description	Very occasional <i>Corymbia calophylla</i> and <i>Melaleuca</i> sp. over mixed weedy grasses and herbs	Vegetation description	Exotic trees over <i>Typha</i> sp. and <i>Cenchrus clandestinus</i>				
Recommended restoration	Restricting horse access to creek will improve erosion risk but is dependent on landholders' will. Plant native <i>Melaleuca</i> trees to provide overstorey.	Recommended restoration	Remove <i>Watsonia</i> and plant native sedges on bank. Manage <i>Typha</i> *.

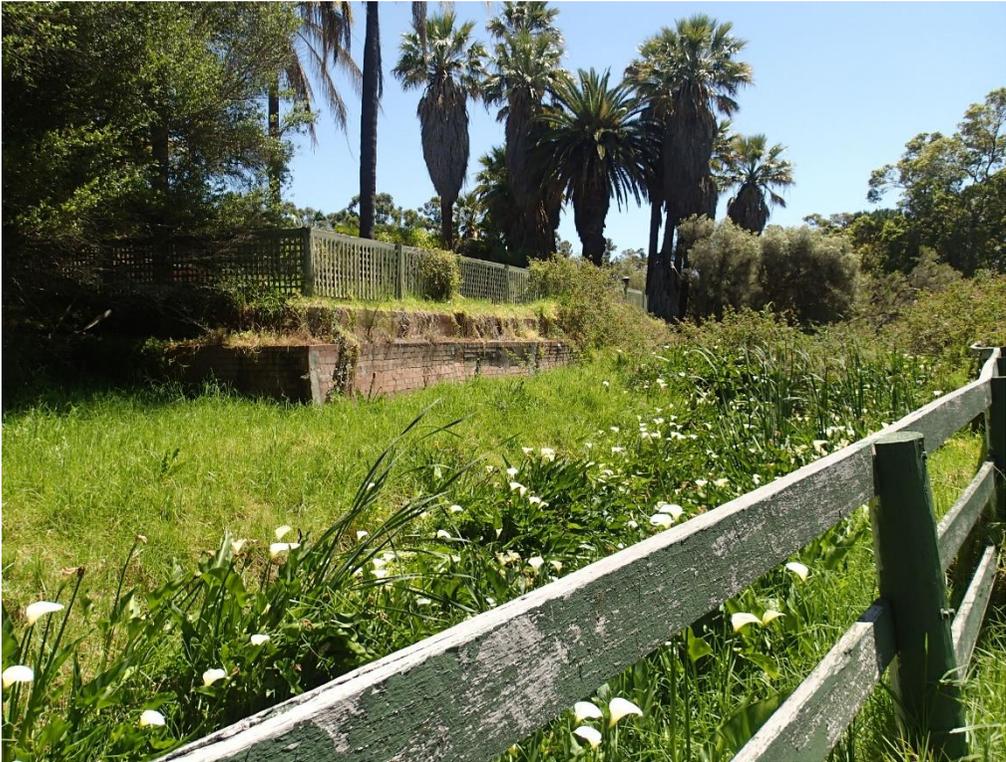
Vegetation description	<i>Agonis flexuosa</i> and Eastern States <i>Eucalyptus</i> sp. over <i>Rosa</i> sp. Dorothy Perkins, <i>Zantedeschia aethiopica</i> and <i>Cenchrus clandestinus</i>	Vegetation description	<i>Melaleuca raphiophylla</i> and <i>Corymbia calophylla</i> over <i>Rosa</i> sp. Dorothy Perkins, <i>Watsonia</i> sp., <i>Zantedeschia aethiopica</i> and weedy grasses				
Recommended restoration	Would require ongoing management to be clear of weeds. Remove Black Flag as a priority. Remove weedy Passionfruit from fence.	Recommended restoration	Would require ongoing management to be clear of weeds. Remove woody weeds: Olive and Rose.

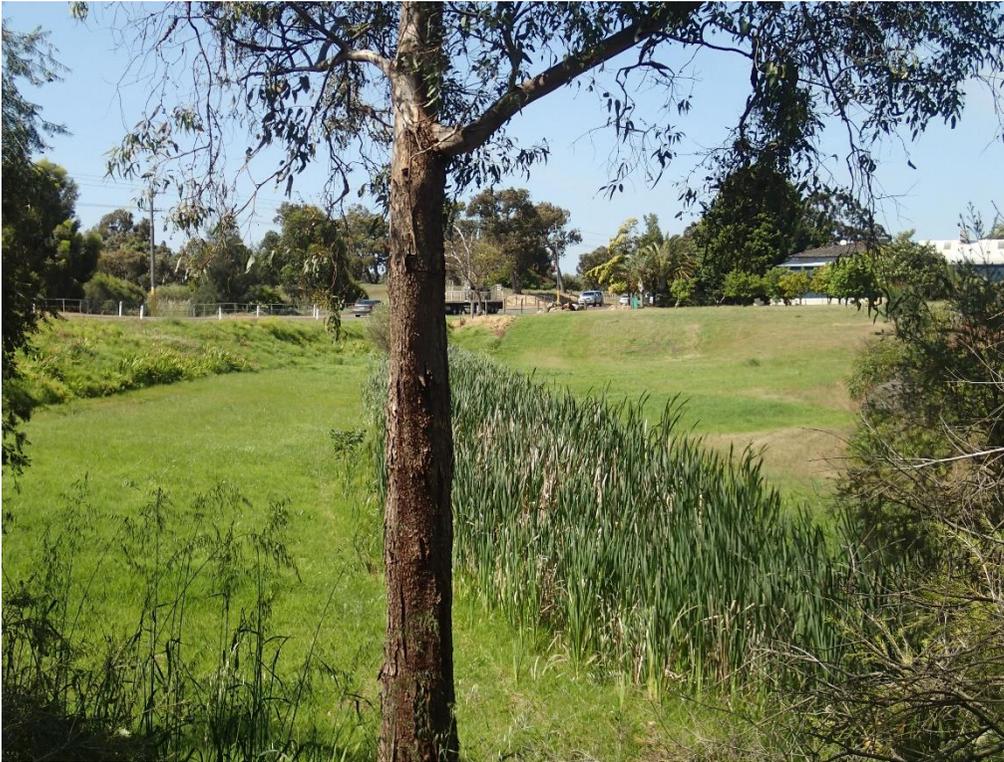
Vegetation description	<i>Typha sp.</i> in stream and <i>Cenchrus clandestinus</i> on bank	Vegetation description	<i>Melaleuca raphiophylla</i> over <i>Cenchrus clandestinus</i> , with some <i>Eucalyptus sp.</i> (white gum) over mixed grasses on upper bank				
Recommended restoration	Work with landholder, has good relationship with neighbour and they jointly manage the creek. Plant native sedges on the banks behind the <i>Typha</i> . Plant overstorey species.	Recommended restoration	Control grasses and plant sedges and other understorey plants. Remove Olive and Fig.

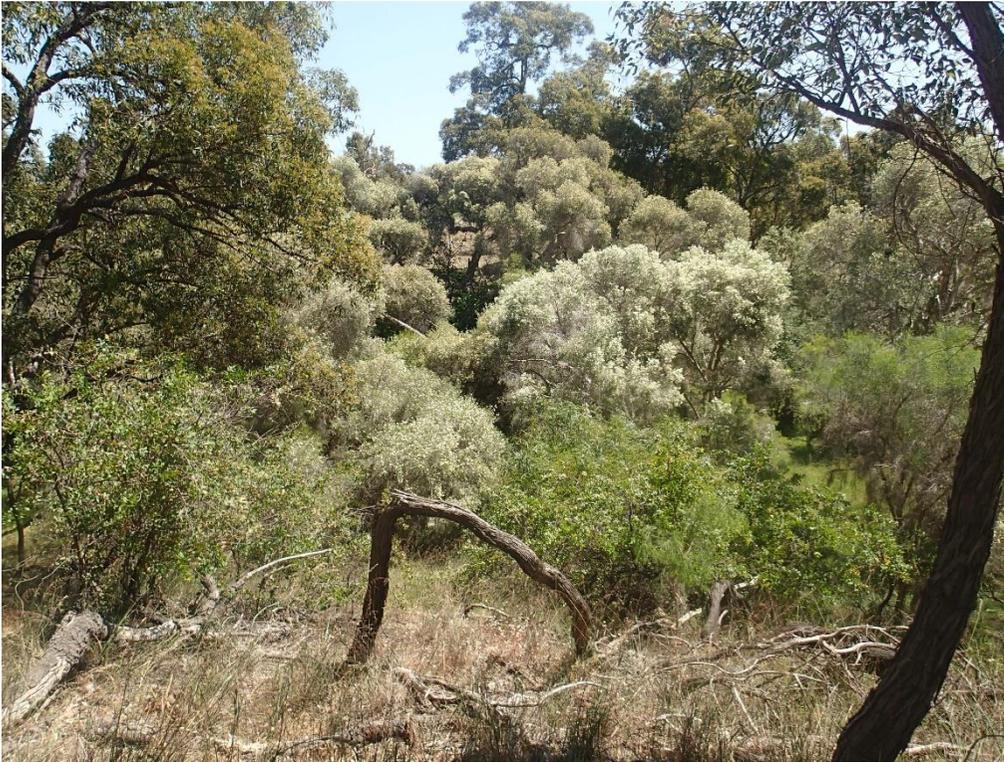
Vegetation description	<i>Corymbia calophylla</i> and <i>Melaleuca raphiophylla</i> over <i>Cenchrus clandestinus</i> and revegetation	Vegetation description	<i>Corymbia calophylla</i> and <i>Melaleuca raphiophylla</i> over <i>Pteridium esculentum</i> and mixed grasses				
Recommended restoration	Grass weed control. Remove Bridal Creeper, Arum Lily, Olive and Figs. Control foxes.	Recommended restoration	Remove Arum Lily and Bridal Creeper.

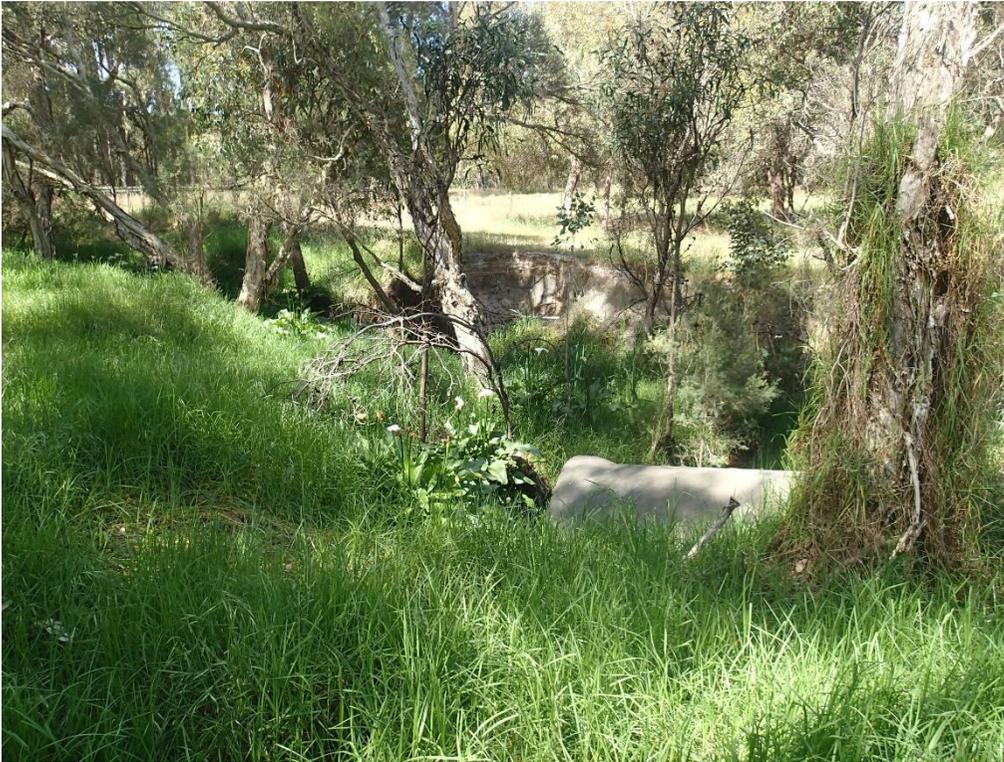
Vegetation description	<i>Eucalyptus rudis</i> and <i>Melaleuca raphiophylla</i> over <i>Zantedeschia aethiopica</i> , <i>Cenchrus clandestinus</i> and other weedy grasses and herbs	Vegetation description	<i>Melaleuca raphiophylla</i> and <i>Schinus terebinthifolius</i> over sparse <i>Zantedeschia aethiopica</i> and dense <i>Cenchrus clandestinus</i>				
Recommended restoration	Move culverts and address erosion around their current placement. There are too many Arum Lilies to easily remove and replace.	Recommended restoration	Remove Brazilian Pepper and Arum Lily. Could plant up banks, although grass invasion from adjacent property will be an ongoing issue.

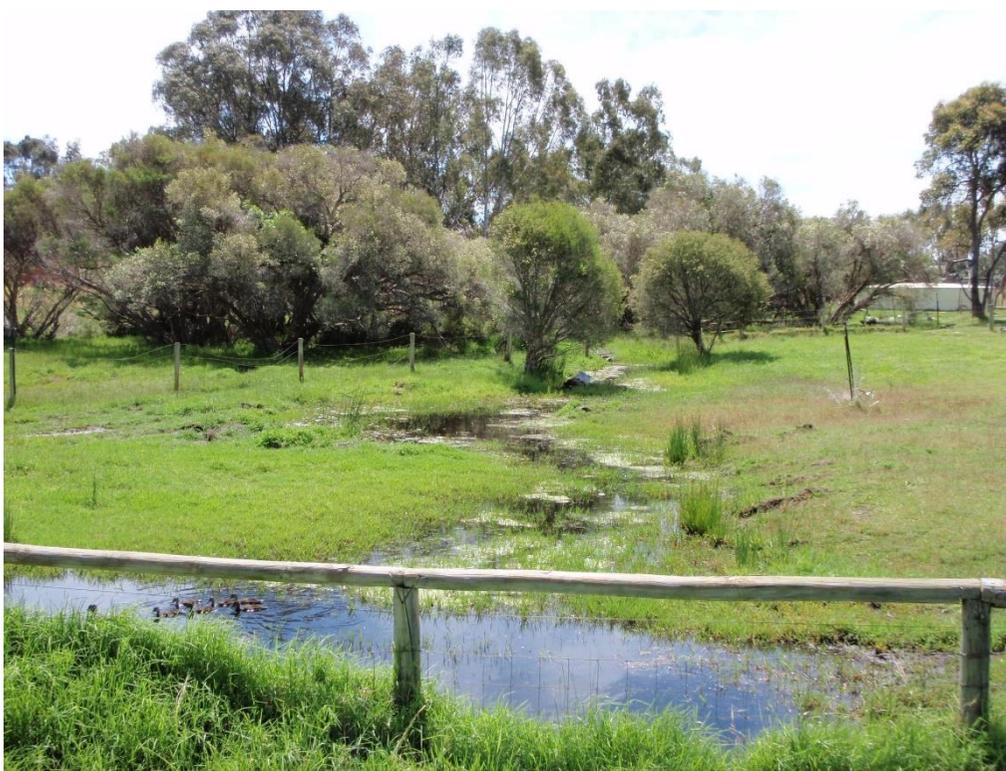
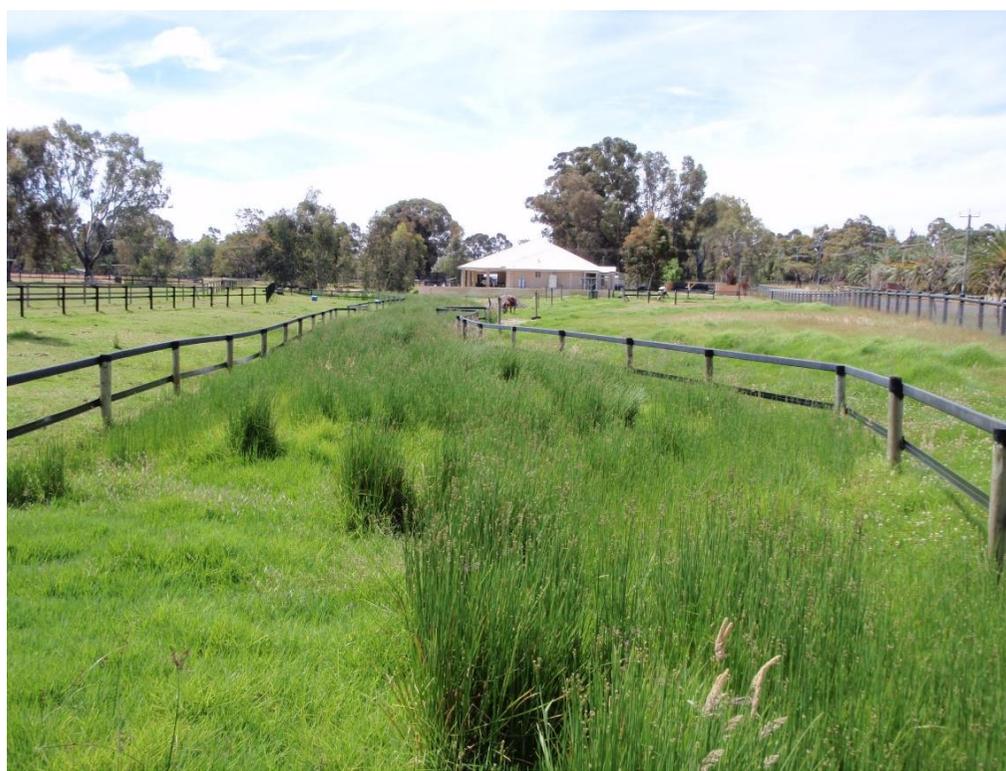
Vegetation description	Eastern States <i>Eucalyptus sp.</i> over mixed weedy grasses	Vegetation description	<i>Juncus microcephalus</i> over <i>Cenchrus clandestinus</i> and other mixed weedy grasses and herbs				
Recommended restoration	Remove Brazilian Pepper and <i>Isolepis prolifera</i> . Fence creek if there's interest from landholders.	Recommended restoration	Encourage owners to plant natives. Stage replacing <i>Juncus microcephalus</i> with native sedges; remove <i>Isolepis prolifera</i> from road reserve. Remove silt.

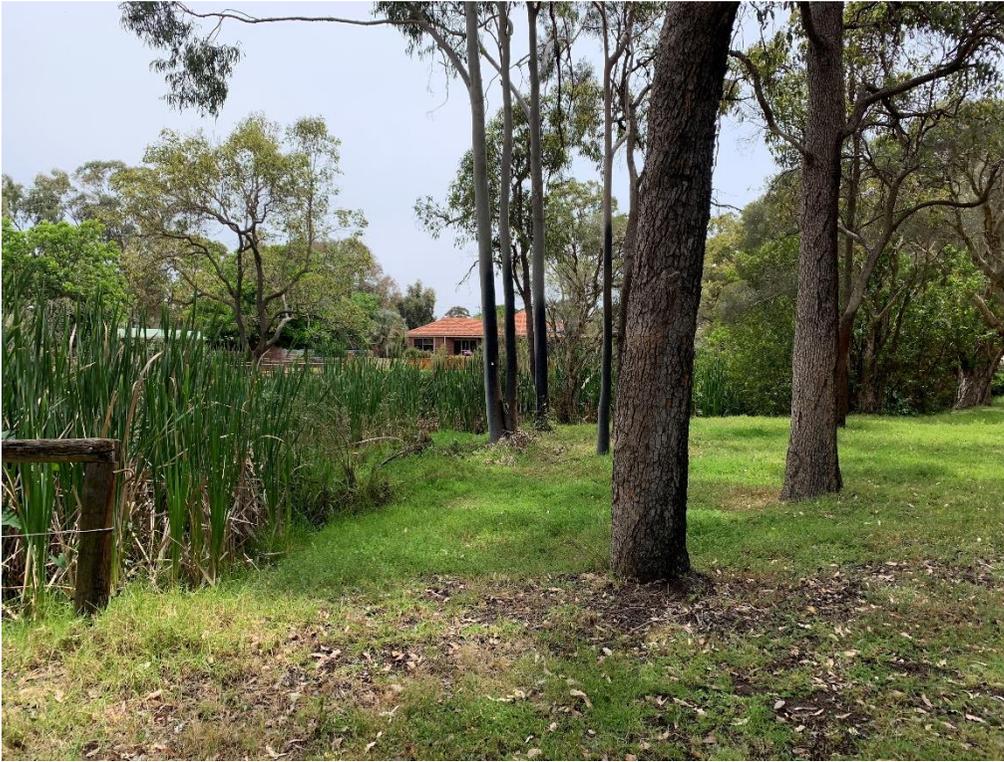
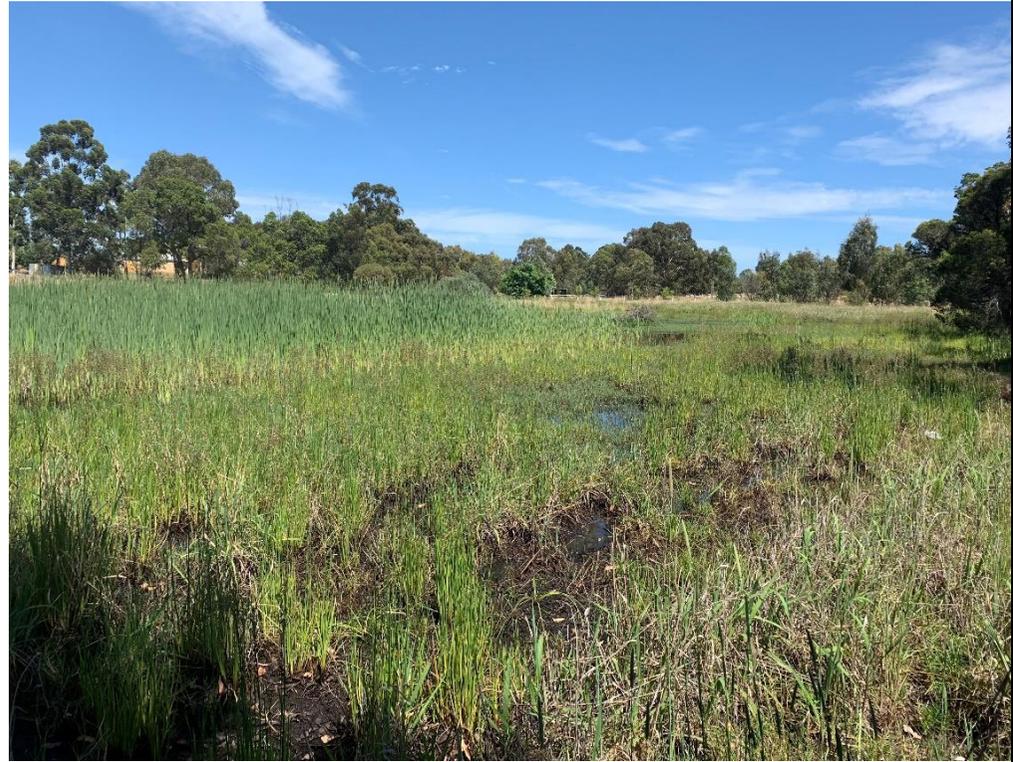
Vegetation description	<i>Corymbia calophylla</i> over <i>Melaleuca raphiophylla</i> over <i>Typha sp.</i> and <i>Colocasia esculenta</i>	Vegetation description	Mixed <i>Eucalyptus sp.</i> over <i>Typha sp.</i> and mixed grasses				
Recommended restoration	Remove <i>Isolepis prolifera</i> , Fig, Brazilian Pepper. Allow <i>Lepidosperma longitudinale</i> and other natives to regenerate at south east corner.	Recommended restoration	Grass weed control. May also need slashing to reduce fire hazard and seed bank. Remove Fig, <i>Arundo</i> , Brazilian Pepper, Pampas Grass. Plant natives.

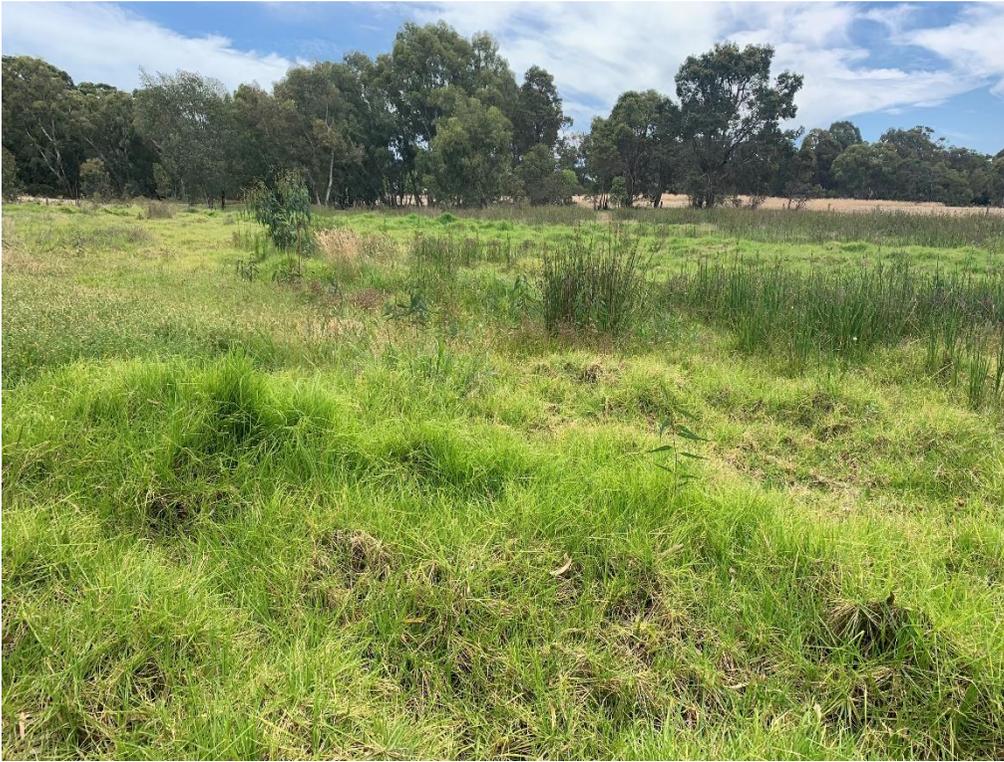
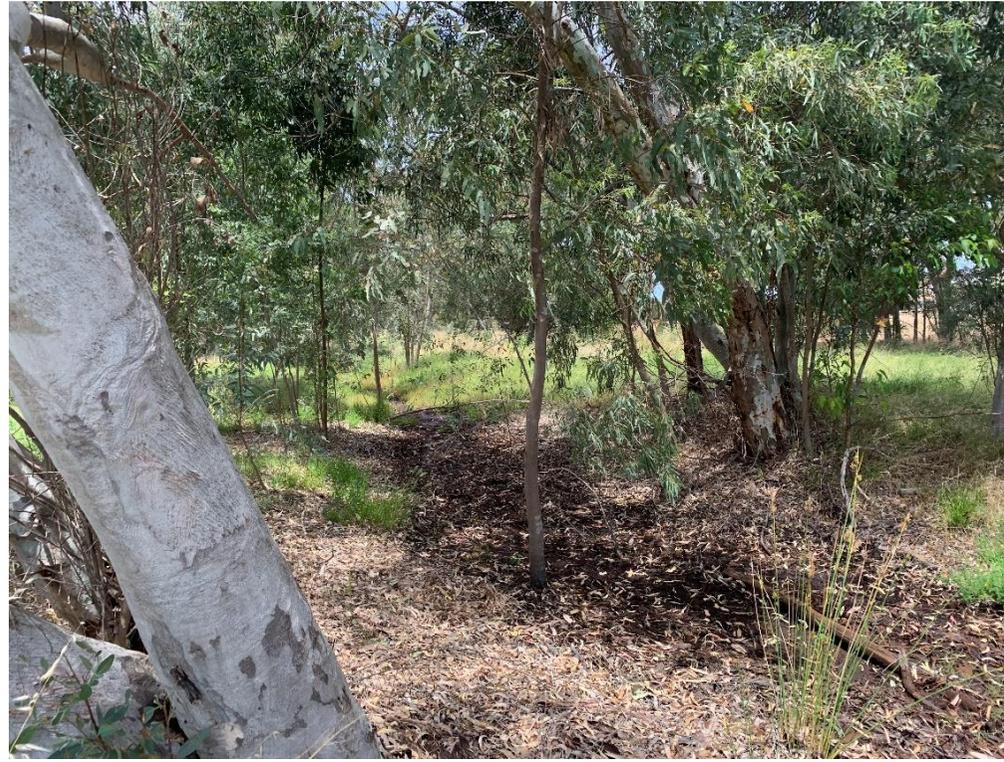
Vegetation description	Sparse <i>Eucalyptus</i> sp. over <i>Juncus pallidus</i> , <i>J. microcephalus</i> , weedy grasses and herbs	Vegetation description	<i>Eucalyptus rudis</i> and other <i>Eucalyptus</i> sp. over <i>Cenchrus clandestinus</i> and other weedy grasses				
Recommended restoration	Control Kikuyu. Allow <i>Juncus pallidus</i> to regenerate and plant local native plants including overstorey species.	Recommended restoration	Slash or control grasses floodplain, not along the edge of creek unless planting as that may destabilise soil.

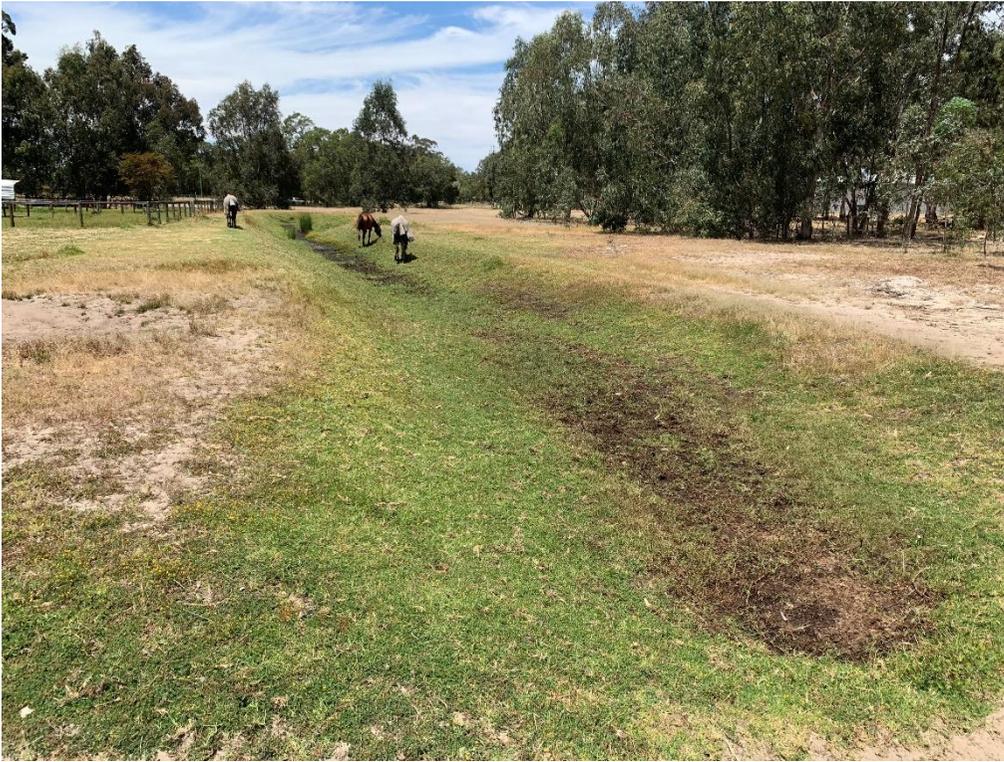
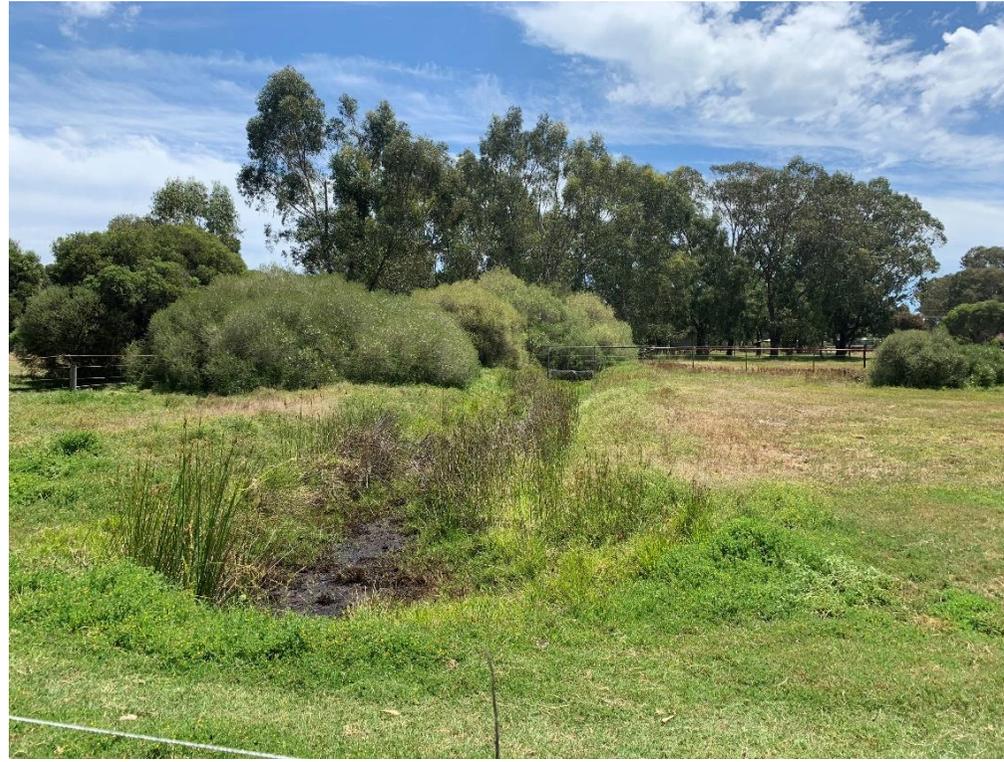
Vegetation description		<i>Weedy grasses and herbs</i>	
Recommended restoration		Consider fencing to limit horse access. Plant overstorey and <i>Juncus pallidus</i> along creek and around dam.		Vegetation description		<i>Sparse Eucalyptus rudis over Melaleuca viminea, Juncus pallidus and mixed grasses</i>	
Recommended restoration				Recommended restoration		Area is zoned for development. Review drainage and development plans. Plant trees, <i>Centella asiatica</i> and other understorey natives. Control grasses on upper banks.

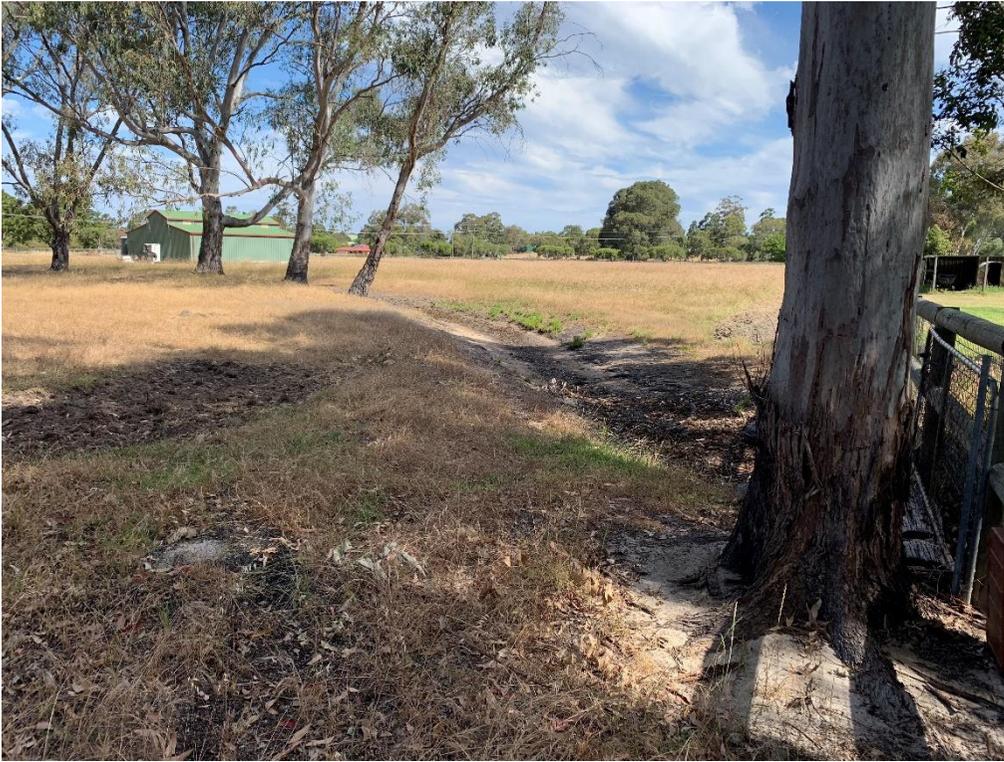
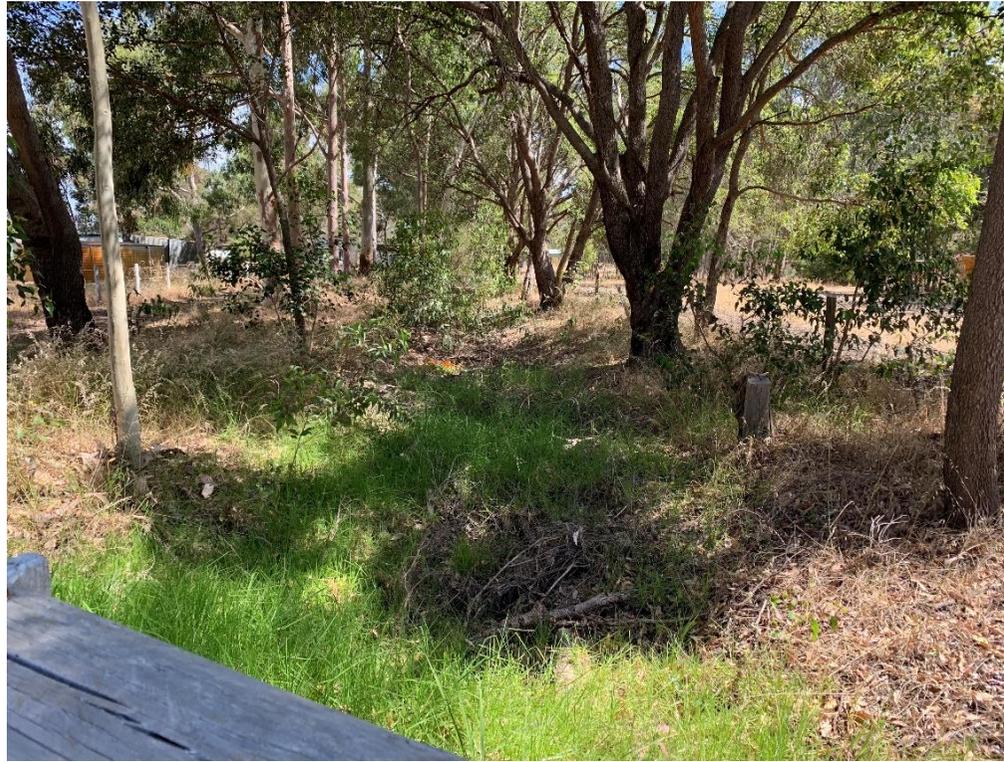
Vegetation description	<i>Eucalyptus</i> sp. possibly <i>E. citriodora</i> or <i>E. camaldulensis</i> over weedy grasses and herbs	Vegetation description	<i>Corymbia calophylla</i> , Eastern States <i>Eucalyptus</i> sp. and <i>E. rudis</i> over weedy grasses
Recommended restoration	Area is zoned for development. Review drainage and development plans. Remove pump and pipe, control grasses, plant native trees at downstream end and plant understory.	Recommended restoration	Area is zoned for development. Review drainage and development plans. Remove small Eastern States <i>Eucalyptus</i> sp. Control grasses and revegetate. Remove Nasturtium. Contain weedy grasses from adjacent paddock.

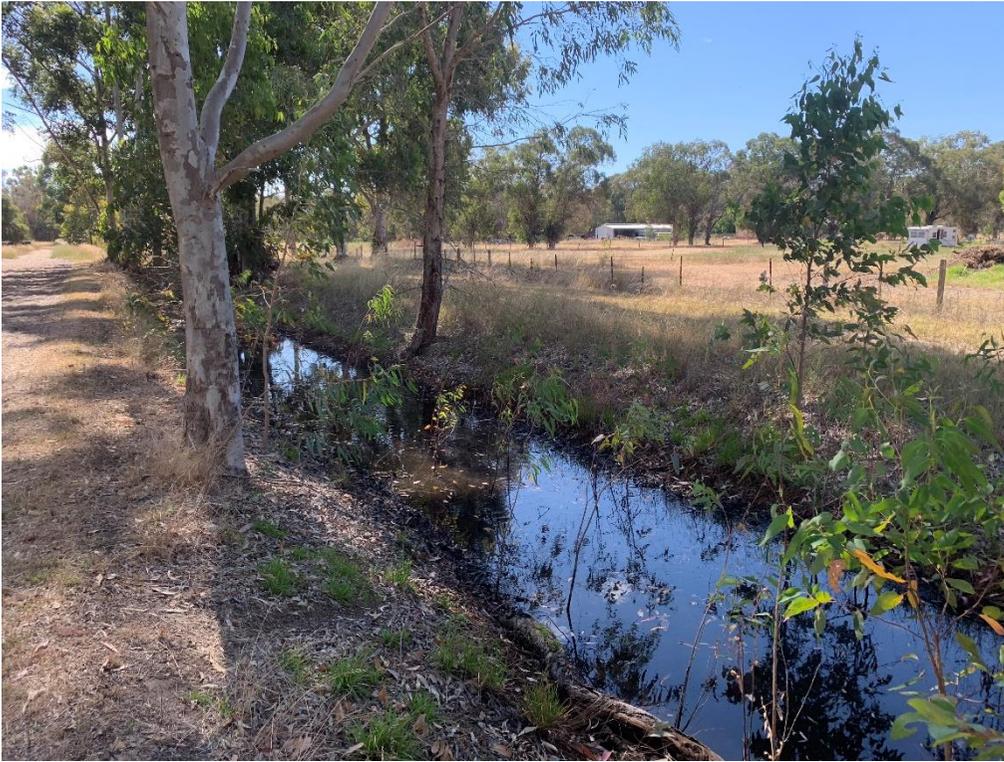
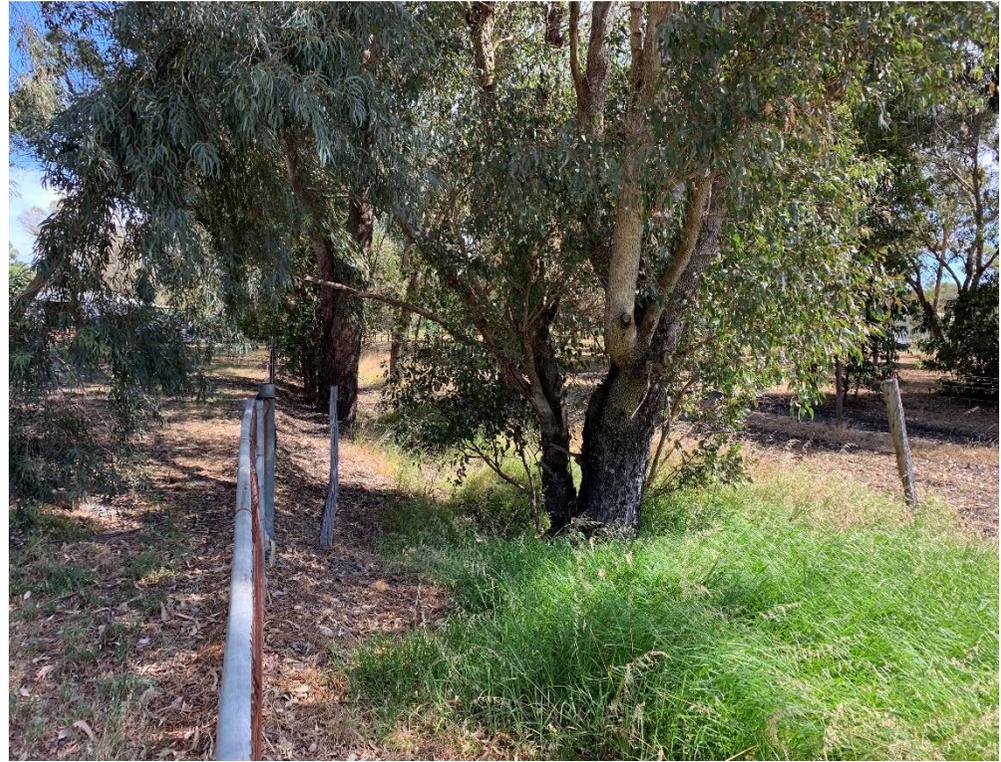
Vegetation description	Mixed Eastern States <i>Eucalyptus</i> sp. over weedy grasses	Vegetation description	<i>Eucalyptus rudis</i> over weedy grasses
Recommended restoration	Area is zoned for development. Review drainage and development plans. Manage grassy weeds and Nut Grass. Hard to plant with wetland species as water is temporary.	Recommended restoration	Area is zoned for development. Review drainage and development plans. Control grasses and plant understorey.

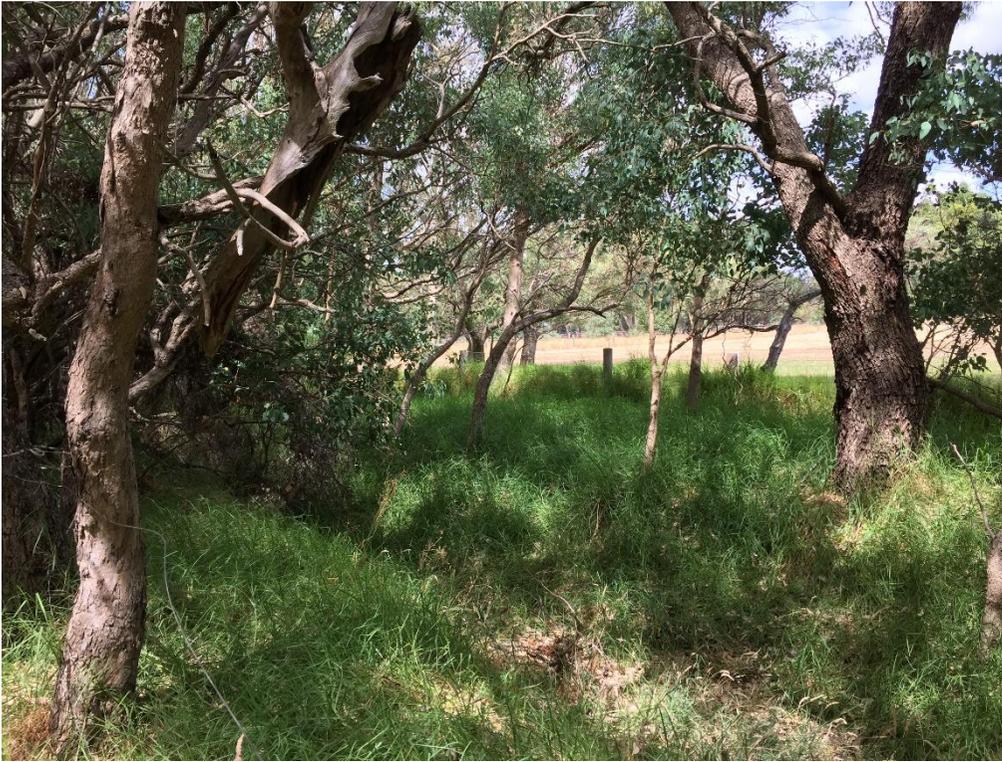
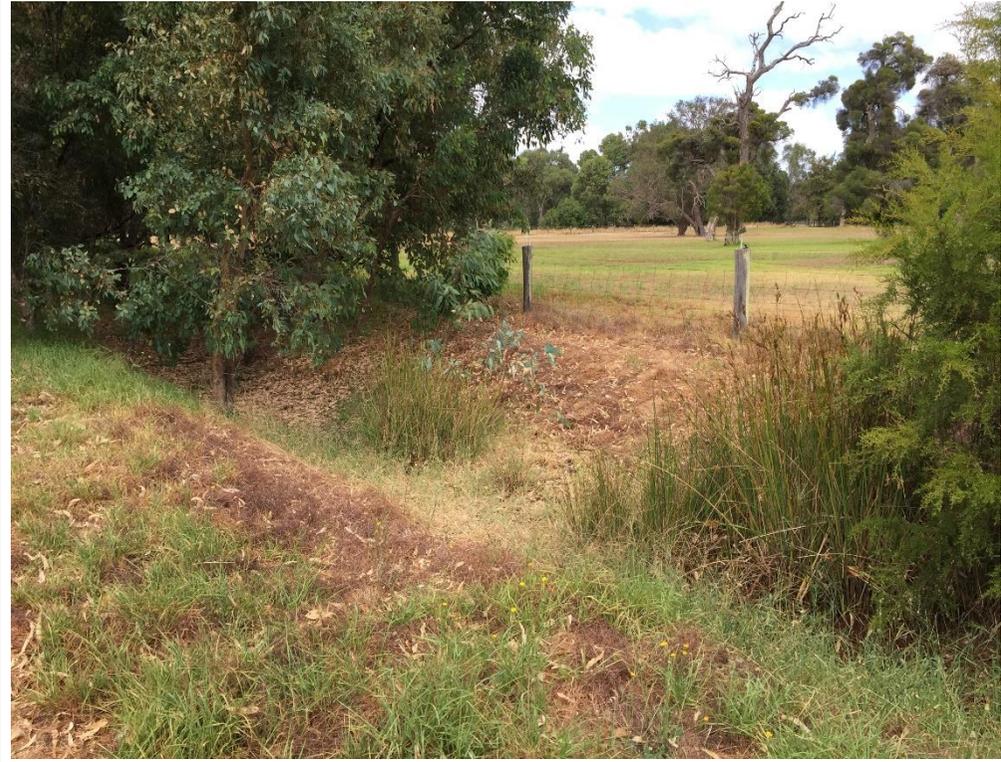
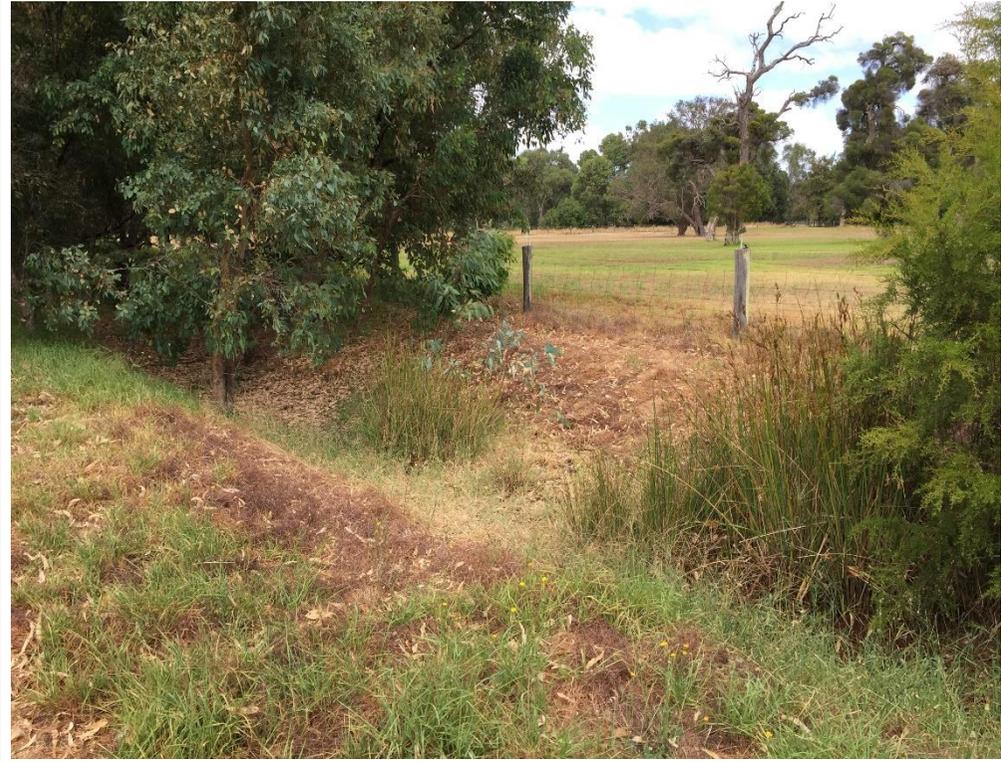
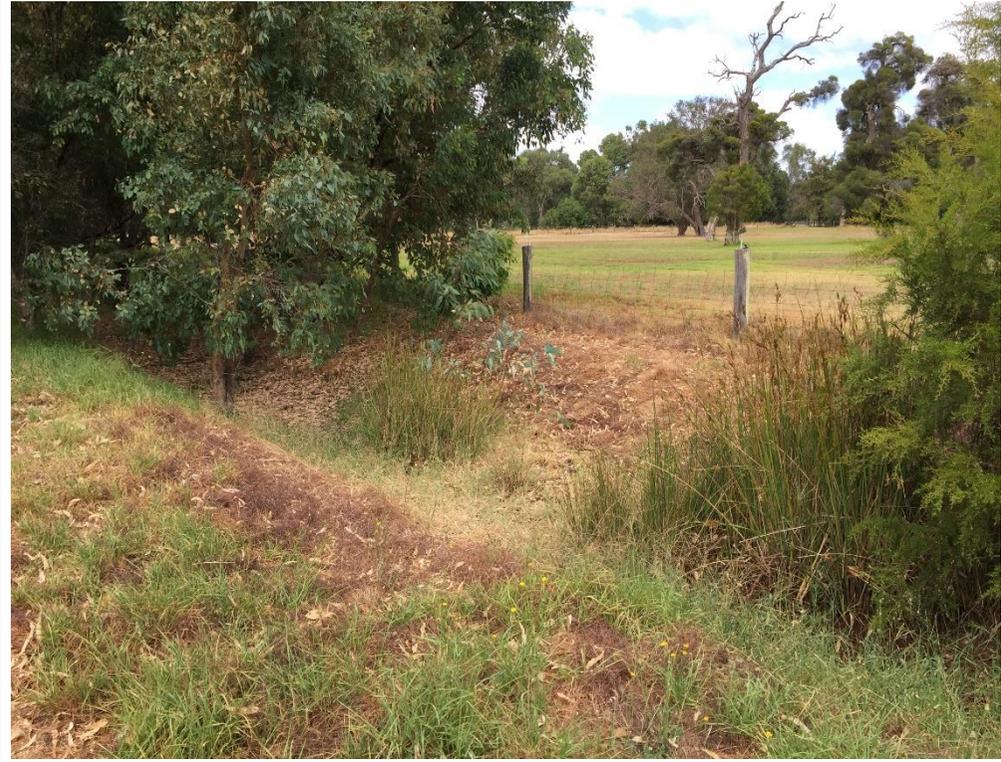
Vegetation description	<i>Eucalyptus rudis</i> over <i>Cenchrus clandestinus</i>	Vegetation description	<i>Corymbia calophylla</i> and mixed Eastern States <i>Eucalyptus</i> sp. over weedy grasses	Vegetation description	<i>Corymbia calophylla</i> and mixed Eastern States <i>Eucalyptus</i> sp. over weedy grasses	Vegetation description	<i>Corymbia calophylla</i> and mixed Eastern States <i>Eucalyptus</i> sp. over weedy grasses
Recommended restoration	Area is zoned for development. Review drainage and development plans. Remove the 1 Brazilian Pepper on the left bank. Control grasses and plant understorey. Move left bank fence further back behind the tree line.	Recommended restoration	Area is zoned for development. Review drainage and development plans. Remove the 1 Brazilian Pepper on the right bank. Remove Flinders Range Wattles. Continue controlling understorey weeds.	Recommended restoration	Area is zoned for development. Review drainage and development plans. Remove the 1 Brazilian Pepper on the right bank. Remove Flinders Range Wattles. Continue controlling understorey weeds.	Recommended restoration	Area is zoned for development. Review drainage and development plans. Remove the 1 Brazilian Pepper on the right bank. Remove Flinders Range Wattles. Continue controlling understorey weeds.

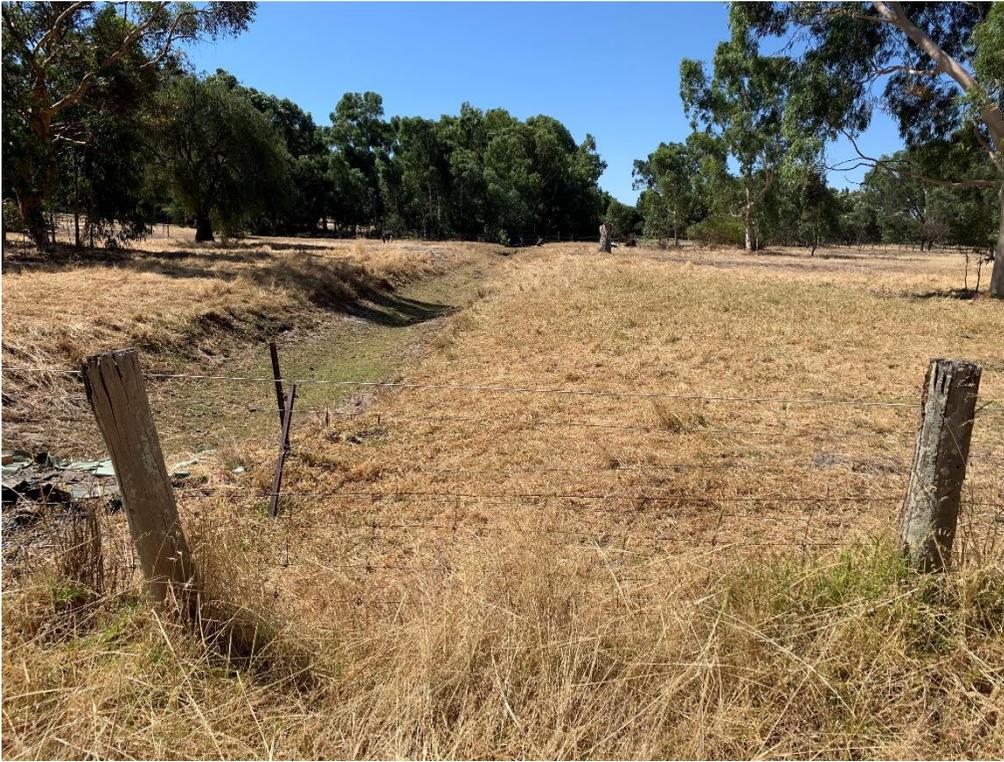
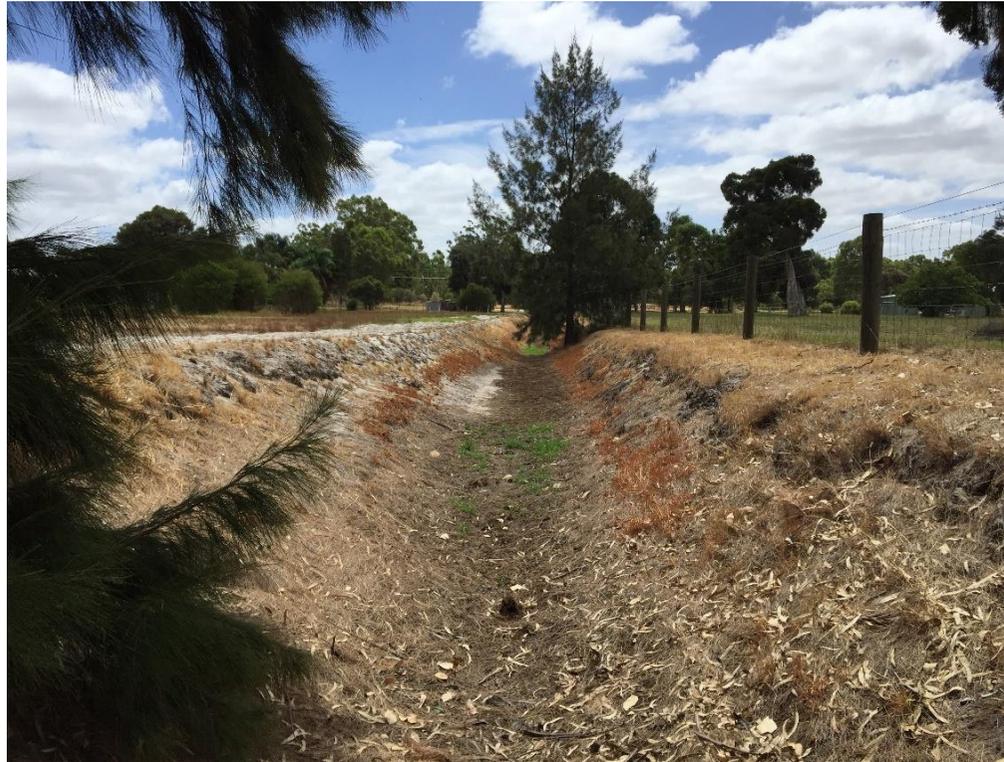
Vegetation description	No overstorey. Weedy grasses	Vegetation description	Very open weedy <i>Casuarina</i> sp. over weedy grasses and herbs				
Recommended restoration	Area is zoned for development. Review drainage and development plans. Rehabilitation easier if the cows can be removed. Plant overstorey and sedges. Control Veldt Grass if revegetating.	Recommended restoration	Area is zoned for development. Review drainage and development plans. Would need to fence on right bank and plant if doing anything.

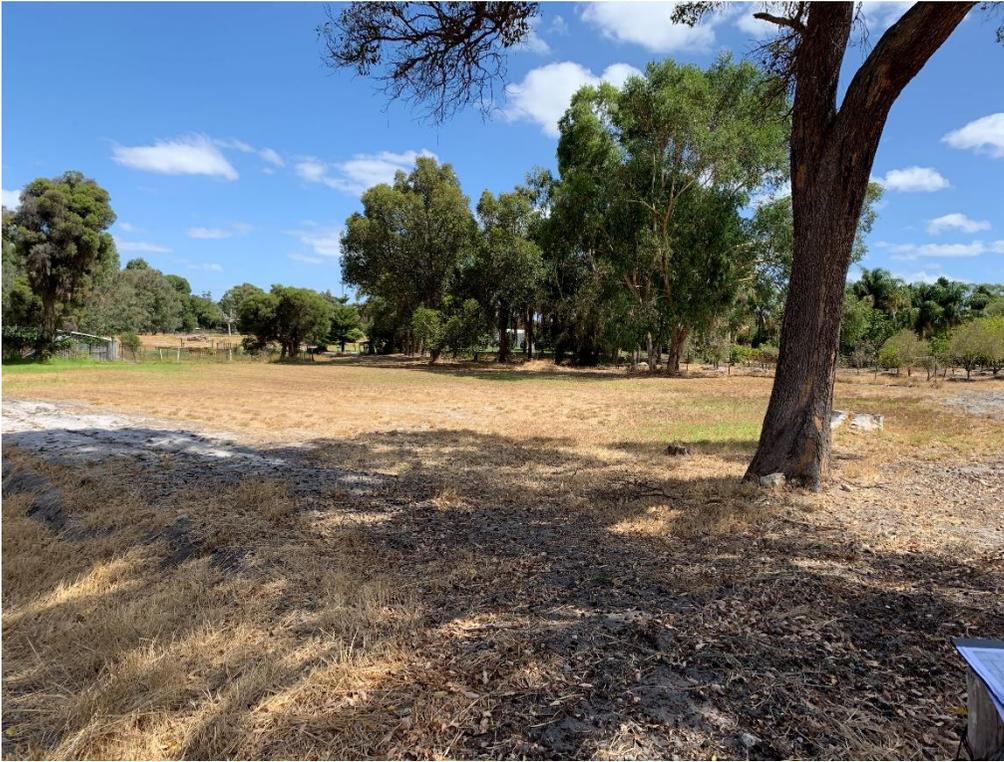
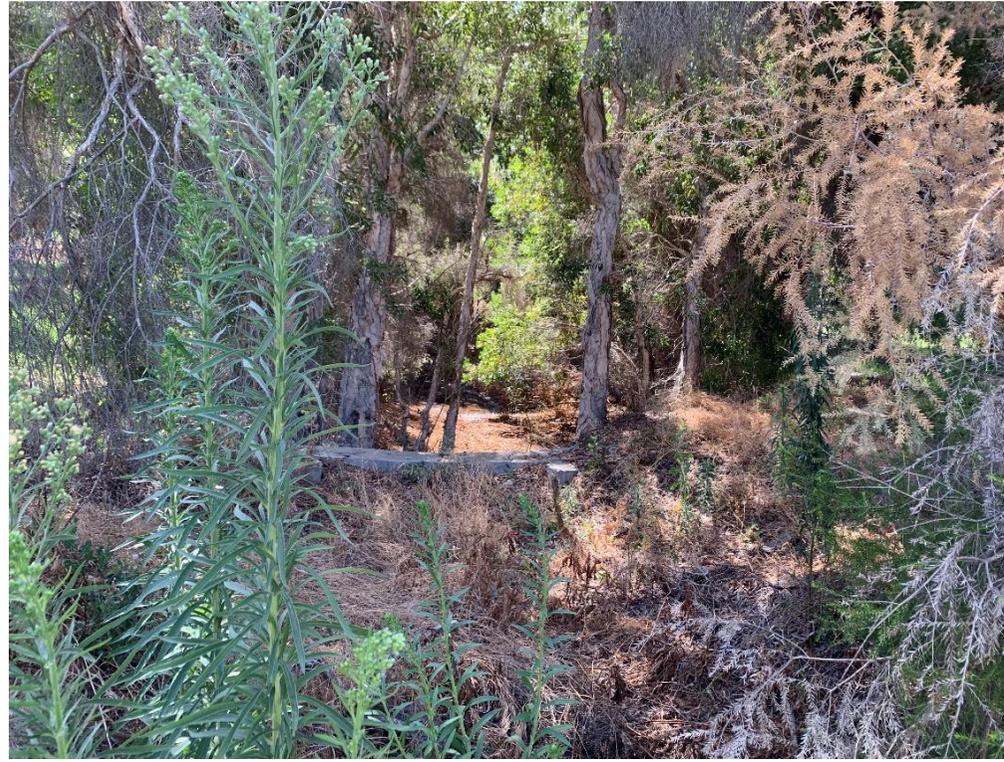
Vegetation description	Garden palms, fruit trees and other exotic trees over weedy grasses	Vegetation description	Mixed exotic trees over mixed weedy grasses				
Recommended restoration	Area is zoned for development. Review drainage and development plans.	Recommended restoration	Area is zoned for development. Review drainage and development plans.
