Department of **Biodiversity,
Conservation and Attractions**

Saint Leonards Creek Foreshore Condition Assessment

Version: 2

Last Updated: November 2020

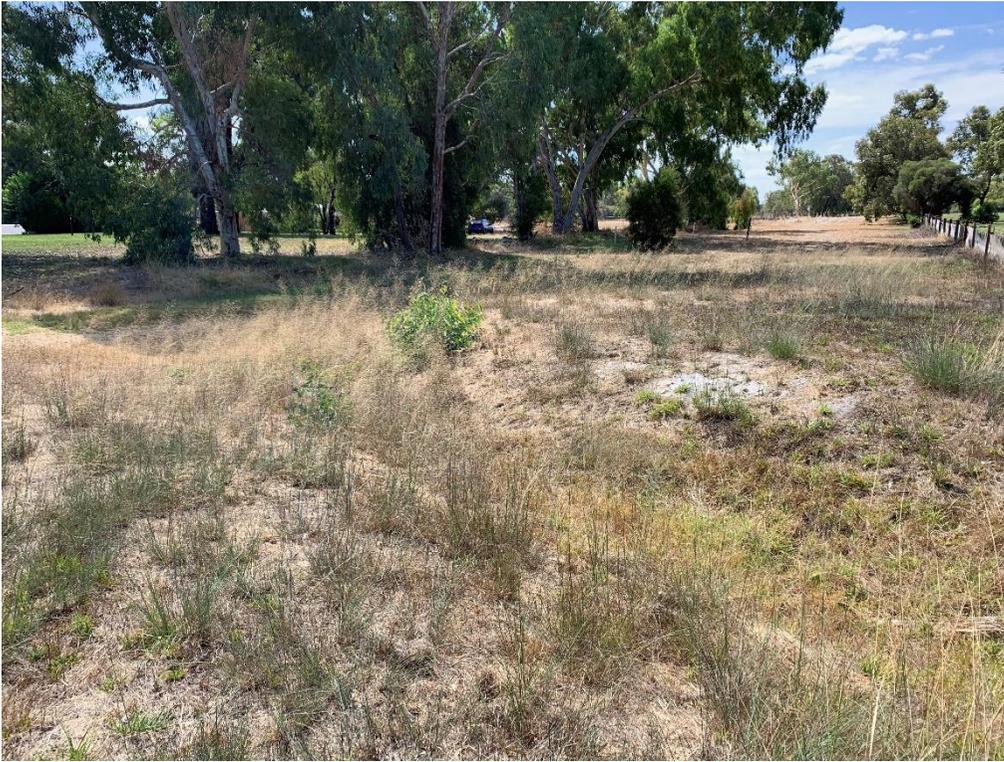
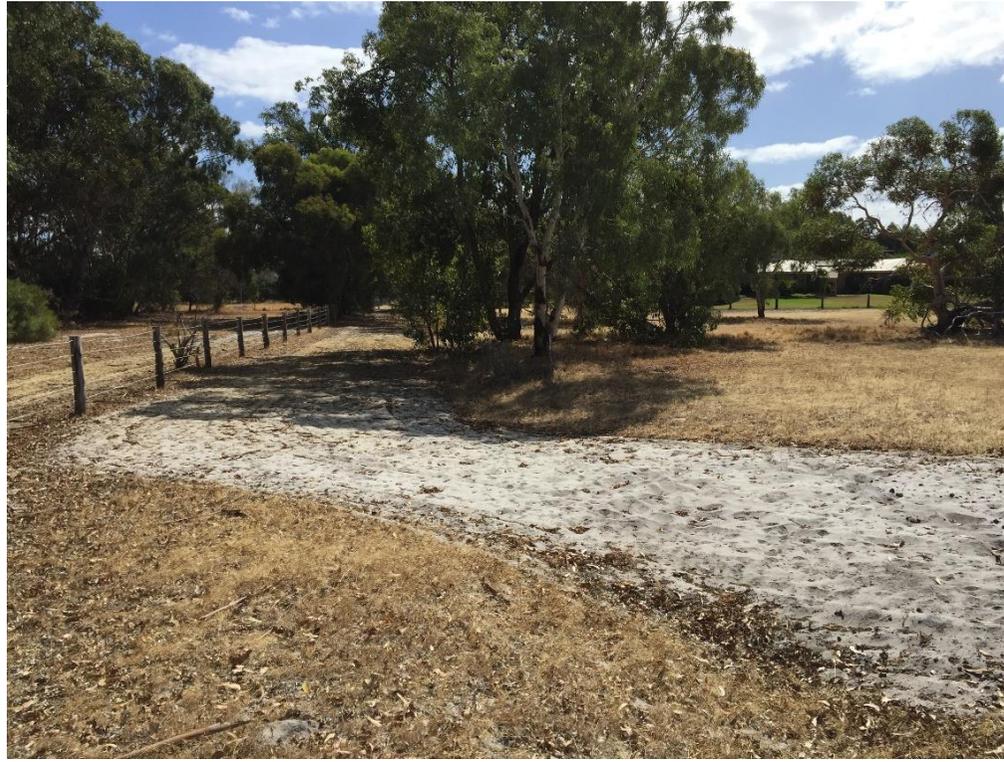
Vegetation description	Eastern States <i>Eucalyptus</i> sp. over <i>Avena barbata</i> and <i>Ehrharta calycina</i>	Vegetation description	Eastern States <i>Eucalyptus</i> sp. over <i>Melaleuca preissiana</i> over weedy grasses				
Recommended restoration	Area is zoned for development. Review drainage and development plans. Wetland plants unlikely to survive here - substrate too dry and almost no water flow year-round.	Recommended restoration	Area is zoned for development. Review drainage and development plans. Little hope of this being a creek again. Wetland plants unlikely to survive here - substrate too dry and almost no water flow year-round.

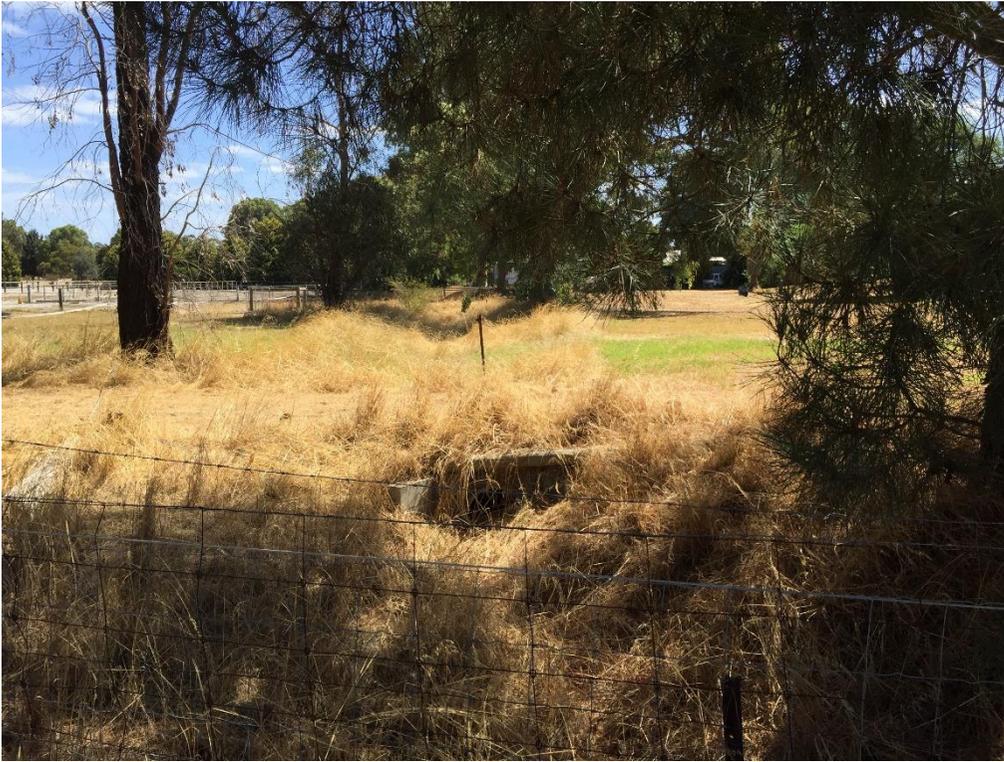
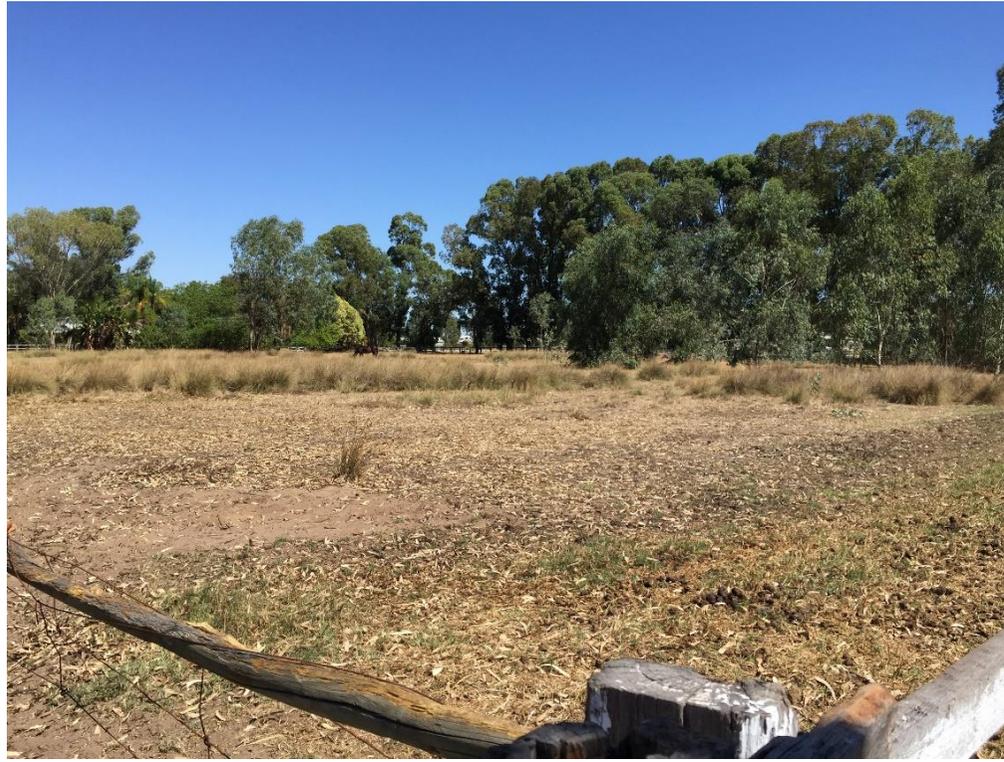
Vegetation description	Open Eastern States <i>Eucalyptus</i> sp. and <i>Pinus</i> sp. over <i>Ehrharta</i> sp.	Vegetation description	Very open mixed <i>Eucalyptus</i> sp. over mixed weedy grasses				
Recommended restoration	Area is zoned for development. Review drainage and development plans. Barely a creek any longer so planting wetland species is unlikely to be effective. Establish an overstorey by planting dryland trees and shrubs.	Recommended restoration	Area is zoned for development. Review drainage and development plans.

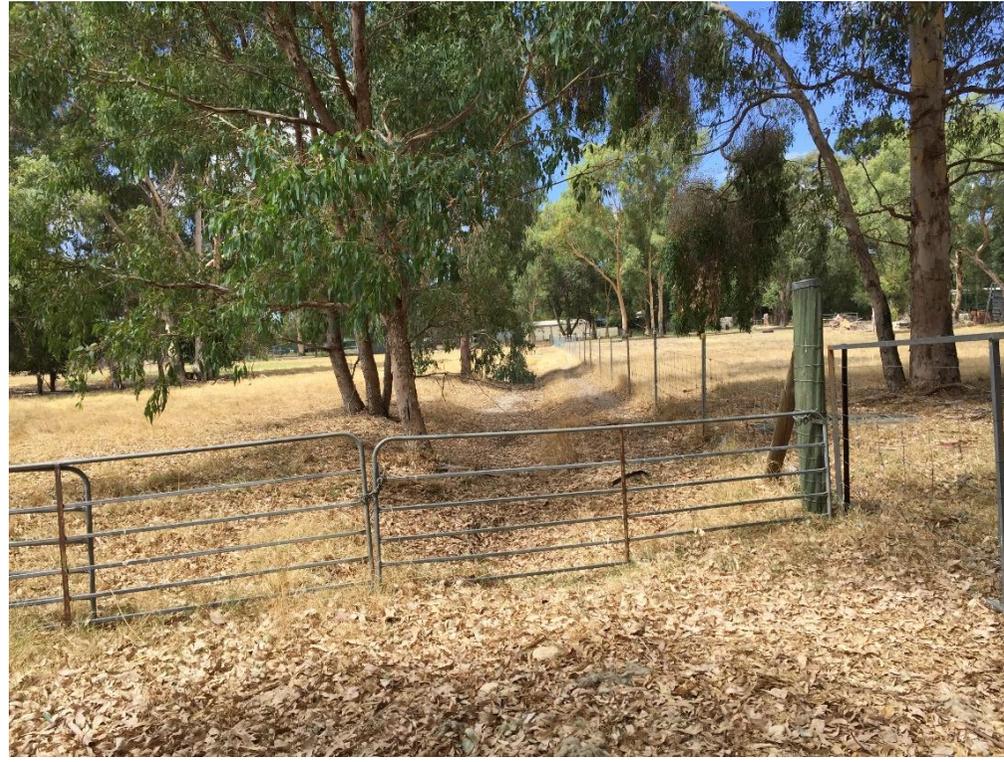
Vegetation description	Open Eastern States <i>Eucalyptus</i> sp. over dried out weedy grasses and herbs	Vegetation description	<i>Eucalyptus rudis</i> over weedy grasses
Recommended restoration	Area is zoned for development. Review drainage and development plans.	Recommended restoration	Area is zoned for development. Review drainage and development plans. If not to be redeveloped, fence left bank and clear out culvert near easement.

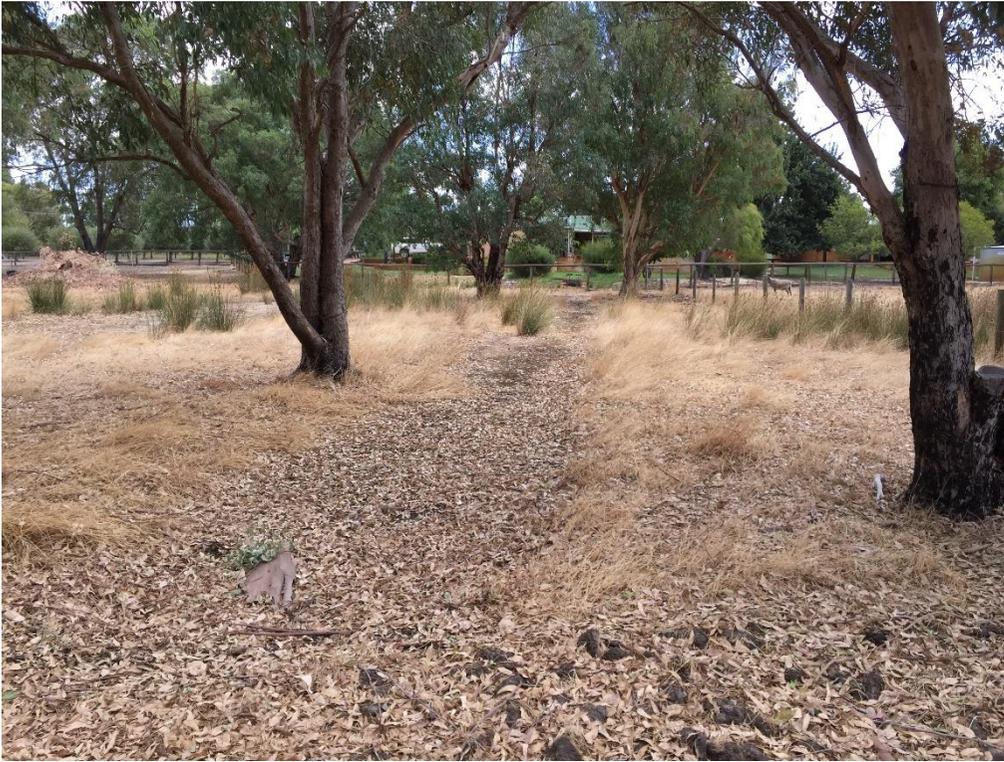
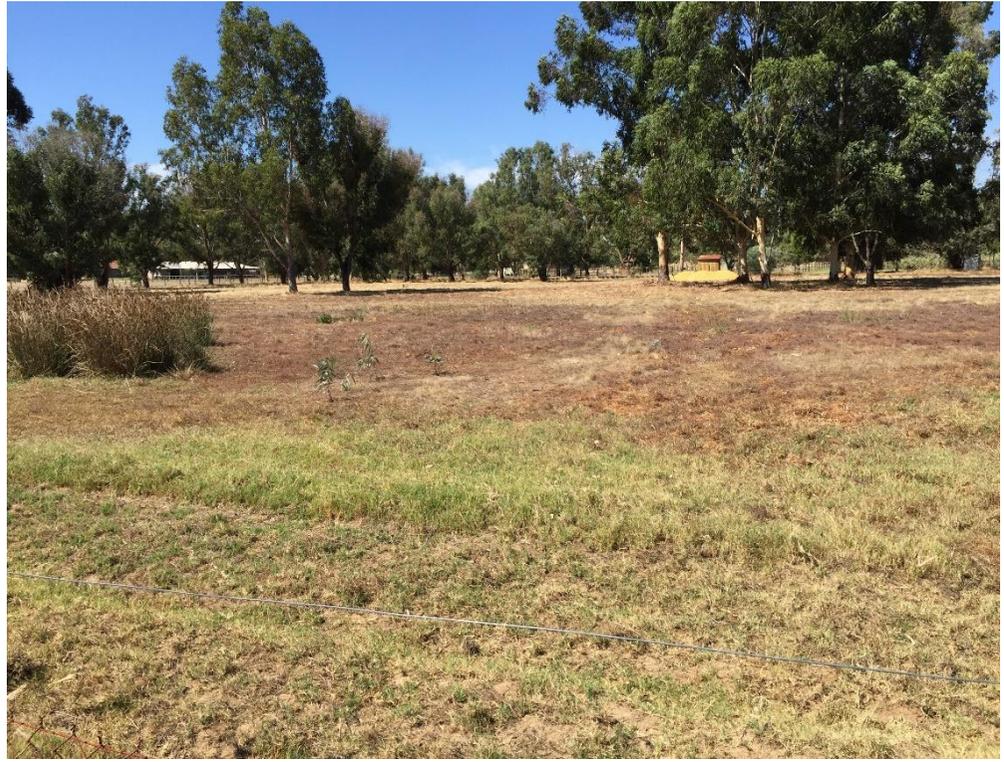
Vegetation description	Open <i>Eucalyptus rudis</i> over <i>Juncus pallidus</i> and mixed grasses	Vegetation description	Eastern States <i>Eucalyptus</i> sp. and exotic trees over fruit trees and <i>Cynodon dactylon</i>
Recommended restoration	Area is zoned for development. Review drainage and development plans. If not to be redeveloped, restrict sheep access to sedges. Revegetate with more sedges and diverse wetland plants.	Recommended restoration	Area is zoned for development. Review drainage and development plans. Mervac may retain the large Eastern States Eucalyptus. Remove Castor Oil. Plant dryland sedges and overstorey species.

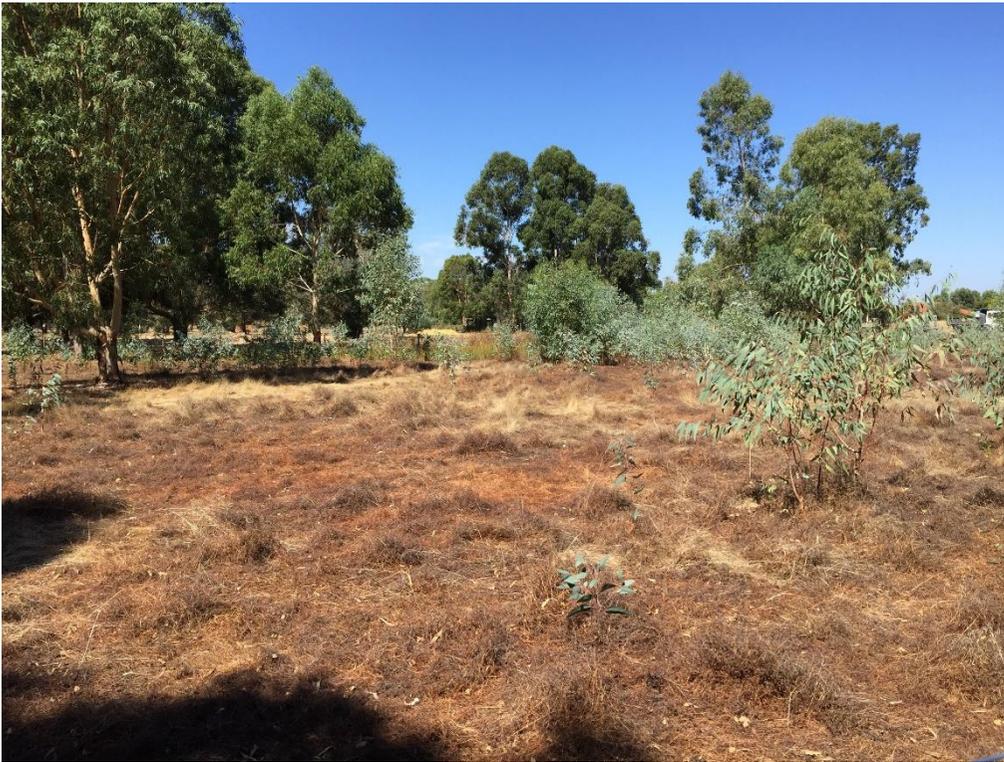
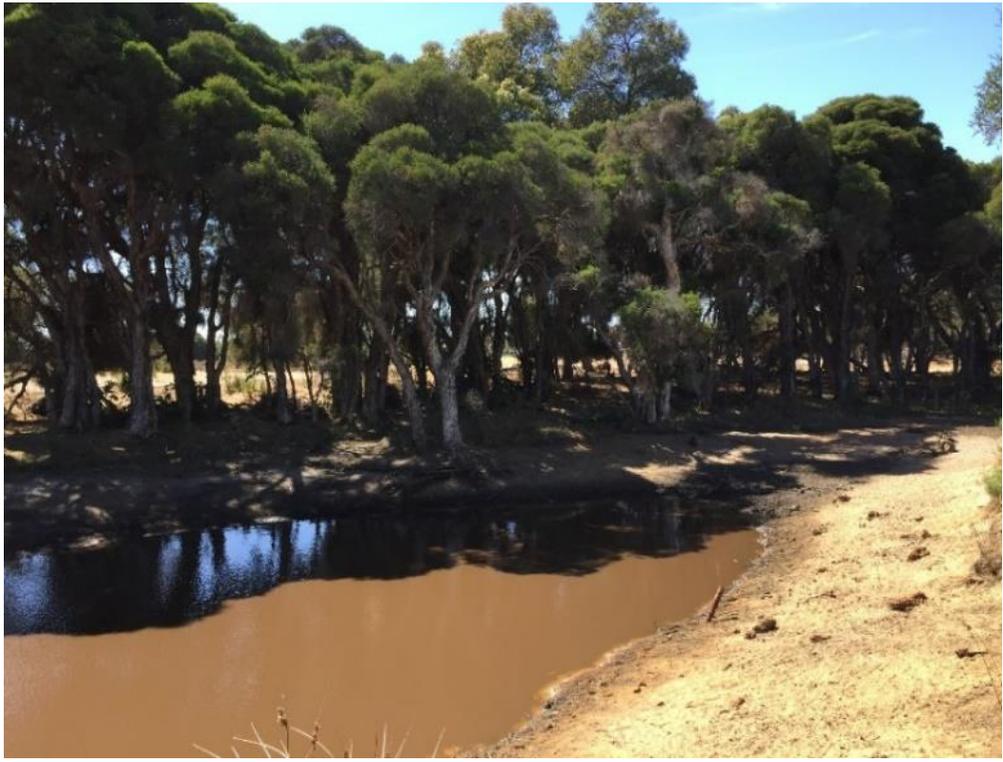
Vegetation description	Eastern States <i>Eucalyptus</i> sp. over mixed weedy grasses and scattered <i>Juncus pallidus</i>	Vegetation description	<i>Melaleuca preissiana</i> over <i>Melaleuca lateritia</i> , <i>Centella asiatica</i> , mixed weedy grasses and some <i>Lepidosperma longitudinale</i>				
Recommended restoration	Area is zoned for development. Review drainage and development plans. Plant the easement over the Dampier Bunbury gas pipeline with local native species including sedges.	Recommended restoration	Retain as much of the overstorey as practicable during development.

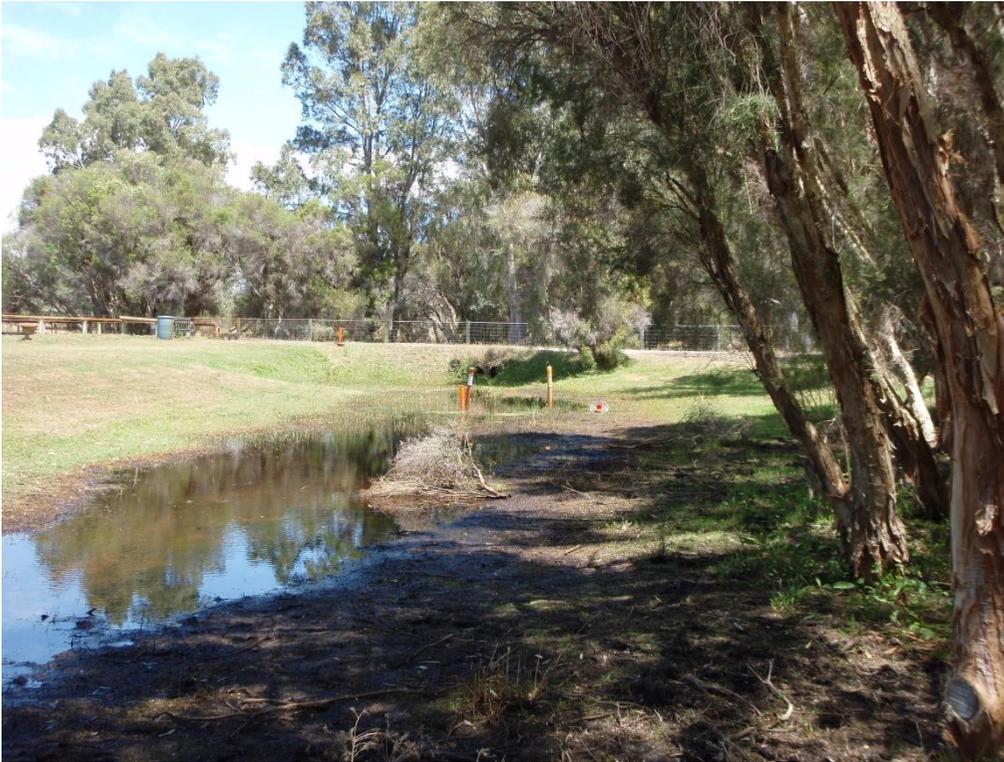
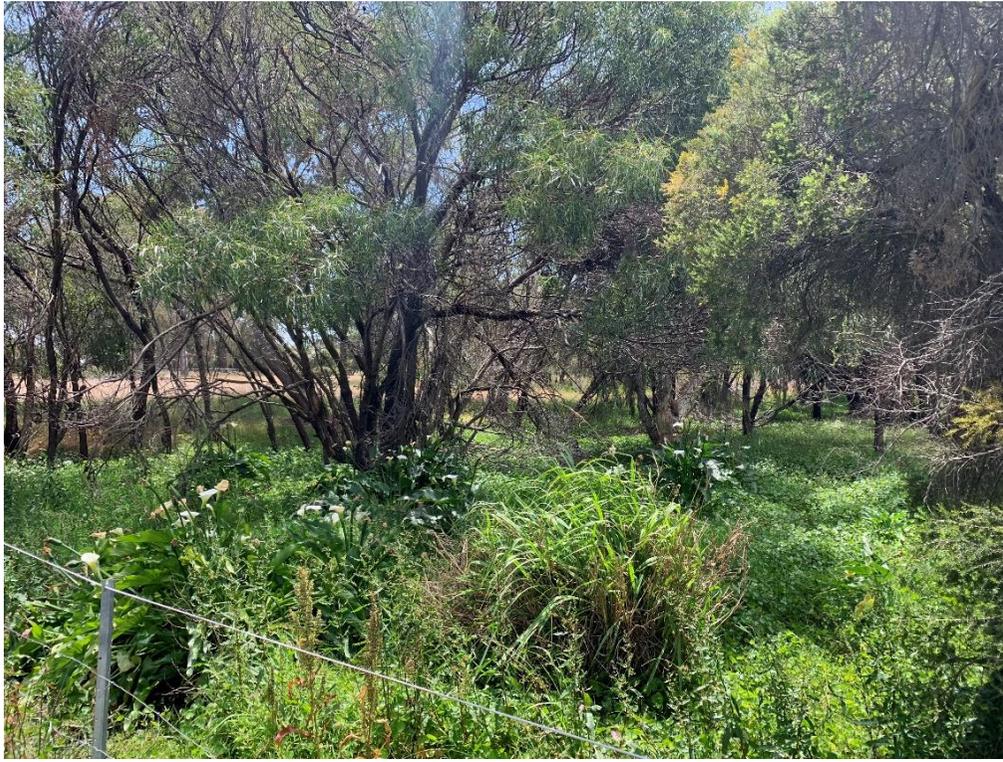
Vegetation description	<i>Melaleuca raphiophylla</i> over <i>Centella asiatica</i> , <i>Juncus pallidus</i> and <i>Cenchrus clandestinus</i>	Vegetation description	<i>Melaleuca preissiana</i> and <i>Acacia saligna</i> over <i>Centella asiatica</i> , <i>Juncus pallidus</i> and mixed grasses and herbs				
Recommended restoration	Remove Brazilian Pepper.	Recommended restoration	Grass selective weed control. Remove Arum Lilies. Plant native sedges.

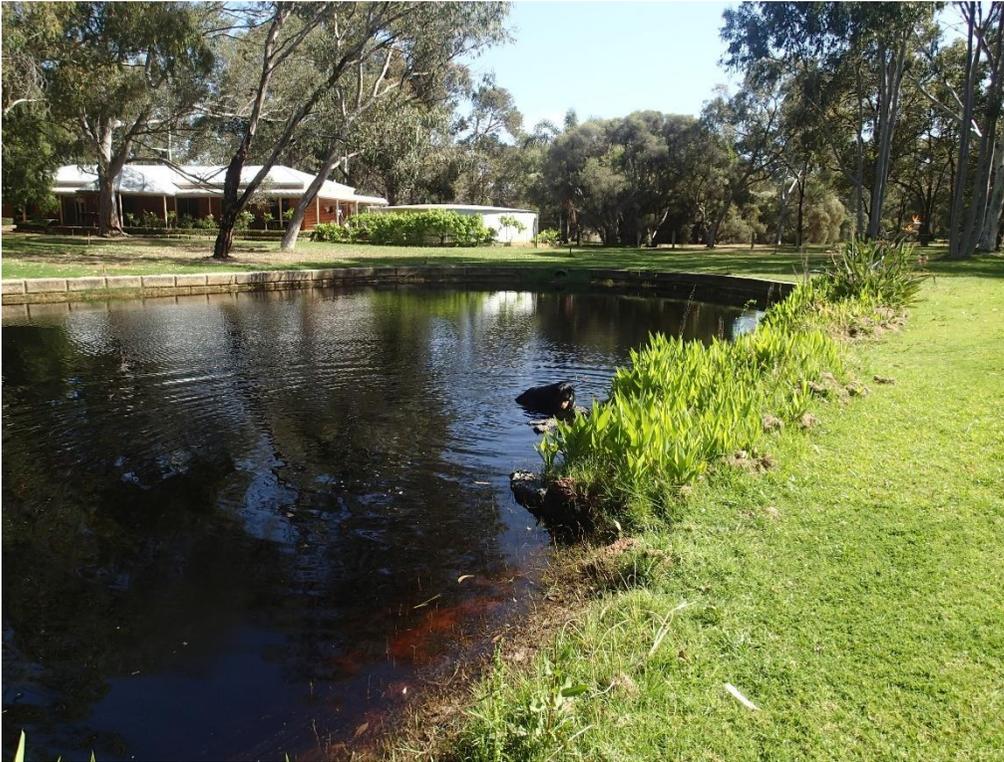
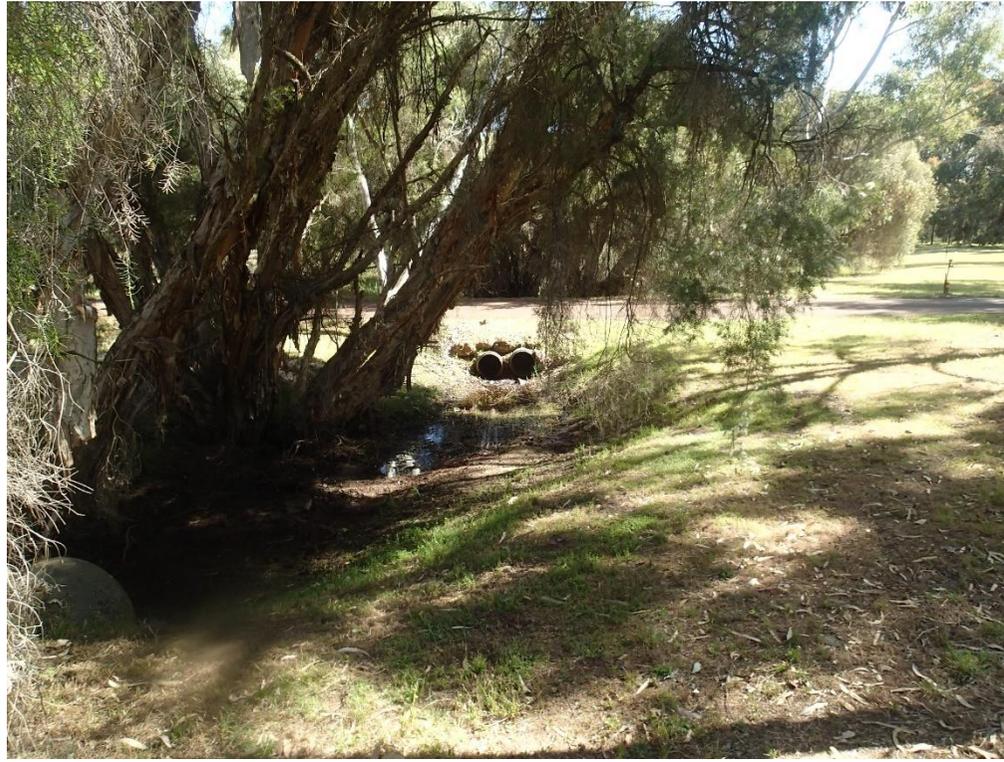
Vegetation description	Very occasional <i>Melaleuca raphiophylla</i> and Eastern States <i>Eucalyptus</i> sp. (White gums) over <i>Canna</i> sp. and mixed grasses	Vegetation description	<i>Melaleuca raphiophylla</i> over low weedy grasses and herbs				
Recommended restoration	Would need major works to restore original creekline. Replace <i>Canna</i> Lilies with native sedges and plant behind limestone blocks on left bank.	Recommended restoration	Plant sedges and mid storey species (weeds are currently low in height and creek is easy to access).

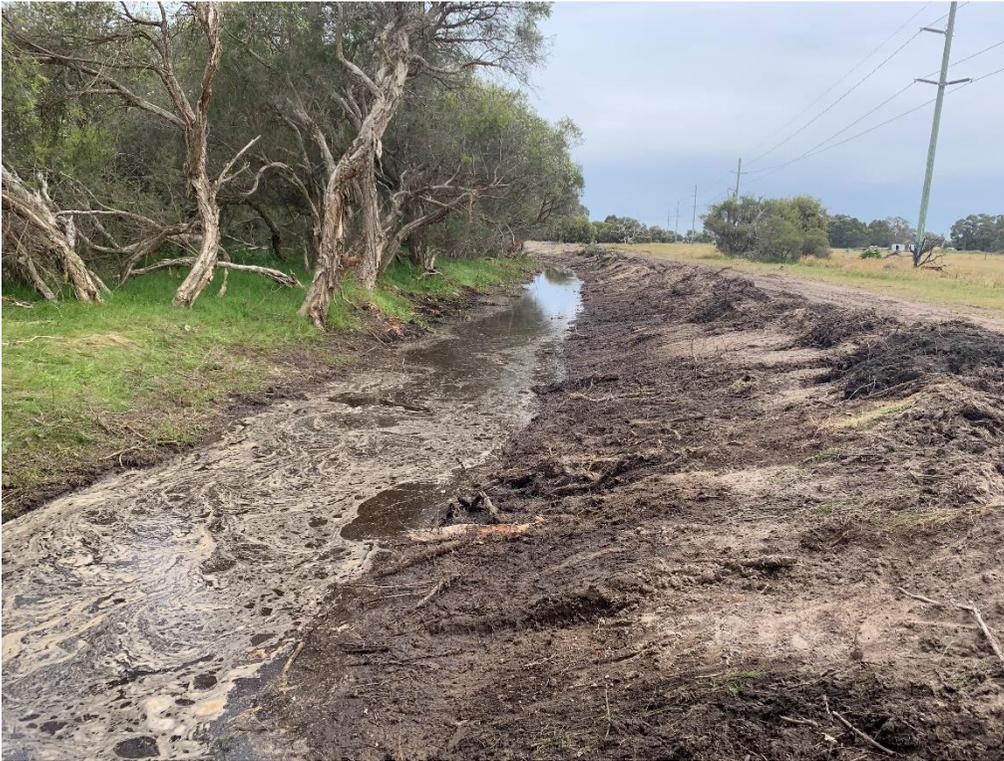
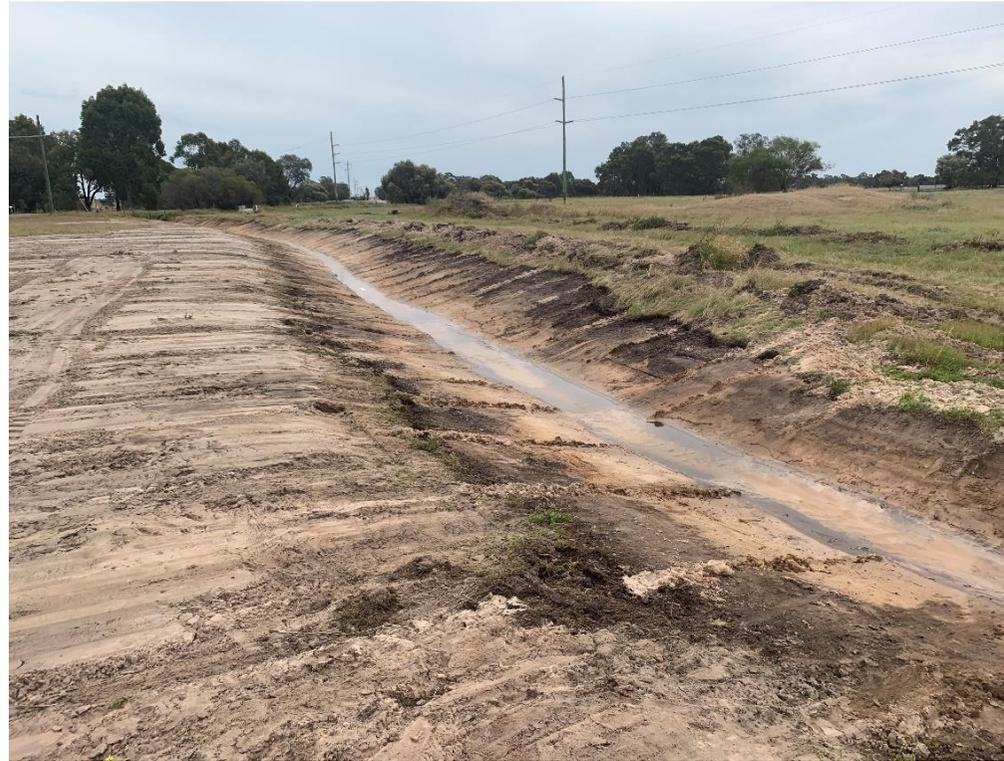
Vegetation description	<i>Melaleuca raphiophylla</i> over <i>Juncus pallidus</i> and weedy grasses	Vegetation description	Mixed weedy herbs and grasses. No overstorey				
Recommended restoration	Review wetland and compensation basin plans for this area. Ensure plans include local native species to provide habitat and shade over the water. Remove Candelabra Aloe.	Recommended restoration	Review wetland and compensation basin plans for this area. Ensure plans include local native species to provide habitat and shade over the water.

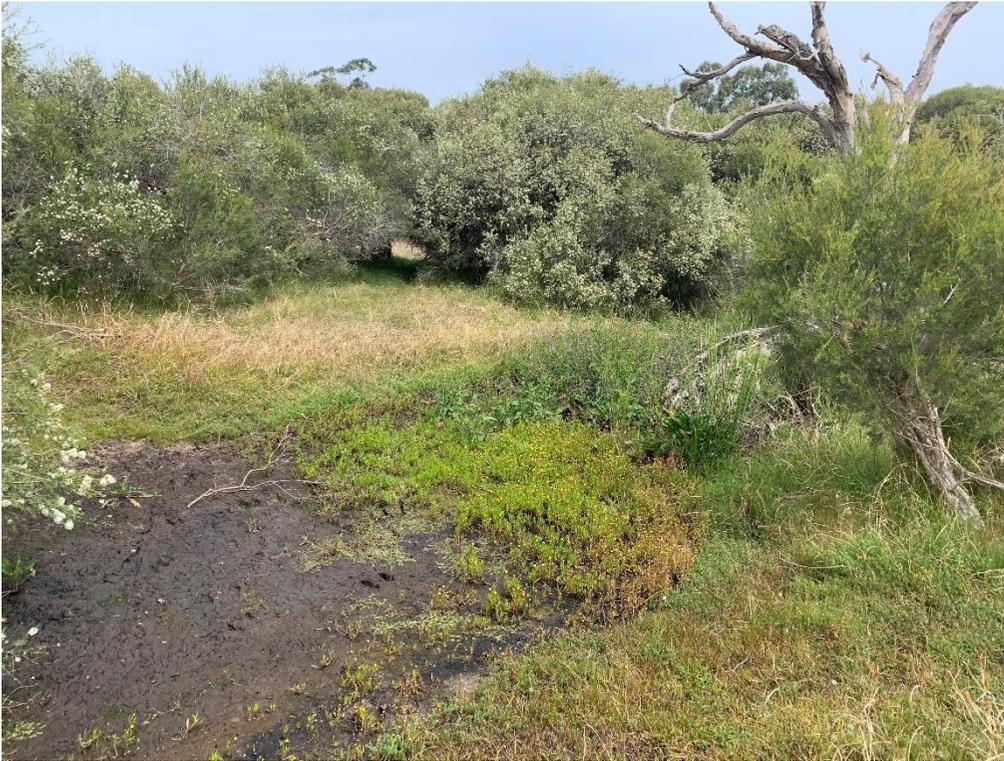
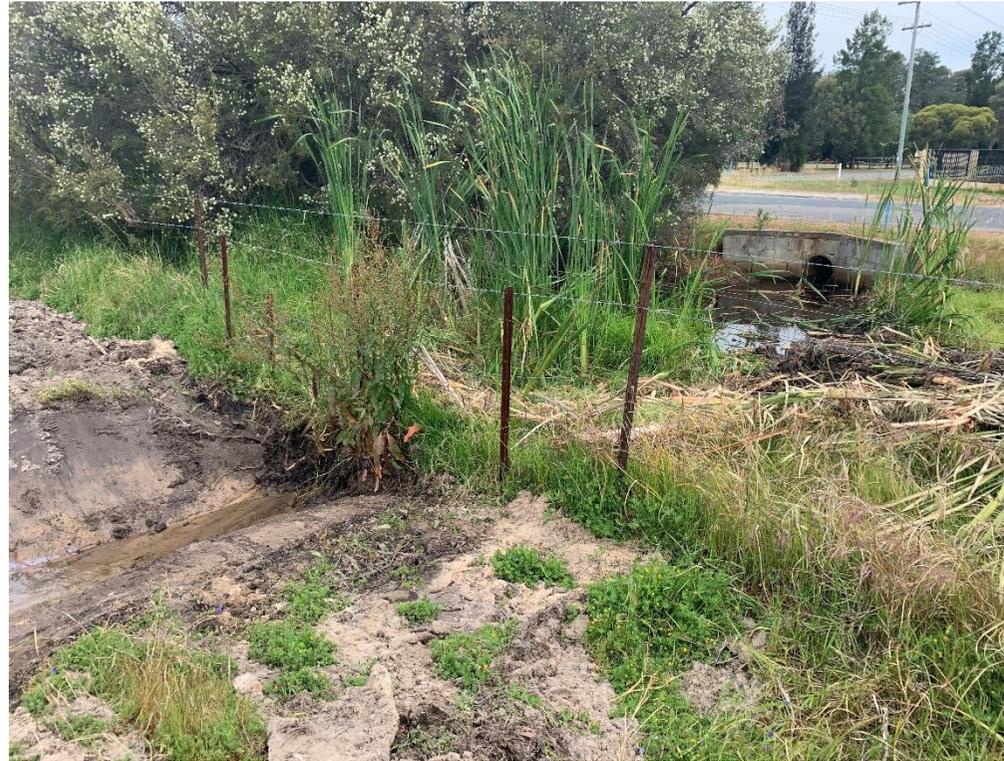
Vegetation description	<i>Melaleuca raphiophylla</i> over mixed grasses and herbs	Vegetation description	Annual grasses and herbs
Recommended restoration	Liaise with City of Swan to reduce further native vegetation damage during future management. Remove inkweed. Control grasses and revegetate. Ensure wetland management plans use local native species to provide habitat and shade over the water.	Recommended restoration	Ensure wetland development plans use locally native species to provide habitat and shade over the water. Remove blockage in creek near fenceline which is slowing flow and causing localised flooding.

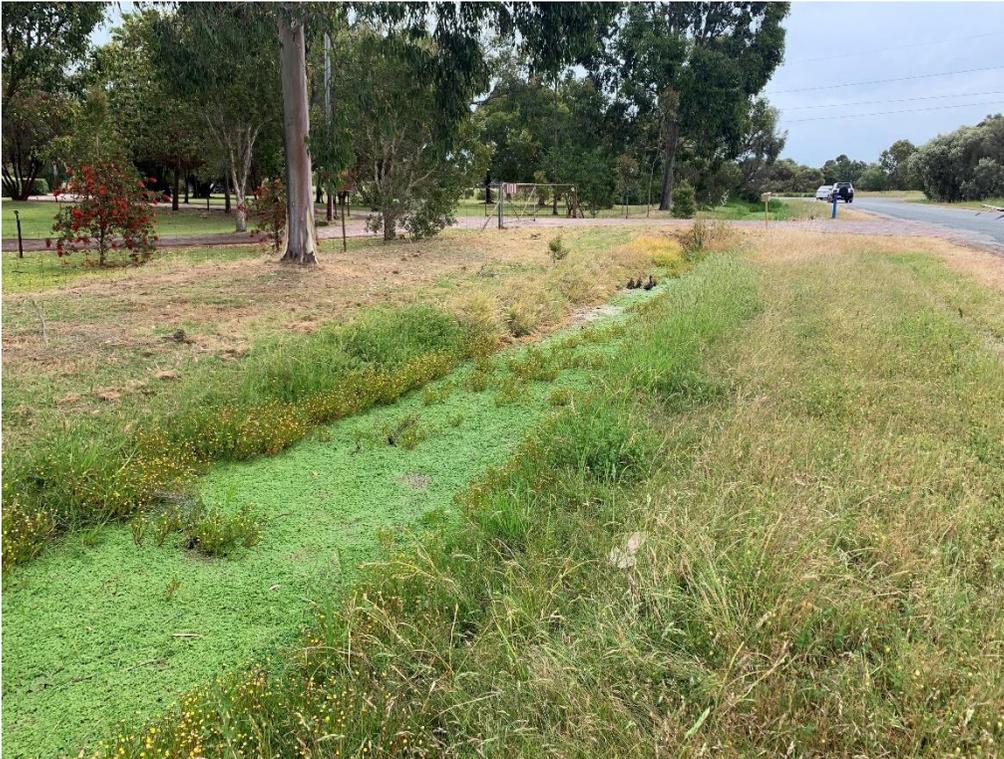
Vegetation description	Mixed planted trees and shrubs over <i>Cenchrus clandestinus</i> and mixed weedy grasses and herbs	Vegetation description	<i>Melaleuca viminea</i> over <i>Isolepis prolifera</i> , <i>Centella asiatica</i> , <i>Ficus carica</i> and <i>Lepidosperma longitudinale</i>				
Recommended restoration	Limited in ability to restore the drain because it gets road stormwater and paddock runoff and is a very narrow area.	Recommended restoration	Ensure weedy material, particularly Cottonbush, does not spread during clearing and construction.

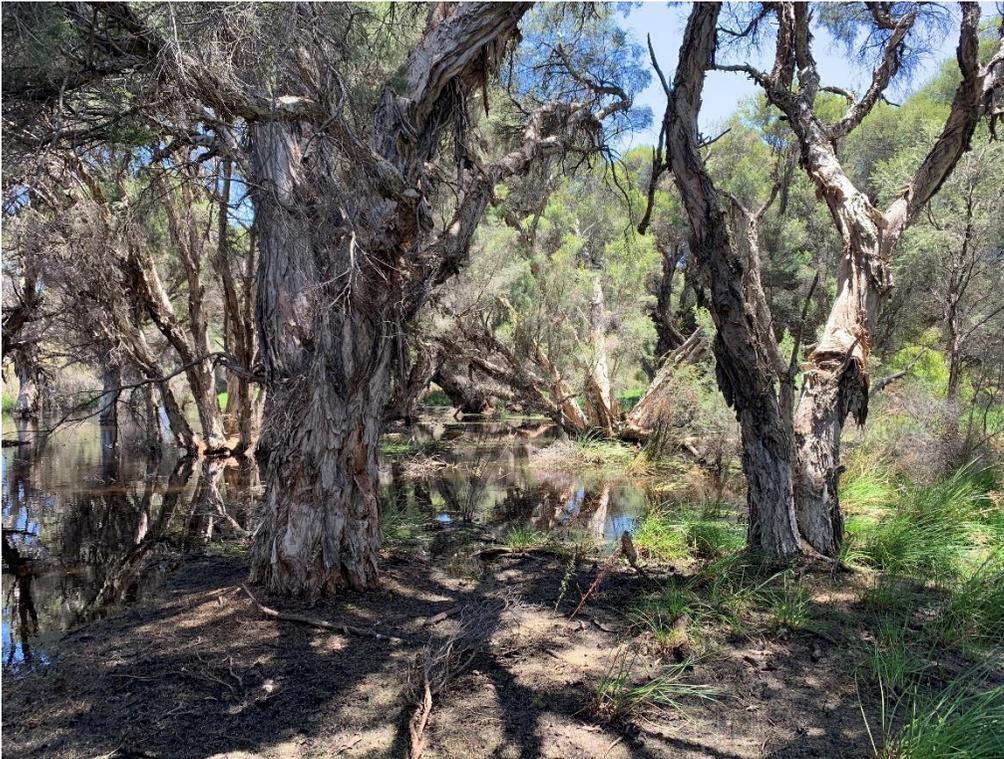
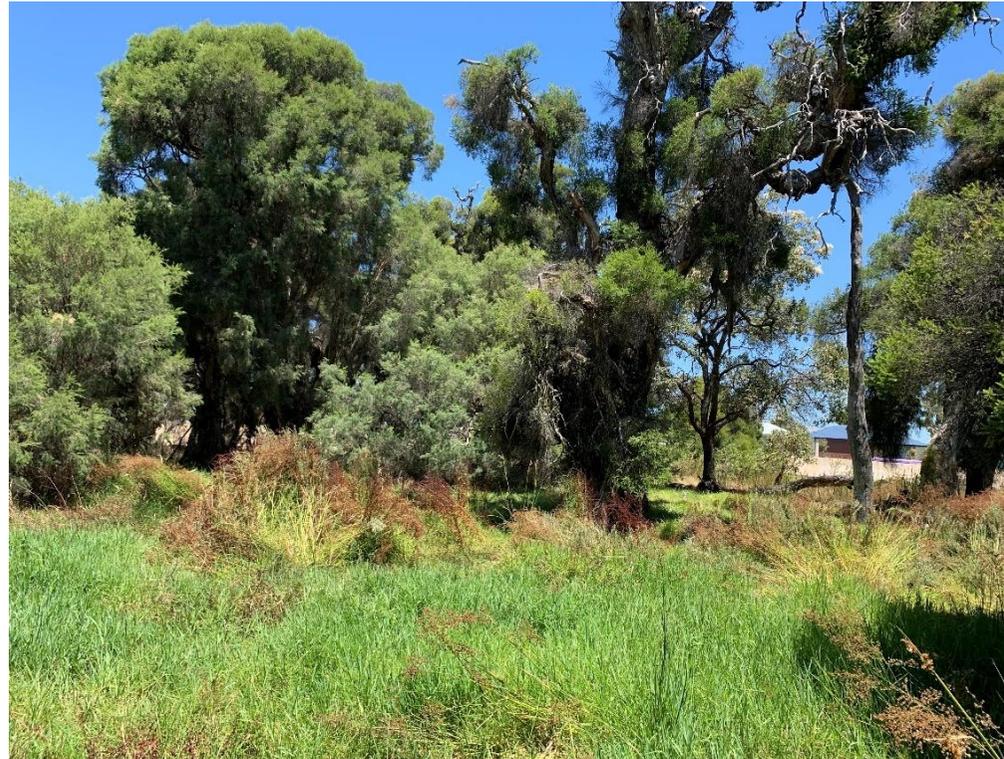
Vegetation description	<i>Melaleuca raphiophylla</i> over <i>Centella asiatica</i> , <i>Juncus pallidus</i> and <i>J. microcephalus</i>	Vegetation description	<i>Melaleuca preissiana</i> over <i>Juncus microcephalus</i> , <i>Isolepis prolifera</i> , <i>Gomphocarpus fruticosus</i> and weedy grasses
Recommended restoration	Address hydrological issues resulting from construction of revetment through wetland. Remove <i>Isolepis prolifera</i> , Fig, Castor Oil, Cottonbush. Plant native grass <i>Hemarthria uncinata</i> . Manage <i>Typha</i> *.	Recommended restoration	Monitor sediment movement from estate. Remove Fig, <i>Isolepis prolifera</i> , Cottonbush. Control weeds in understorey and revegetate. Manage <i>Typha</i> *.

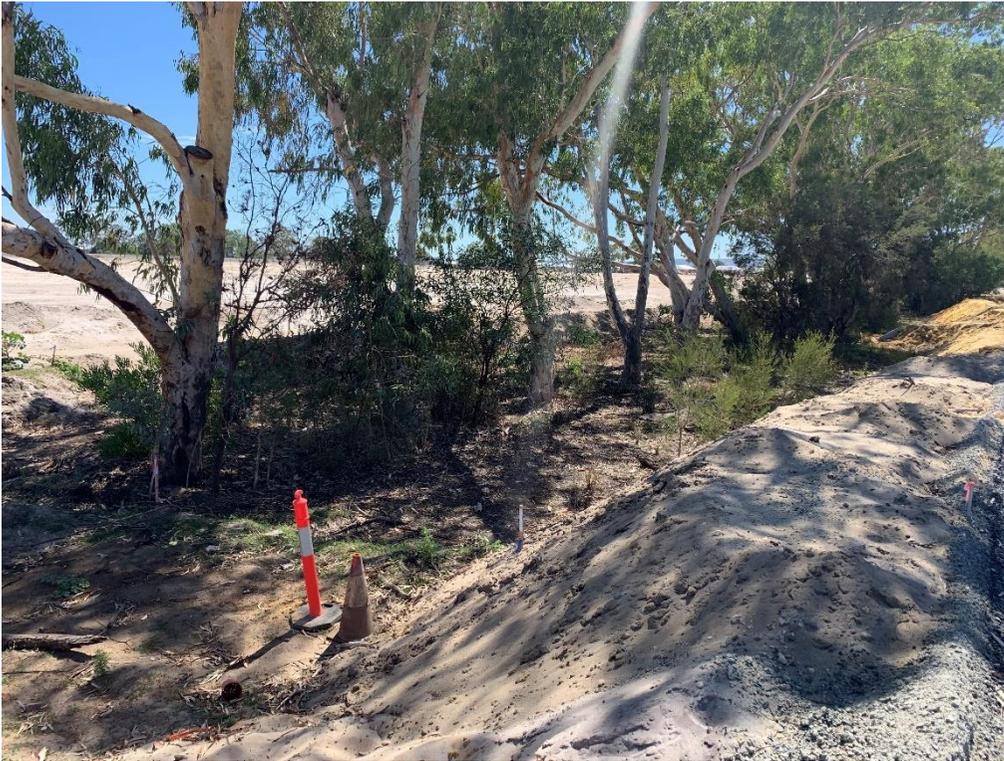
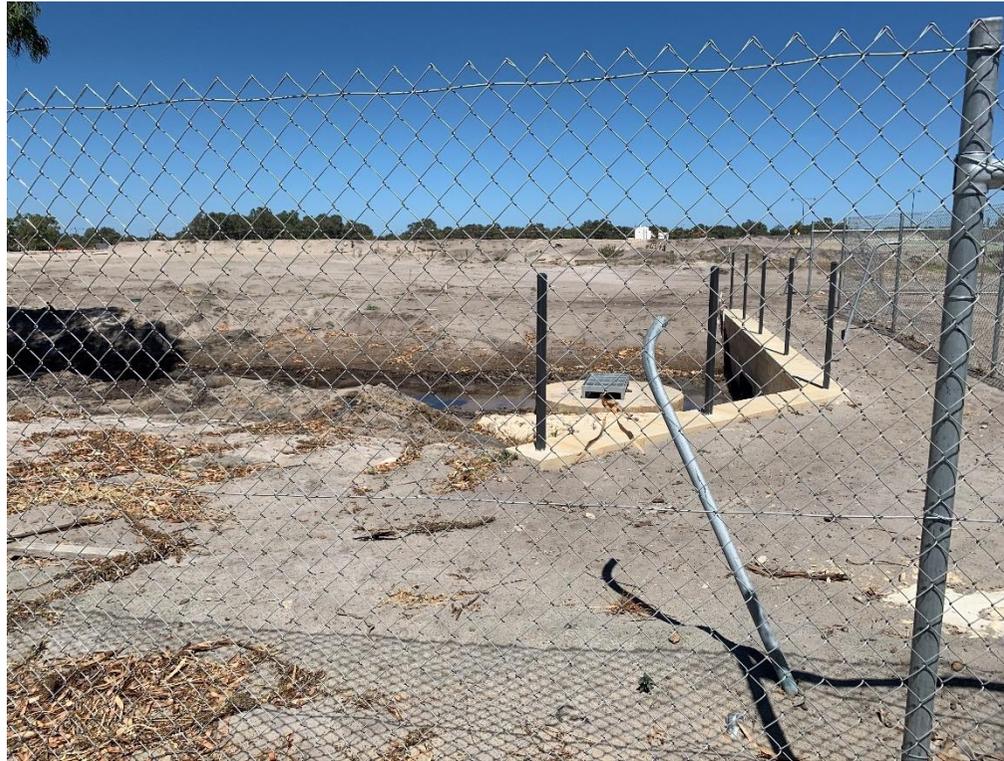
Vegetation description		Eastern States <i>Eucalyptus</i> sp. over <i>Acacia saligna</i> , sparse understorey weeds and <i>Juncus pallidus</i>	
Recommended restoration		Stabilise embankment. Hand pull fleabane. Plant native shrubs and sedges. Potential for a restoration project and interpretational signage in a visible location adjacent to proposed shopping centre.		Recommended restoration		Plant densely. Install meanders in creekline and/or install jute matting to stop sand falling into creek. Remove Sydney Golden wattle but leave <i>Eucalyptus</i> overstorey.

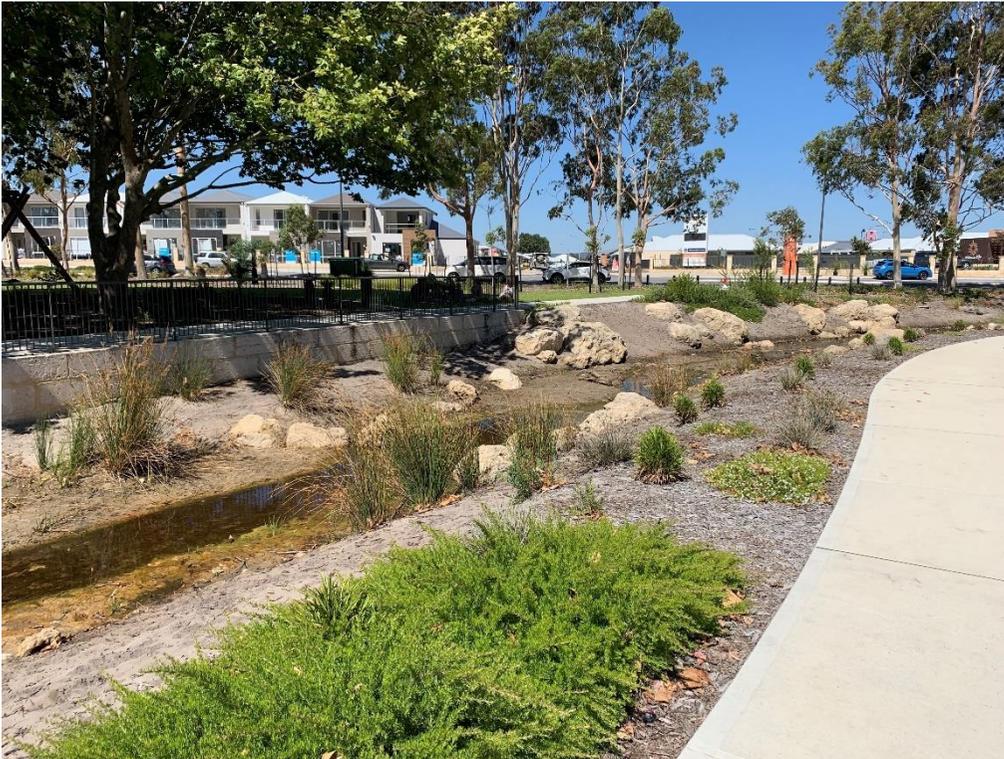
Vegetation description		No overstorey. Revegetated landscaped plants using natives and native hybrids	
Recommended restoration		Plant a dense sedge bed; monitor for weeds and remove. Manage young <i>Typha</i> *; manage deciduous trees (remove fallen leaves in creek periodically) and plant overstorey.		Vegetation description		Very open young <i>Melaleuca raphiophylla</i> , <i>M. preissiana</i> and <i>Corymbia ficifolia</i> over mixed sedges and native landscape plants	
Recommended restoration		Remove <i>Juncus microcephalus</i> and monitor for new weeds. Manage emerging <i>Typha</i> *. Infill plant on bank, especially where banks are subsiding. Plant more overstorey trees.		Recommended restoration		Remove <i>Juncus microcephalus</i> and monitor for new weeds. Manage emerging <i>Typha</i> *. Infill plant on bank, especially where banks are subsiding. Plant more overstorey trees.

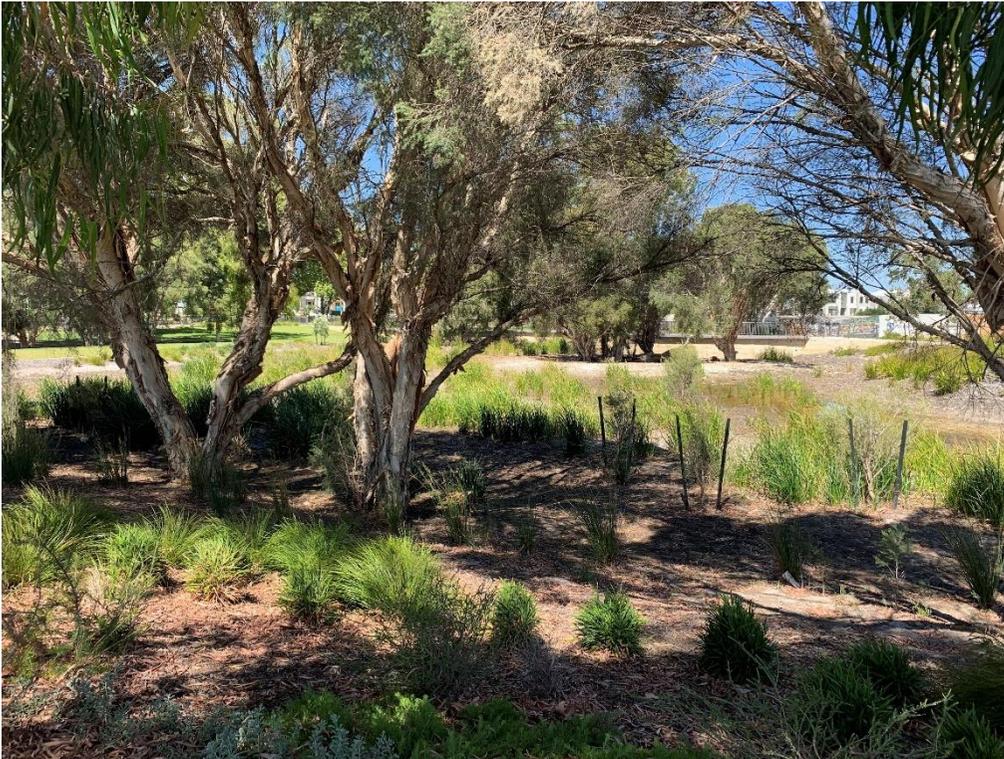
Vegetation description	<i>Melaleuca raphiophylla</i> over <i>Juncus pallidus</i> in basin and <i>Baumea preissii</i> and native landscape plants on edge	Vegetation description	<i>Melaleuca thymoides</i> over <i>Juncus kraussii</i> , <i>Grevillea crithmifolia</i> and <i>Calothamnus</i> sp.				
Recommended restoration	Maintain current management – hand weed emerging weeds and allow native plant regeneration. Plant more overstorey plants. Remove blown in domestic rubbish.	Recommended restoration	Monitor for weeds and hand pull if required. Could control weeds in open area near bubble up drain.

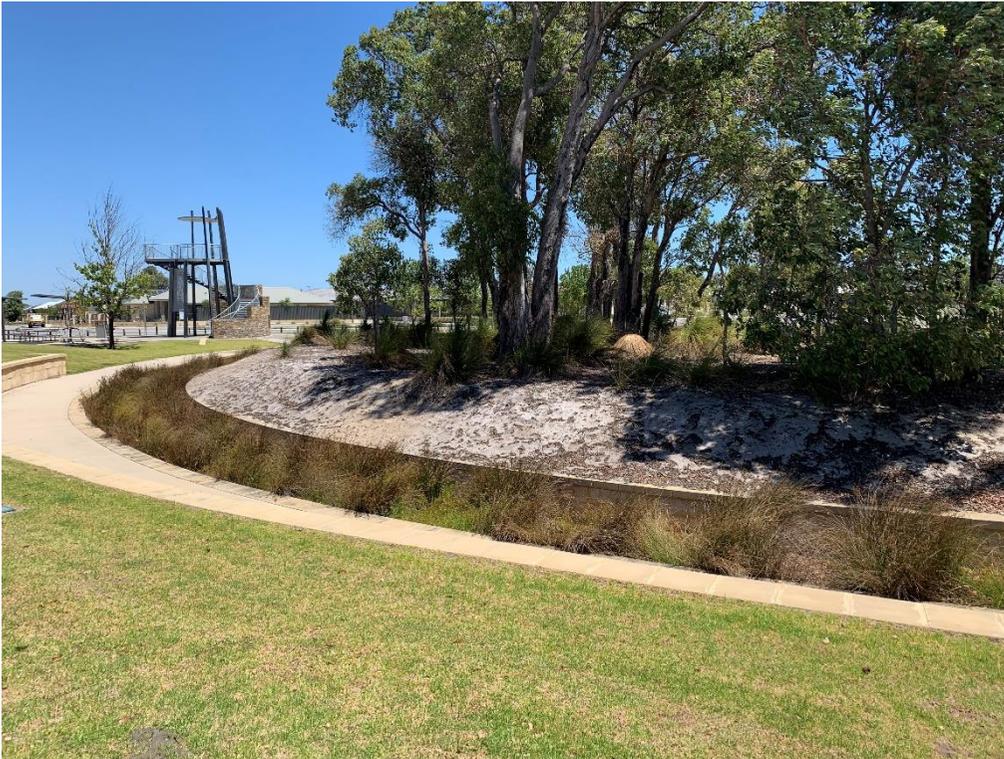
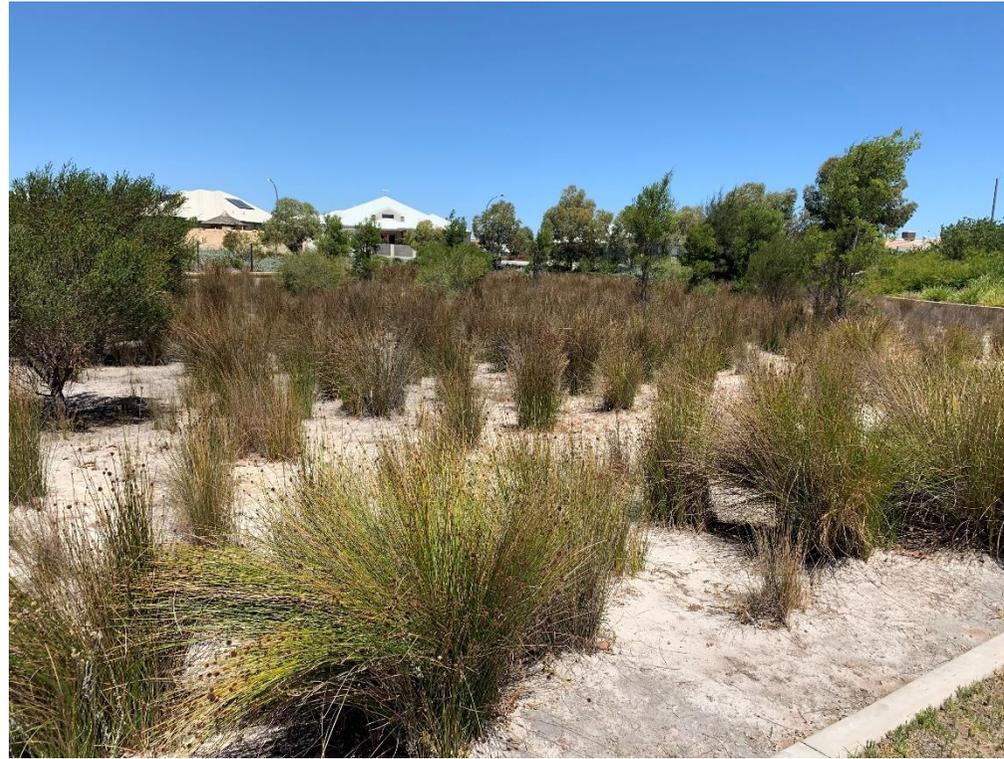
Vegetation description	<i>Corymbia calophylla</i> over <i>Xanthorrhoea preissii</i> in central mound of park, with <i>Juncus kraussii</i> and <i>Cyperus</i> sp. in constructed moat	Vegetation description	<i>Corymbia calophylla</i> over <i>Cenchrus clandestinus</i> , and <i>Melaleuca preissiana</i> over <i>Juncus kraussii</i>	Vegetation description	<i>Corymbia calophylla</i> over <i>Cenchrus clandestinus</i> , and <i>Melaleuca preissiana</i> over <i>Juncus kraussii</i>	Vegetation description	<i>Corymbia calophylla</i> over <i>Cenchrus clandestinus</i> , and <i>Melaleuca preissiana</i> over <i>Juncus kraussii</i>
Recommended restoration	Rehabilitation is hard as it ideally needs to be redesigned. Too small to be viable for wildlife. Put jute matting on slope under Marri and plant. Remove Nut Grass. Manage emerging <i>Typha</i> *.	Recommended restoration	Monitor for weeds and hand pull.	Recommended restoration	Monitor for weeds and hand pull.	Recommended restoration	Monitor for weeds and hand pull.
