Ashfield Flats Master Plan

Part 2: Context

Prepared for the Department of Biodiversity, Conservation and Attractions

February 2024

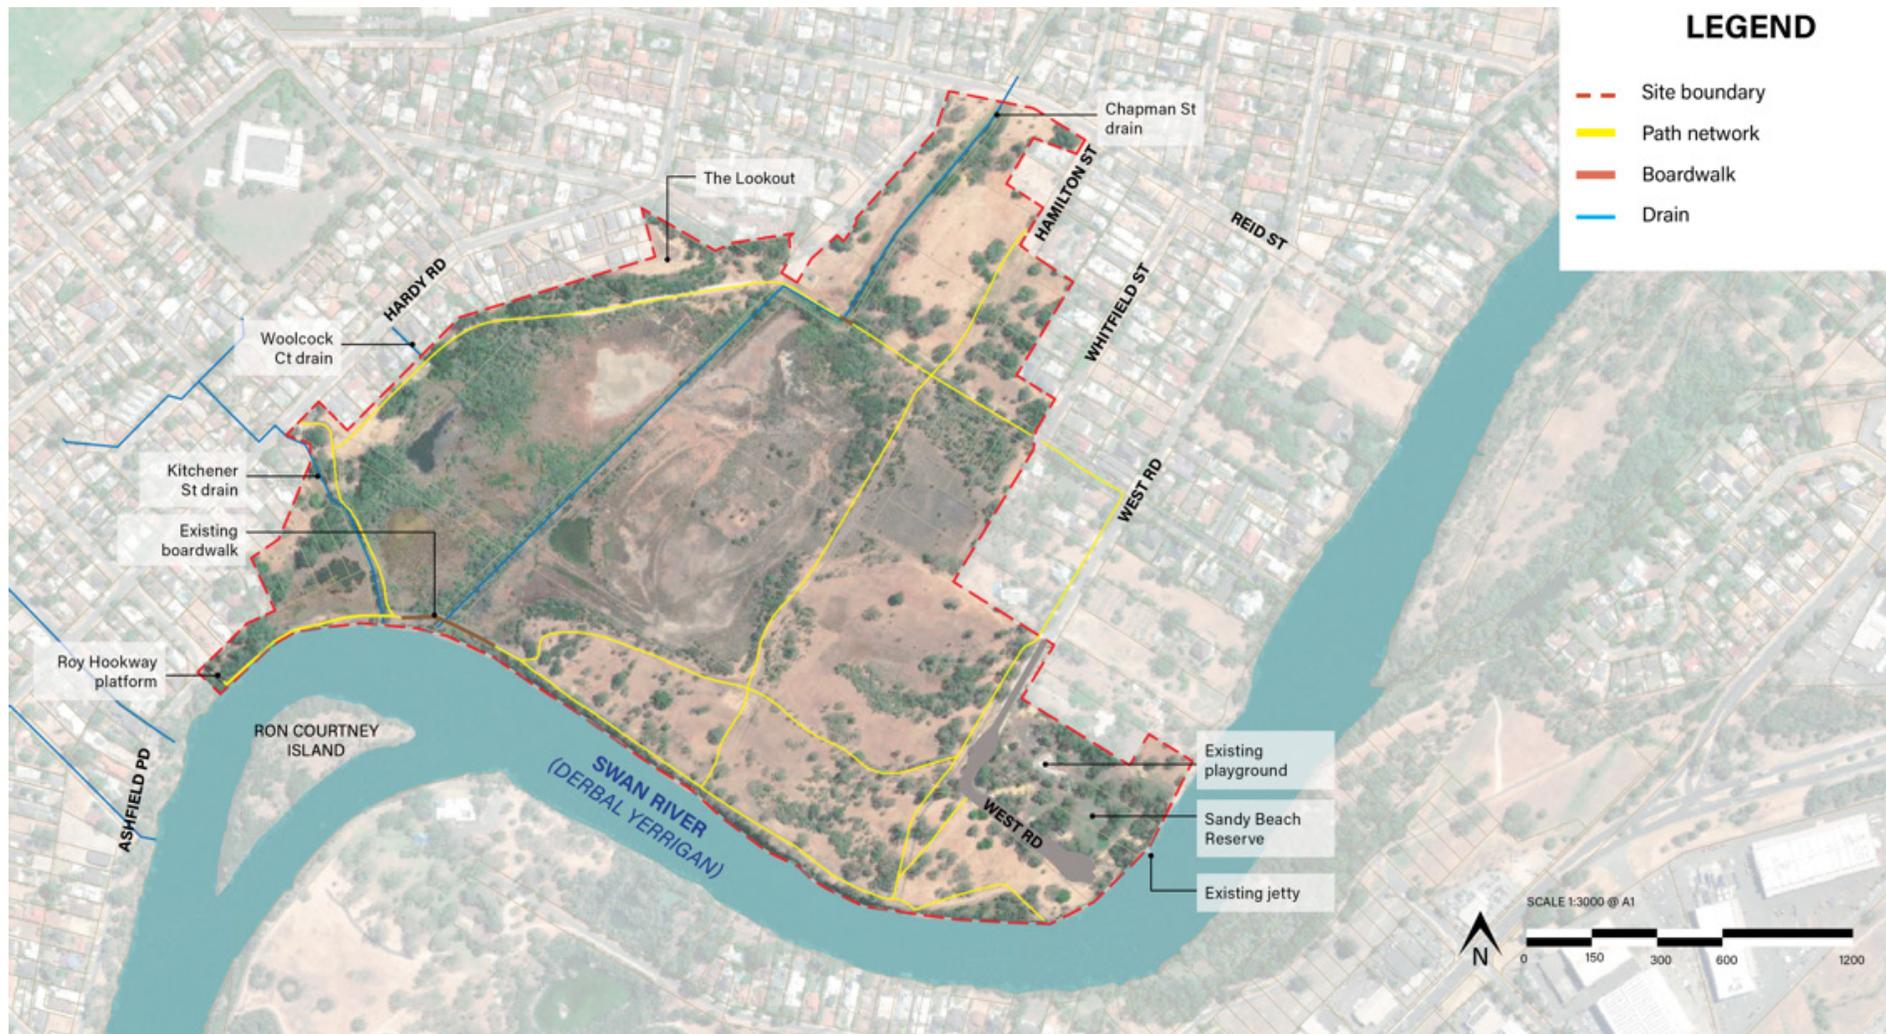
Figure 1: Ashfield Flats Master Plan area

Ashfield Flats (the study area) is the largest remaining river flat in the Perth Metropolitan area in the suburbs of Ashfield and Bassendean, covering approximately 64 hectares. It lies on the banks of the Swan River (Derbarl Yerrigan), 33km upriver from the coast as shown in Figure 1.

The Ashfield Flats Master Plan area contains extensive areas of public open space including the Sandy Beach Reserve and areas of remnant vegetation. It contains a range of built and natural features, including a jetty, boardwalk, lookout, large playground, dog beach, a Bush Forever site and the largest remaining occurrence of a Subtropical and Temperate Coastal Saltmarsh community in the Swan and Canning River Estuary.

The Ashfield Flats Master Plan has been prepared for the Department of Biodiversity, Conservation and Attractions (DBCA), together with the Department of Planning, Lands and Heritage (DPLH), the Department of Water and Environmental Regulation (DWER), Water Corporation and the Town of Bassendean to provide guidance for the management of Ashfield Flats in Bassendean (Figure 1).

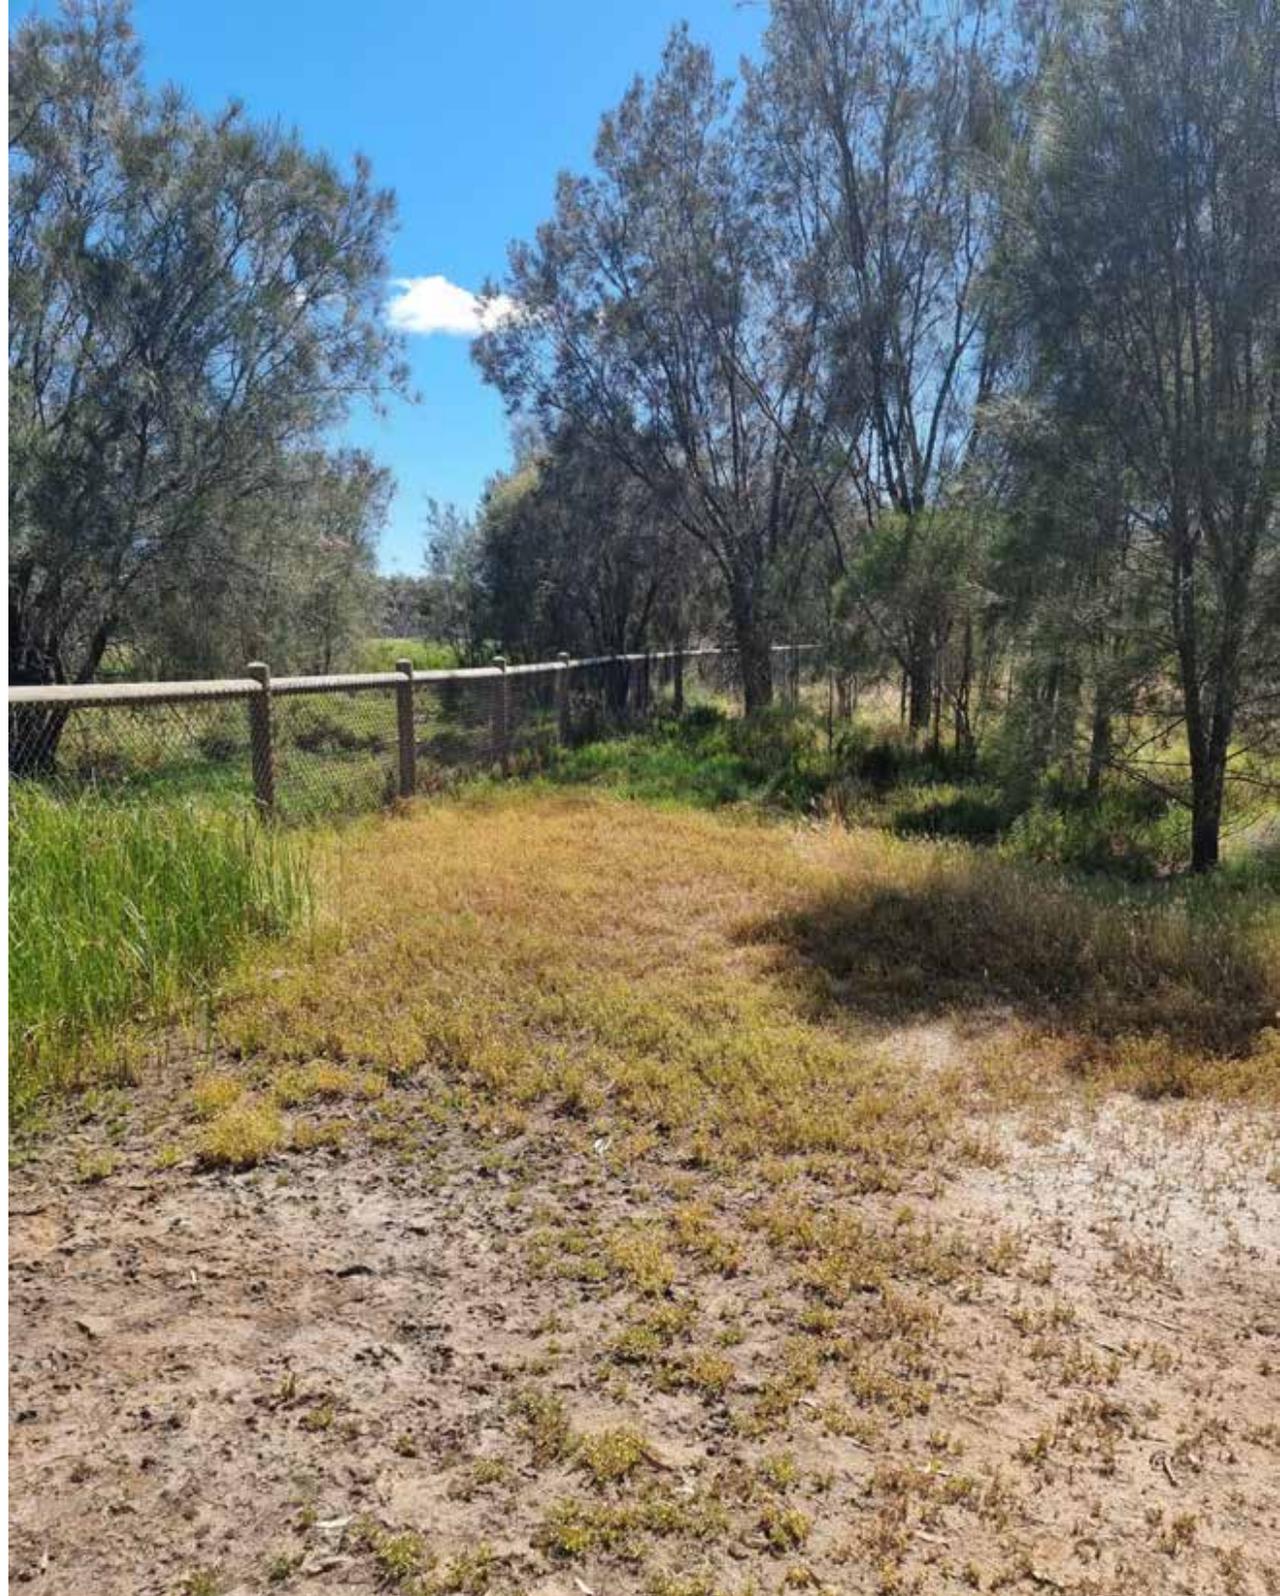
Figure 5: Ownership and management responsibility of the study area

Ashfield Flats is reserved as Parks and Recreation under the Metropolitan Region Scheme (MRS). The site falls under the ownership and management of three bodies — the majority is vested with the Western Australian Planning Commission (WAPC) (and managed by DPLH); the two main drains found within the site are managed by the Water Corporation; and the remainder is vested with the Town of Bassendean (Figure 5).

Ashfield Flats is located wholly within the Swan Canning Riverpark and its associated Development Control Area (DCA), as seen by the brown hatching in Figure 5. Accordingly, this Master Plan has been prepared in accordance with the *Swan and Canning Rivers Management Act 2006*, *Swan and Canning Rivers Management Regulations 2007* and DBCA policies for planning and development.

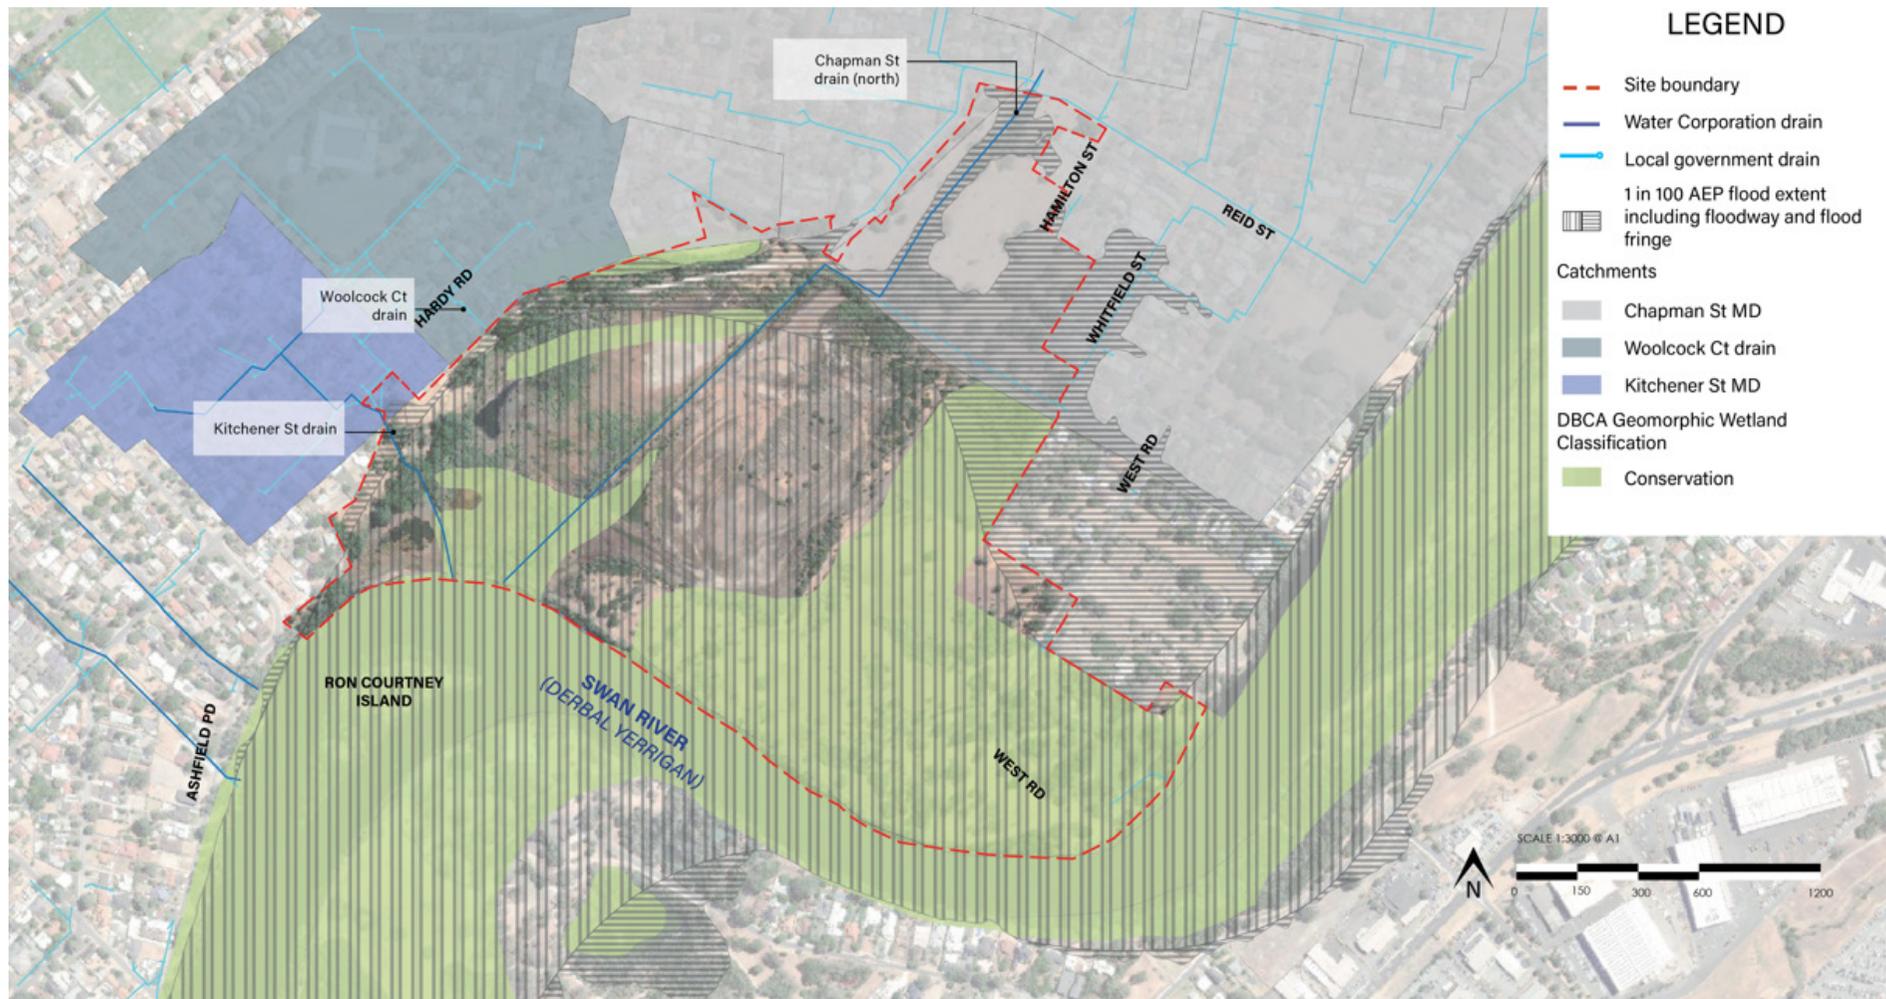
Figure 9: Water Resources

The Swan River (Derbarl Yerrigan) is a Nationally Important Wetland (Directory of Important Wetlands in Australia, 2005), an Environmentally Sensitive Area (*Environmental Protection Act, 1986*) and a Conservation Category wetland in the Geomorphic Wetlands (Swan Coastal Plain) database (DBCA, 2023) (Figure 9). Conservation category wetlands are wetlands that support a high level of environmental attributes and function (Environmental Protection Authority, 2008) (i.e. highest priority wetlands).

DBCA's current Geomorphic Wetland dataset categorises the wetlands as Conservation Category and Multiple Use (Figure 9). Investigations of the site indicate that the identified wetland values and functions of Ashfield Flats are more commensurate with a larger portion functioning as Conservation Category wetland, and the disturbed areas functioning as Resource Enhancement and Multiple Use wetlands (DBCA, 2019).

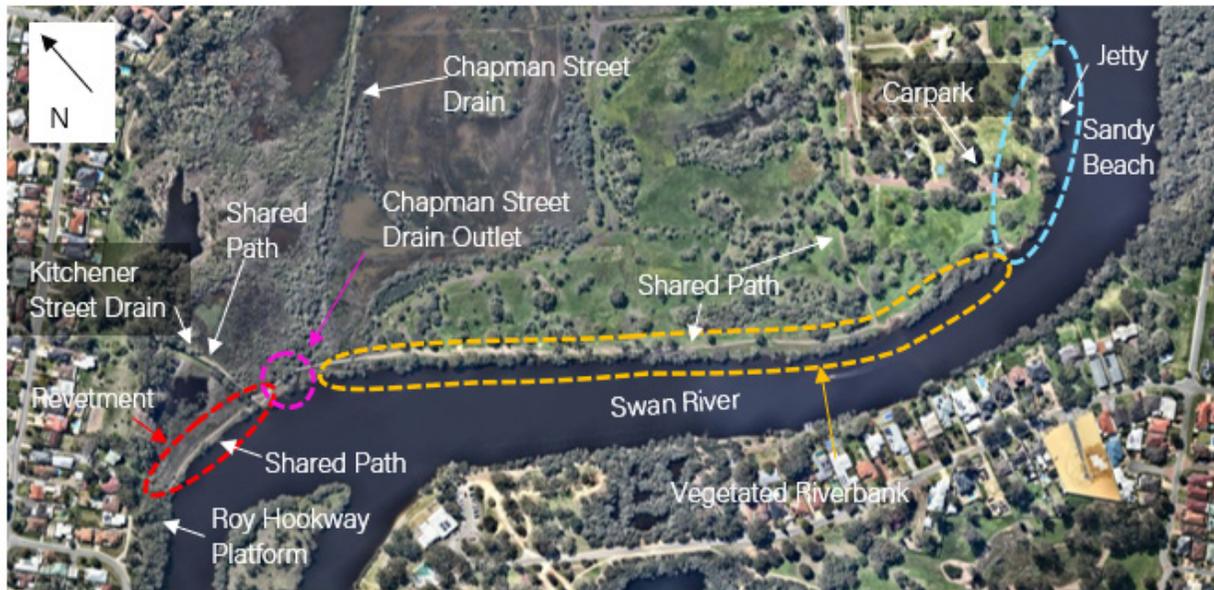
Figure 12: Layout and foreshore sections

The foreshore can generally be characterised by separating the approximately 1.2 km length into four sections, based on the existing infrastructure, level of erosion and conditions (shown in Figure 12. Further details of the four sections are described below.

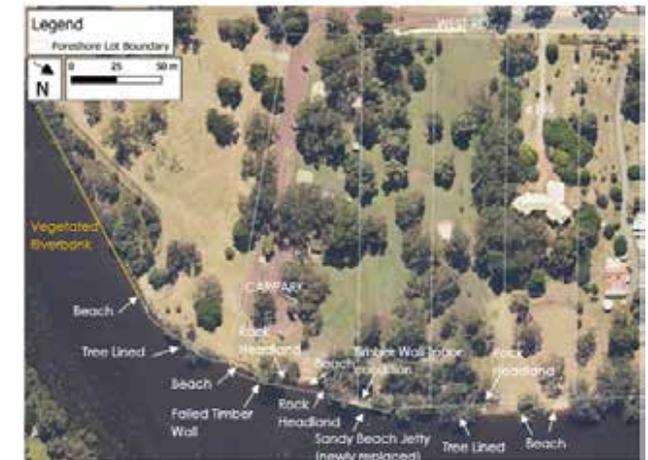
Figure 13: Sandy Beach

Sandy Beach is a popular area for recreating, including for kayak and canoe launching and dog walking, with a grassed foreshore area fronting a large public carpark. A plan showing the area and the various stretches of shoreline is provided in Figure 13.

A number of built assets are located within the vicinity of the carpark. As outlined in MRA (2022), these built assets are currently mostly in poor to average condition.

The Sandy Beach Jetty has recently been replaced by DBCA. The new jetty appears to have been implemented with a relatively short design life, estimated to be in order of 10-20 years.

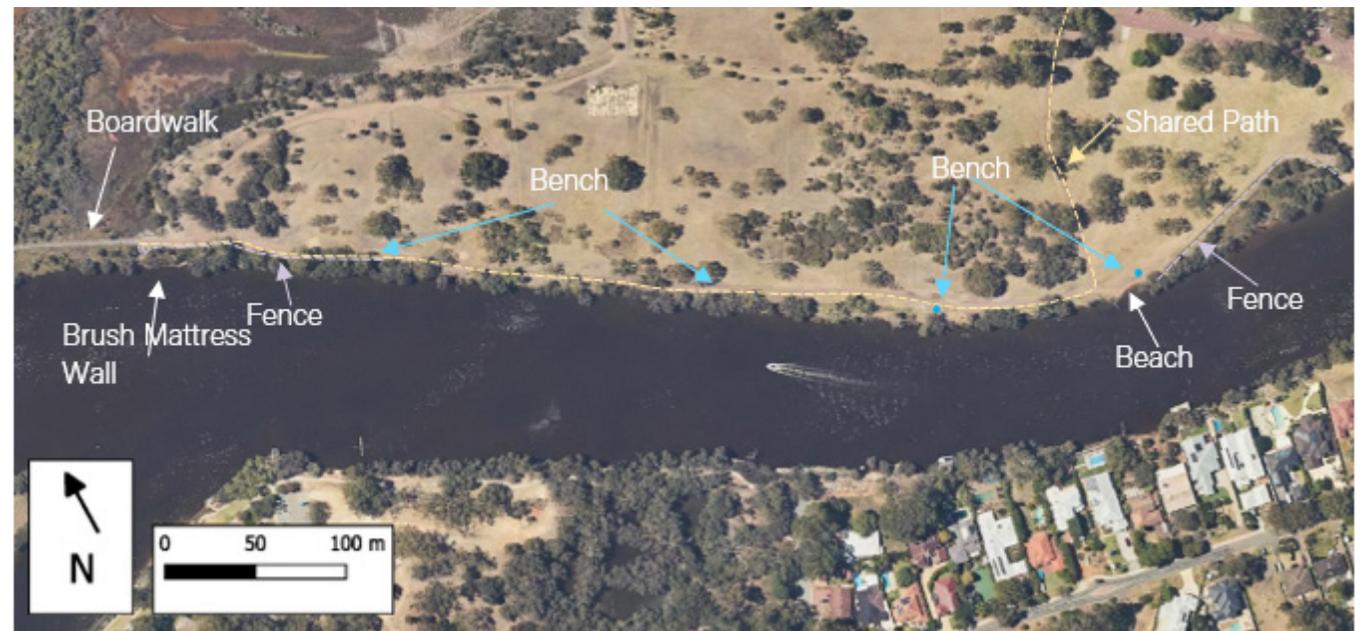
Figure 14: Ashfield Flats vegetated riverbank

The extent of this stretch of foreshore and associated assets are shown in Figure 14. As outlined in MRA (2022), the shoreline fronting Ashfield Flats is in poor condition, as erosion of the shoreline, scarping of the bank and undercutting of trees is evident throughout the riverbank.

A shared path runs parallel to the riverbank. This path is located relatively close to the river. The buffer between the path and the riverbank decreases to 1-2 m in some areas and the path is considered to be at risk of erosion.

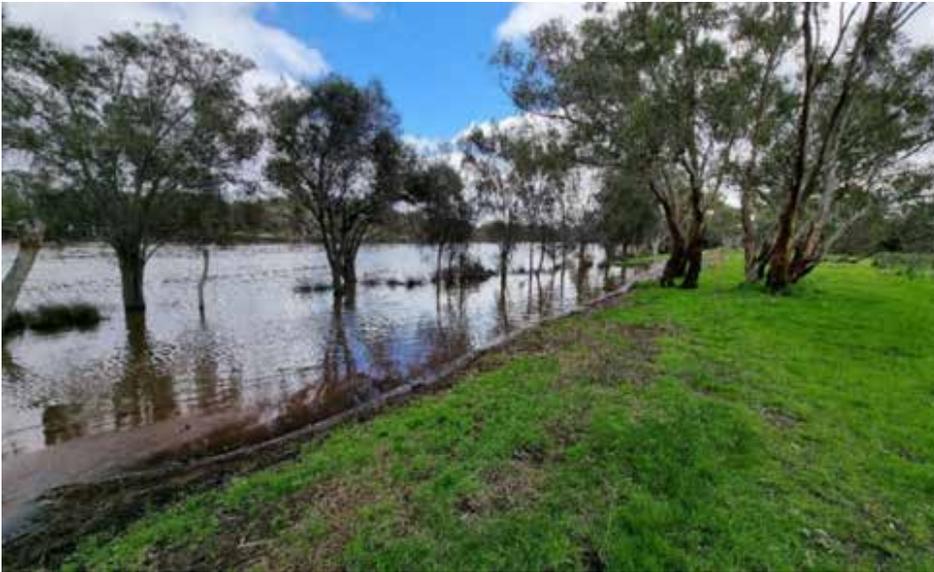
Plate 1: Foreshore inundation during 2021

The foreshore in this area is low lying and known to be subject to inundation from time to time. Photographs from inundation of the area during 2021 are provided in Plate 1 and Plate 2.

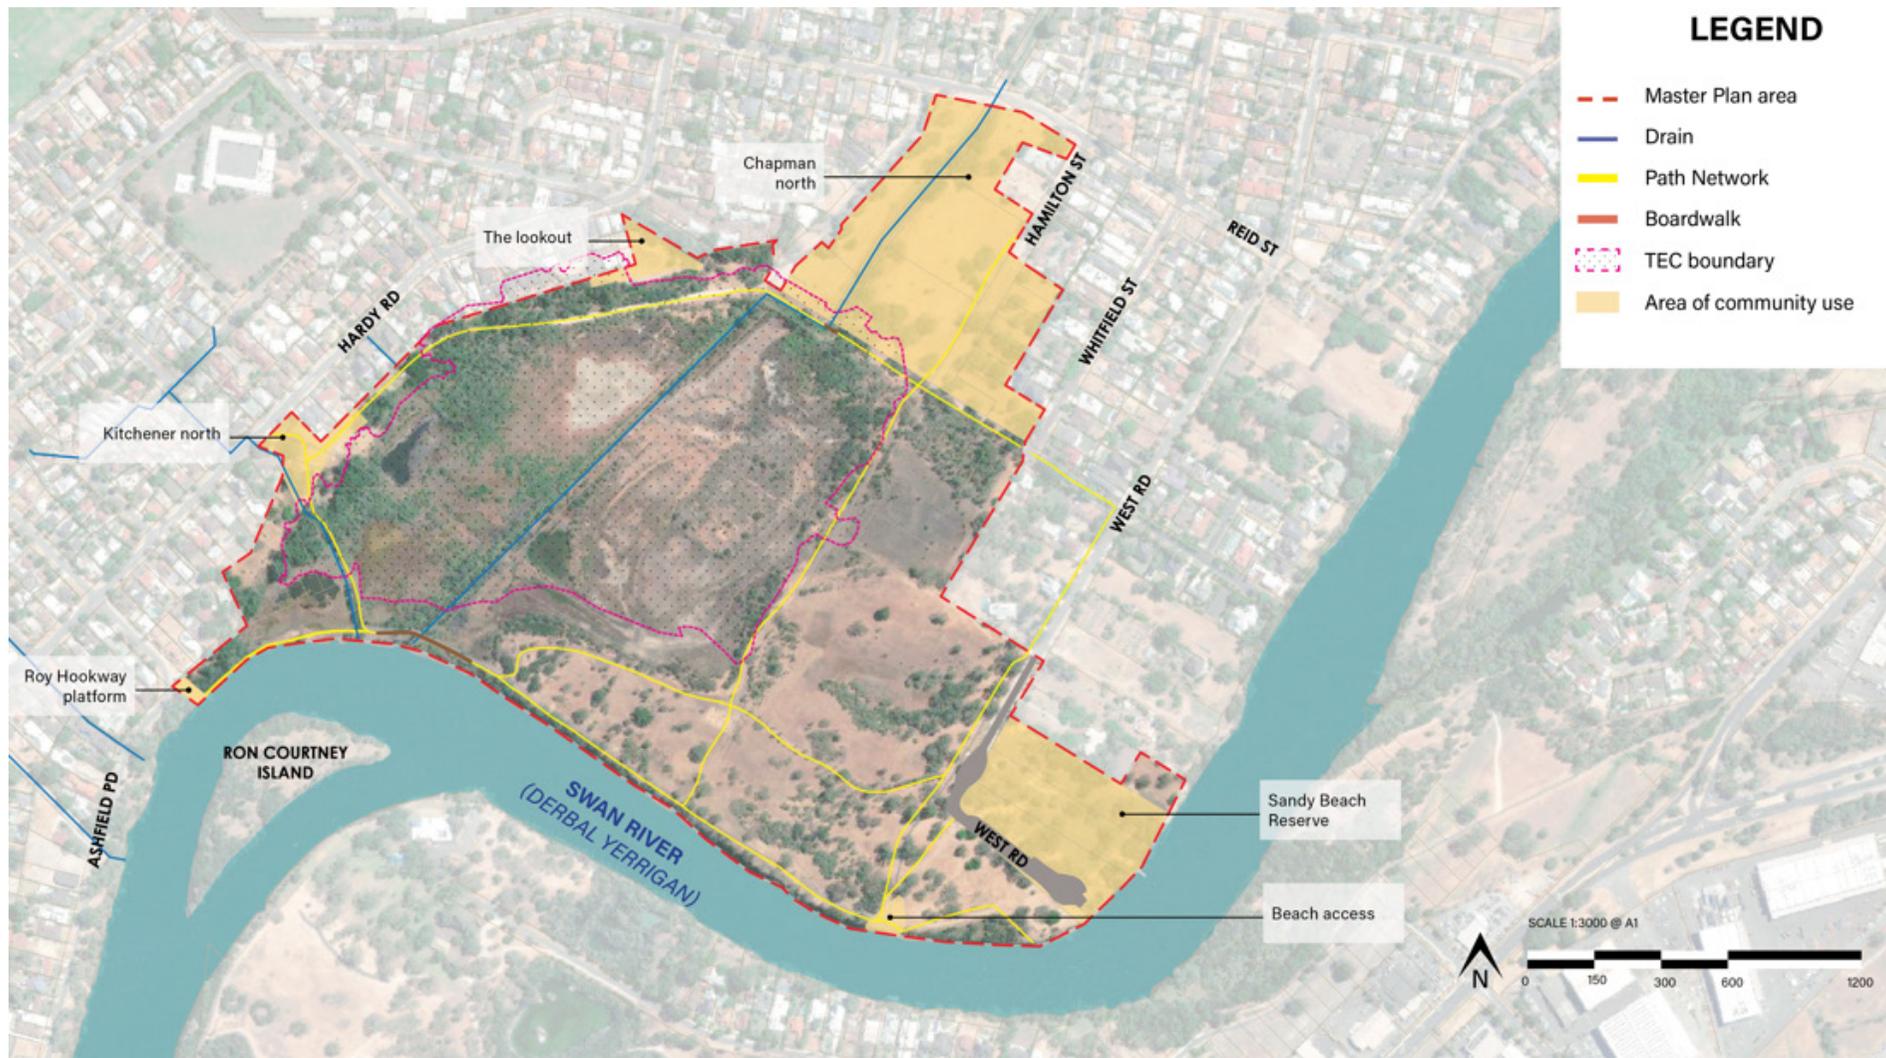
Figure 20: Main areas of use

The site also contains physical infrastructure such as the playground, toilets, jetty, bridges, walkways (paths), drains, roads, fences, bollards, bins, drink fountains and lights. The key areas of use are shown in Figure 20 and include:

- Chapman North – The area is predominantly parkland setting bordered to the west by the Chapman Street open drain. It can be accessed from Whitfield and Hamilton streets via well-utilised informal paths and contains Iverson Place Reserve, Hamilton Street Reserve, and Whitfield Street public open space. The site is filled with potentially contaminated material although the northern portion (Lot 8111) is remediated for restricted use.

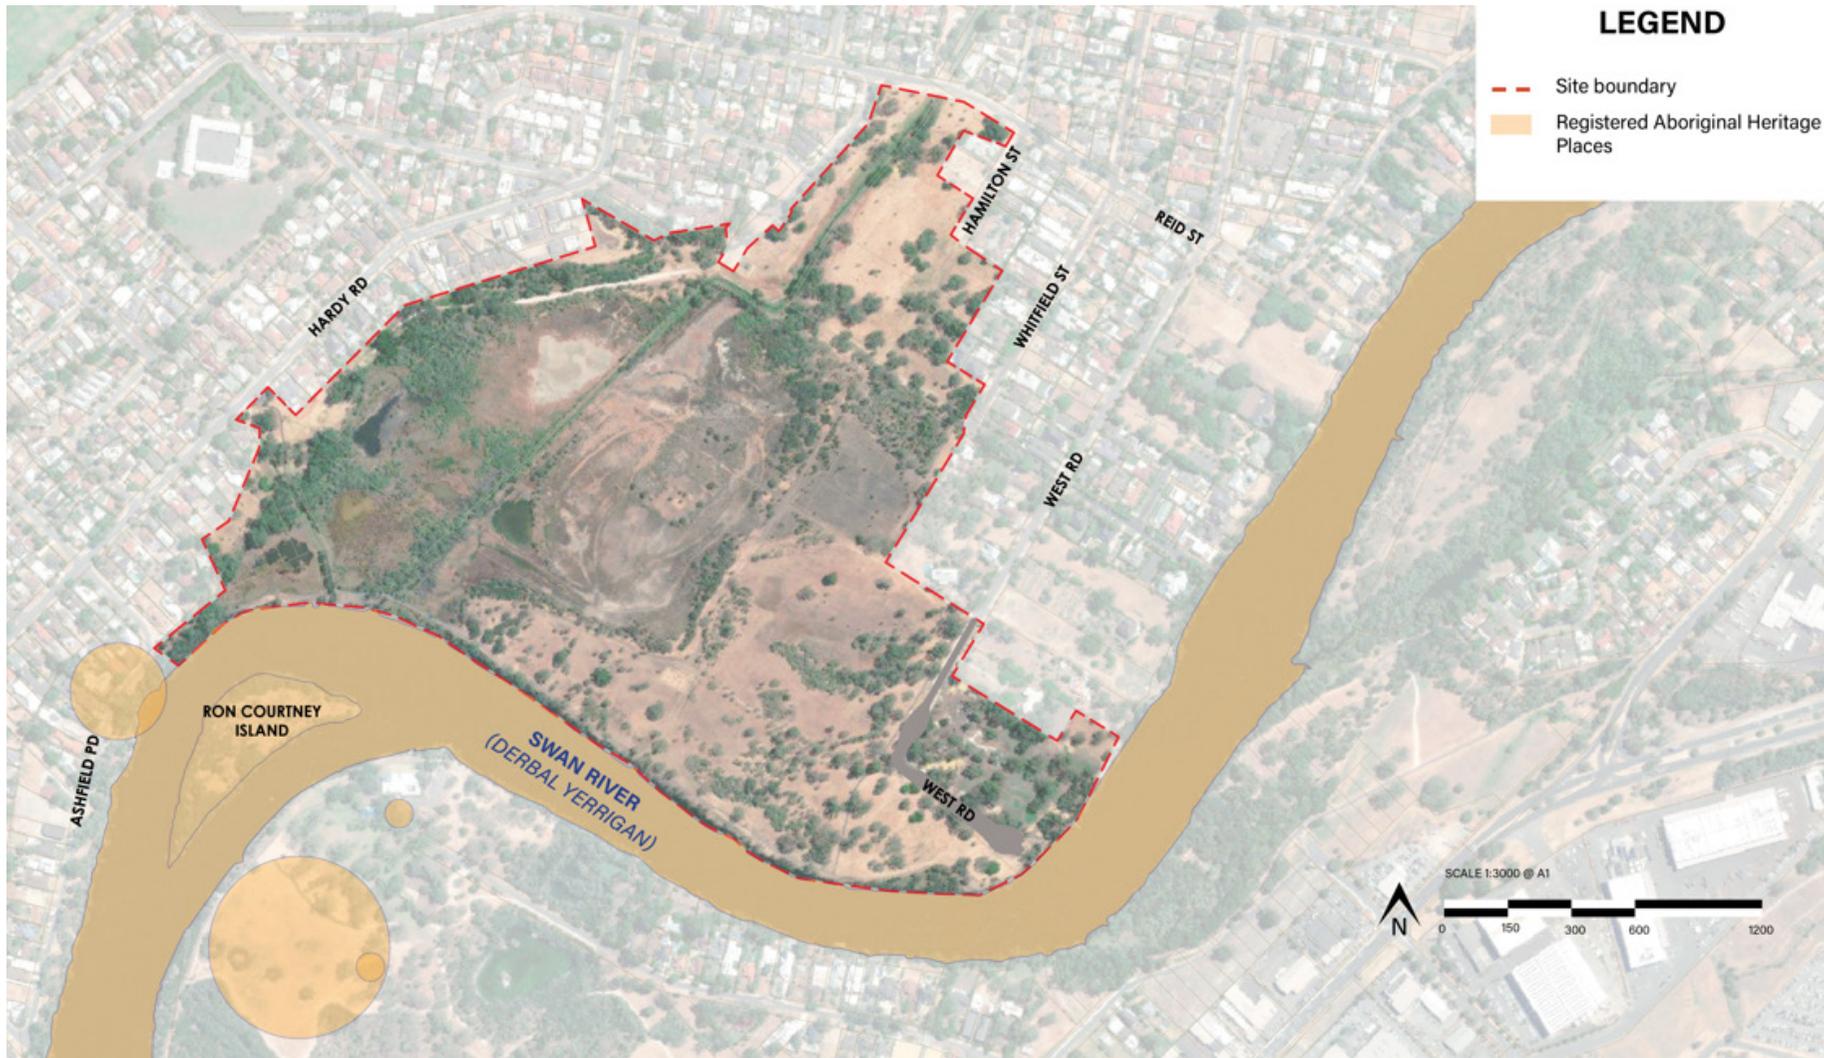
Figure 21: Registered Aboriginal Heritage Sites (DPLH-001)

The DPLH is responsible for assessing the impact of development on Aboriginal Heritage sites. A search of Registered Aboriginal sites using the DPLH Registered Aboriginal Heritage Places Database revealed two sites within the study area, neither with gender restrictions, as shown by the hatched area in Figure 21.
