Form 1 – Application for Approval of Development
Swan and Canning Rivers Management Act 2006 – Part 5 – section 72(1)

Drawing BAYSIDE KITCHEN
EXTENSION AND REFURBISHMENT
5 Hackett Drive, Crawley WA 6009

RE: Arboricultural Assessment; Trees adjacent Bayside Kitchen

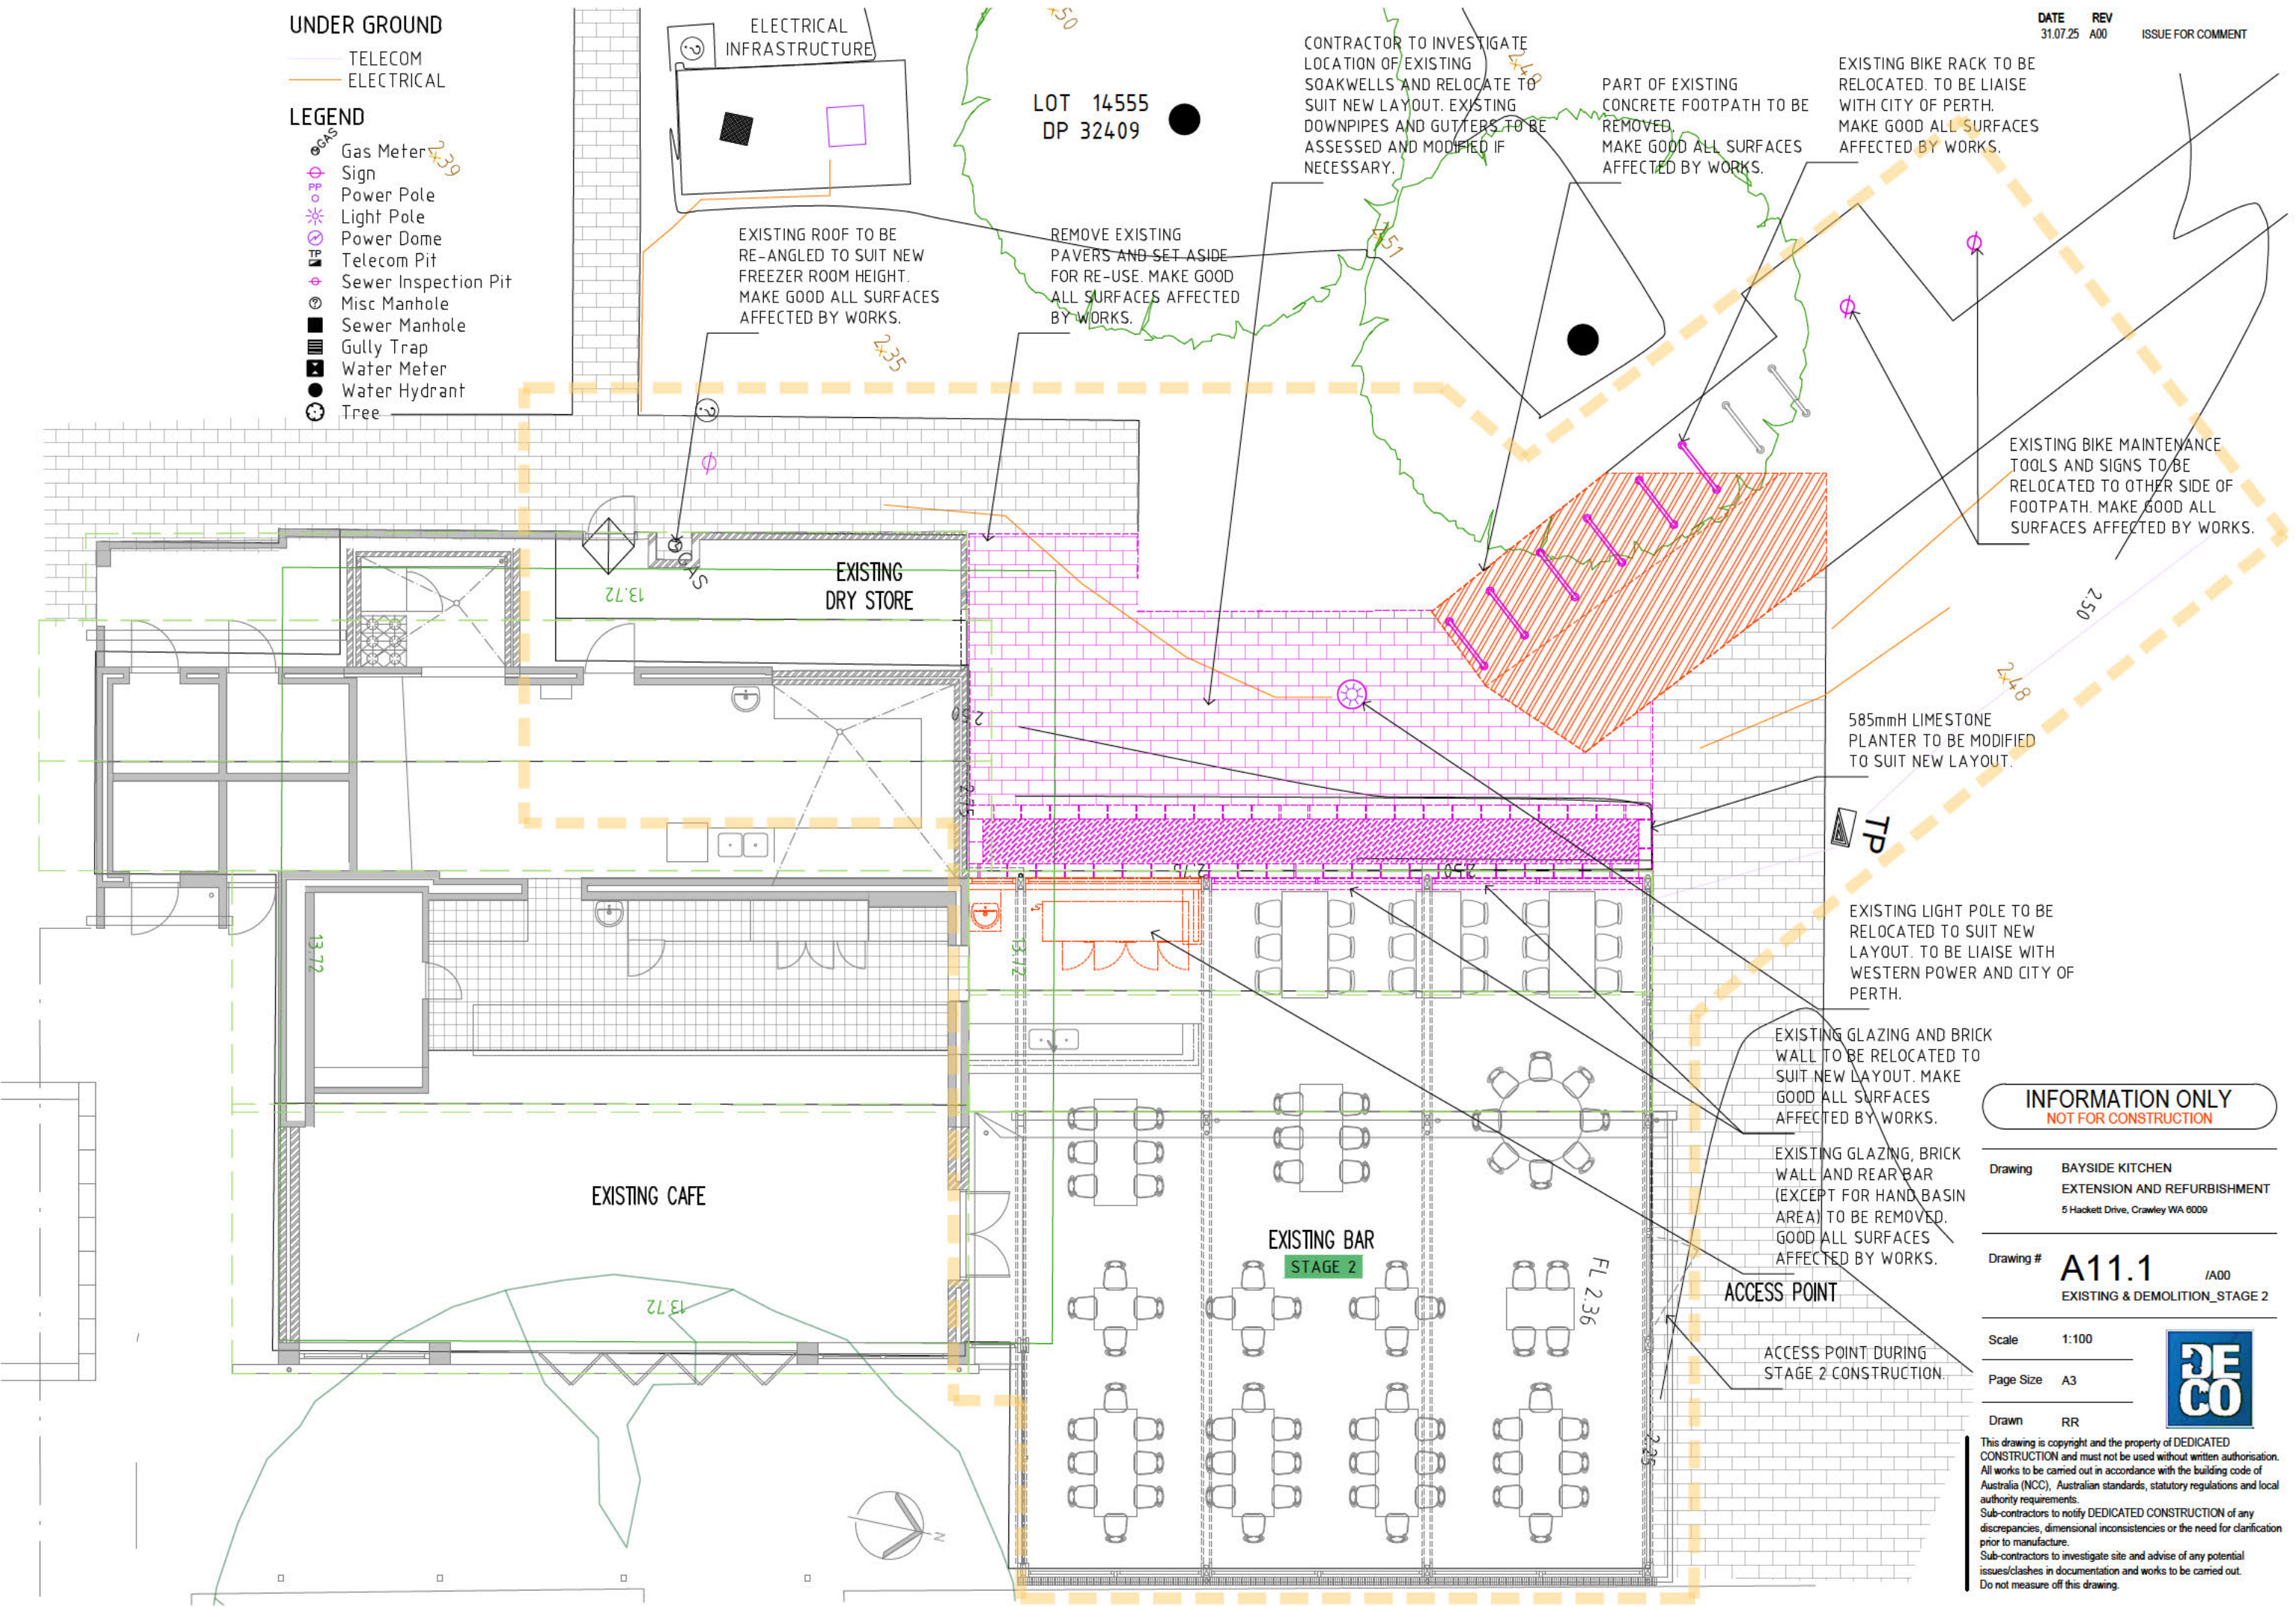
Drawing # **A11.1** /A00
EXISTING & DEMOLITION_STAGE 2

CONTRACTOR TO INVESTIGATE LOCATION OF EXISTING SOAKWELLS AND RELOCATE TO SUIT NEW LAYOUT. EXISTING DOWNPIPES AND GUTTERS TO BE ASSESSED AND MODIFIED IF NECESSARY.

PART OF EXISTING CONCRETE FOOTPATH TO BE REMOVED. MAKE GOOD ALL SURFACES AFFECTED BY WORKS.

EXISTING BIKE RACK TO BE RELOCATED. TO BE LIAISE WITH CITY OF PERTH. MAKE GOOD ALL SURFACES AFFECTED BY WORKS.

EXISTING ROOF TO BE RE-ANGLED TO SUIT NEW FREEZER ROOM HEIGHT. MAKE GOOD ALL SURFACES AFFECTED BY WORKS.

REMOVE EXISTING PAVERS AND SET ASIDE FOR RE-USE. MAKE GOOD ALL SURFACES AFFECTED BY WORKS.

EXISTING BIKE MAINTENANCE TOOLS AND SIGNS TO BE RELOCATED TO OTHER SIDE OF FOOTPATH. MAKE GOOD ALL SURFACES AFFECTED BY WORKS.

585mmH LIMESTONE PLANTER TO BE MODIFIED TO SUIT NEW LAYOUT.

EXISTING LIGHT POLE TO BE RELOCATED TO SUIT NEW LAYOUT. TO BE LIAISE WITH WESTERN POWER AND CITY OF PERTH.

EXISTING GLAZING AND BRICK WALL TO BE RELOCATED TO SUIT NEW LAYOUT. MAKE GOOD ALL SURFACES AFFECTED BY WORKS.

EXISTING GLAZING, BRICK WALL AND REAR BAR (EXCEPT FOR HAND BASIN AREA) TO BE REMOVED. GOOD ALL SURFACES AFFECTED BY WORKS.

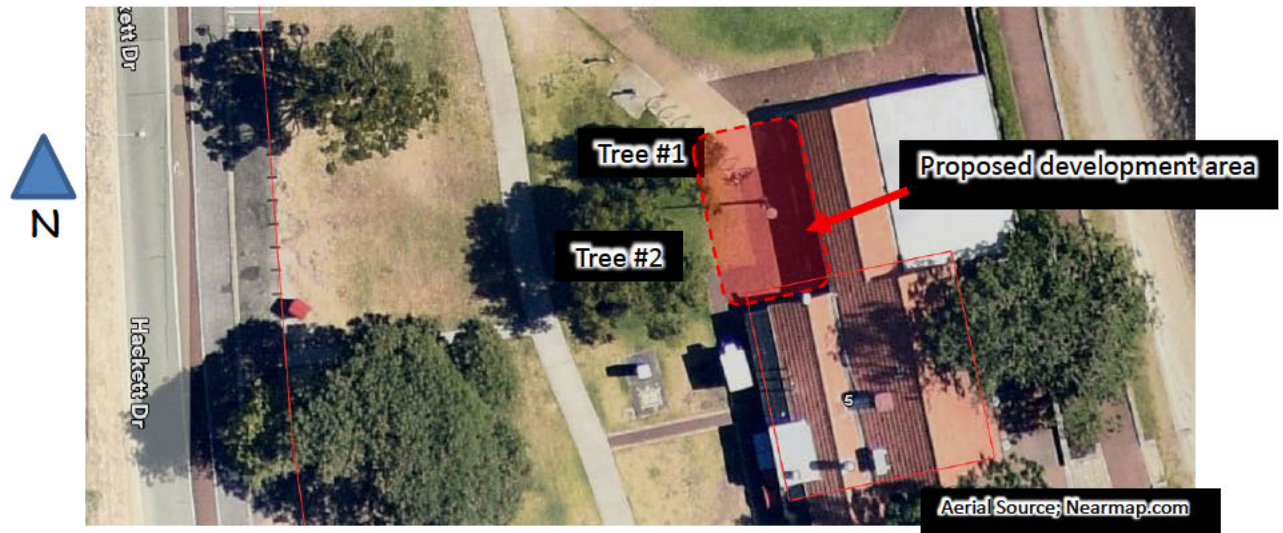
2.1 Tree Location

Two Trees were noted to be in the vicinity of the area of the proposed development. Their location is shown on the aerial below.

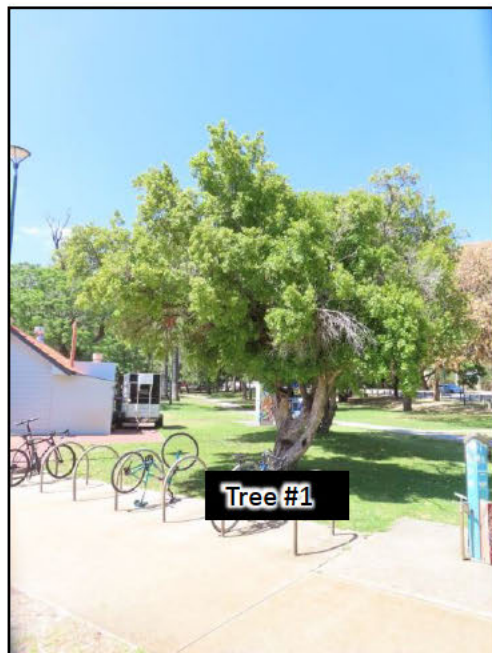
2.2.1 Tree #1

Species; Lillypilly (*Acmena smithii*)
Approx. Height; 6m
DSH; 57cm
DRF; 57cm
Canopy Spread; 5-6m north-south
 5-6m east- west (4m east)
NRZ; 6.8m
SRZ; 2.6m

Mature tree. A small section of its canopy looks to be declining but overall remains in reasonably good health. Areas of decay noticeable in parts of its main stem and canopy structure. Not of any concerns at this time. Canopy spread 4m east of main stem and constitutes a larger percentage of its canopy.

3.1 Tree #1

Based on the Plan Provided the majority of the development proposed looks to be over an area that already looks to have been disturbed at some stage over the Tree's life span. As such it is considered fair to assume that any root mass from the Tree that may have been in that area has previously been removed. Construction of the main aspects of the proposed development therefore looks likely to have marginal (if any) impact to the Tree.

Proposed changes to the paving *may* however have some potential to impact the root zone of the Tree. cursory probing along the edge of the proposed development area did suggest that there are some roots up to around 3-5cm in diameter present in the lawn area. However, the volume of roots present appears to be limited.

Based on these findings, removal of the level of root mass encountered appears to be acceptable on the provision that the remaining NRZ of the Tree will be protected in accordance with AS4970 guidelines at all times during the construction phase of the development and that the existing irrigation that the Tree is currently accustomed to is maintained at current volumes and frequency during construction.

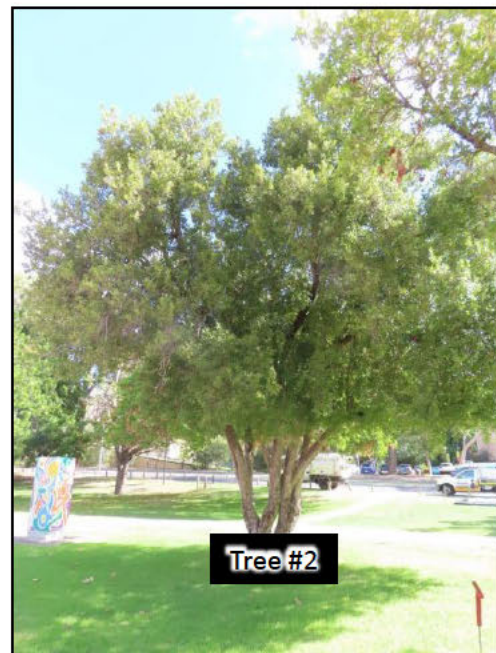
2.2.2 Tree #2

Species; Lillypilly (*Acmena smithii*)
Approx. Height; 8m
DSH; 46 & 33cm
DRF; 72cm
Canopy Spread; 7-8m north-south
 8-9m east- west (5m east)
NRZ; 6.8m
SRZ; 2.9m

Mature tree. Currently shows good health and a good (typical) structural form. Multi-stemmed from near ground level. Areas of decay noticeable in parts of its main stem and canopy structure but not of any concerns at this time in terms of impact to its structural integrity.

3.2 Tree #2

Based on the Plan Provided encroachment into the NRZ of this Tree from the main aspects of the development looks to be marginal (<10%) and as such would not be anticipated to have any major impact to the future health or potential life span of the Tree, on the provision that the remainder of its NRZ is protected in accordance with AS4970 guidelines at all times during the construction phase of the development.

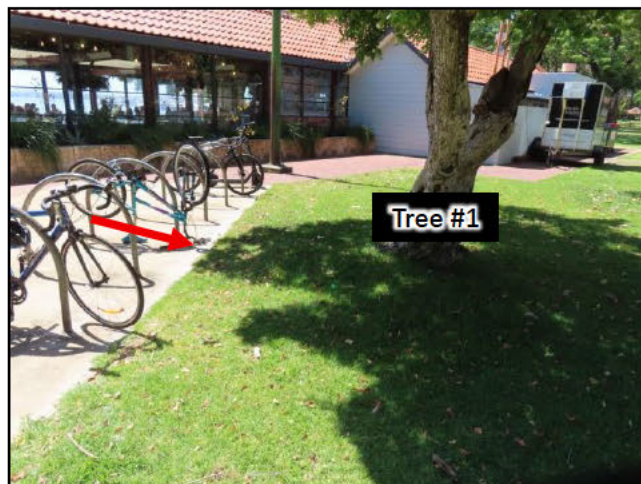
Both Trees look to be in an irrigated lawn area.

Some signs to suggest some level of excavation has previously occurred in the NRZ of Tree #1 when the existing concrete path and bike racks were installed.

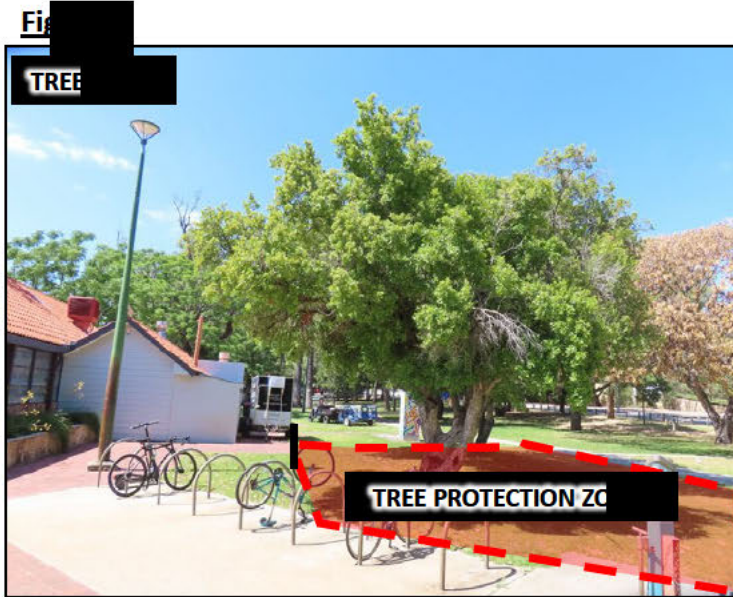
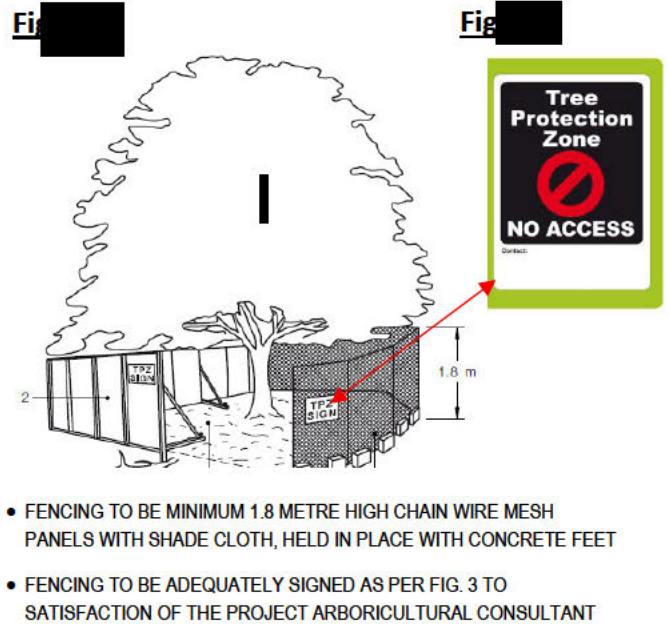
TREE PROTECTION METHOD STATEMENT

- THE AREA BETWEEN THE EDGE OF THE PROPOSED WORKS AREA, THE EXISTING CONCRETE FOOTPATHS TO THE TREE'S EAST AND NORTH AS INDICATED ON Fig. 1 IS TO BE TREATED AS THE TREE'S TREE PROTECTION ZONE AND PROTECTED IN ACCORDANCE WITH AS4970 GUIDELINES AT ALL TIMES DURING THE CONSTRUCTION PROCESS. . RECOMMEND INCORPORATING TREE #2 INTO THE SAME TPZ AREA.

- PROTECTIVE FENCING IS TO BE INSTALLED TO EXCLUDE THE TPZ AREA FROM THE SITE IN ACCORDANCE WITH AS 4970 GUIDELINES & Fig. 2 & 3 BEFORE ANY WORKS OCCUR ON THE LOT.

- Setting up of a Tree Protection Zone for the Trees prior to development works commencing in accordance with AS4970 guidelines; refer details attached to this report. *Both Trees are recommended to be incorporated into the one single Tree Protection Zone area.*

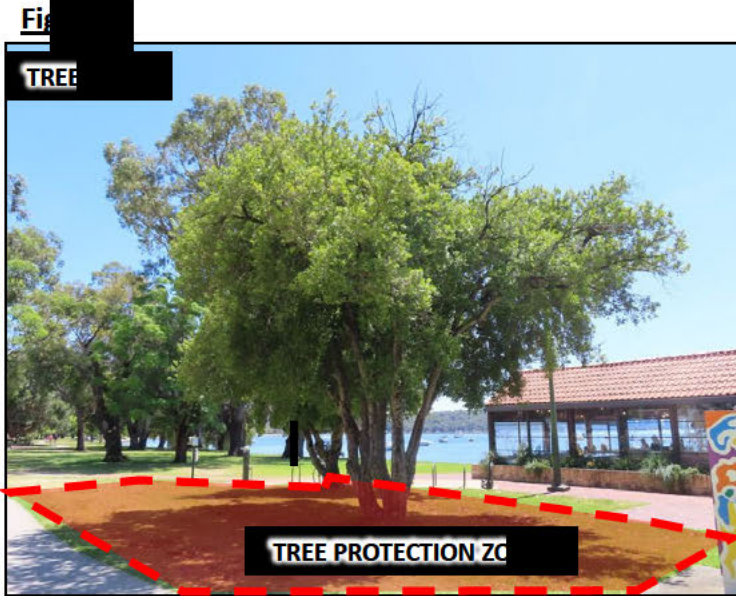
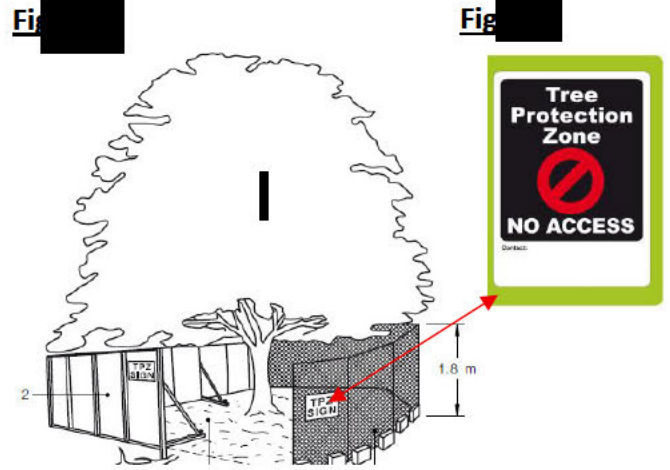
TREE PROTECTION METHOD STATEMENT

- FENCING TO BE MINIMUM 1.8 METRE HIGH CHAIN WIRE MESH PANELS WITH SHADE CLOTH, HELD IN PLACE WITH CONCRETE FEET
- FENCING TO BE ADEQUATELY SIGNED AS PER FIG. 3 TO SATISFACTION OF THE PROJECT ARBORICULTURAL CONSULTANT

2. THE AREA BETWEEN THE EDGE OF THE PROPOSED WORKS AREA, THE EXISTING CONCRETE FOOTPATHS TO THE TREE'S EAST AND NORTH AS INDICATED ON Fig. 1 IS TO BE TREATED AS THE TREE'S 'TREE PROTECTION ZONE' (TPZ) AND PROTECTED IN ACCORDANCE WITH AS4970 GUIDELINES AT ALL TIMES DURING THE CONSTRUCTION PROCESS. RECOMMEND INCORPORATING TREE #1 INTO THE SAME TPZ AREA.

4. PROTECTIVE FENCING IS TO BE INSTALLED TO EXCLUDE THE TPZ AREA FROM THE SITE IN ACCORDANCE WITH AS 4970 GUIDELINES & Fig. 2 & 3 BEFORE ANY WORKS OCCUR ON THE LOT.

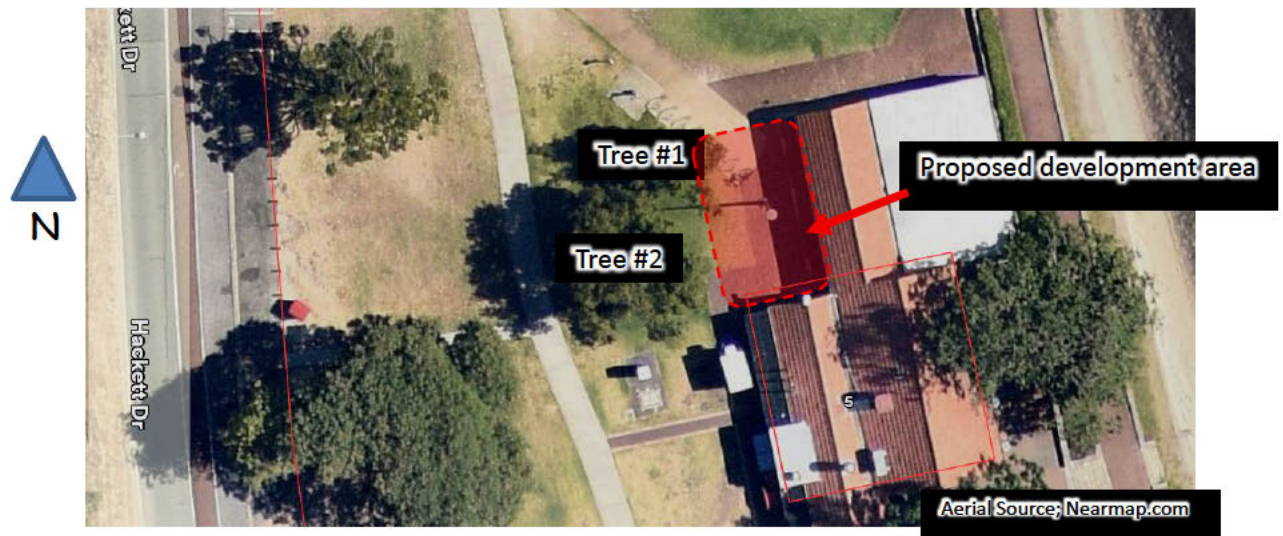
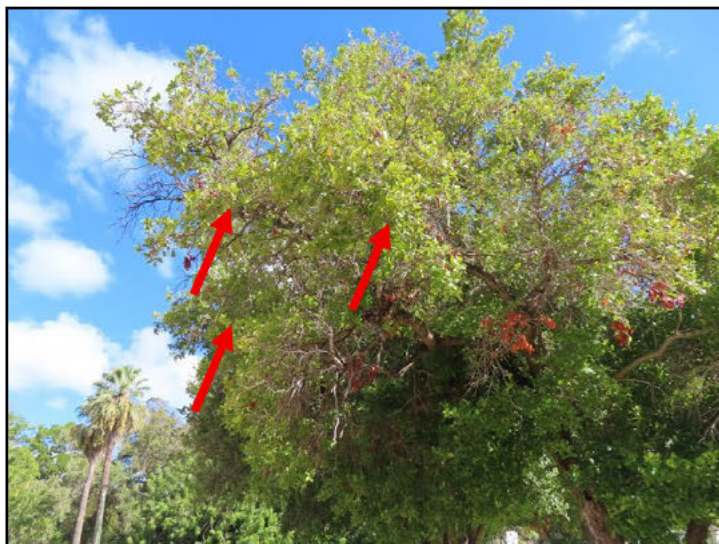
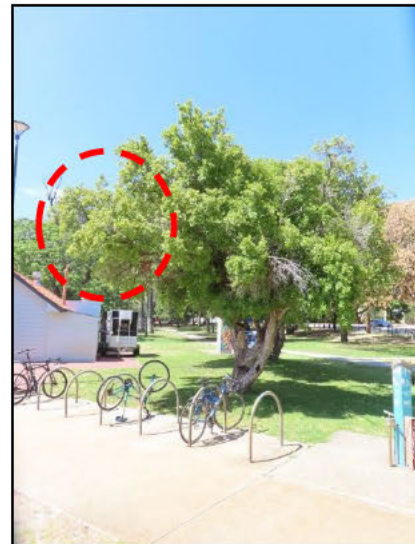
Tree #1; Lillypilly

Undertake selective canopy works to provide greater clearance from the proposed roofline; areas indicated on the image above.

No other canopy works are required to be undertaken.

- Canopy pruning to provide greater clearance for the proposed building is also recommended to be provided *before* general construction works commence so to avoid any potential conflicts during the construction period.
