Swan and Canning Rivers Foreshore Assessment and Management Strategy

March 2008

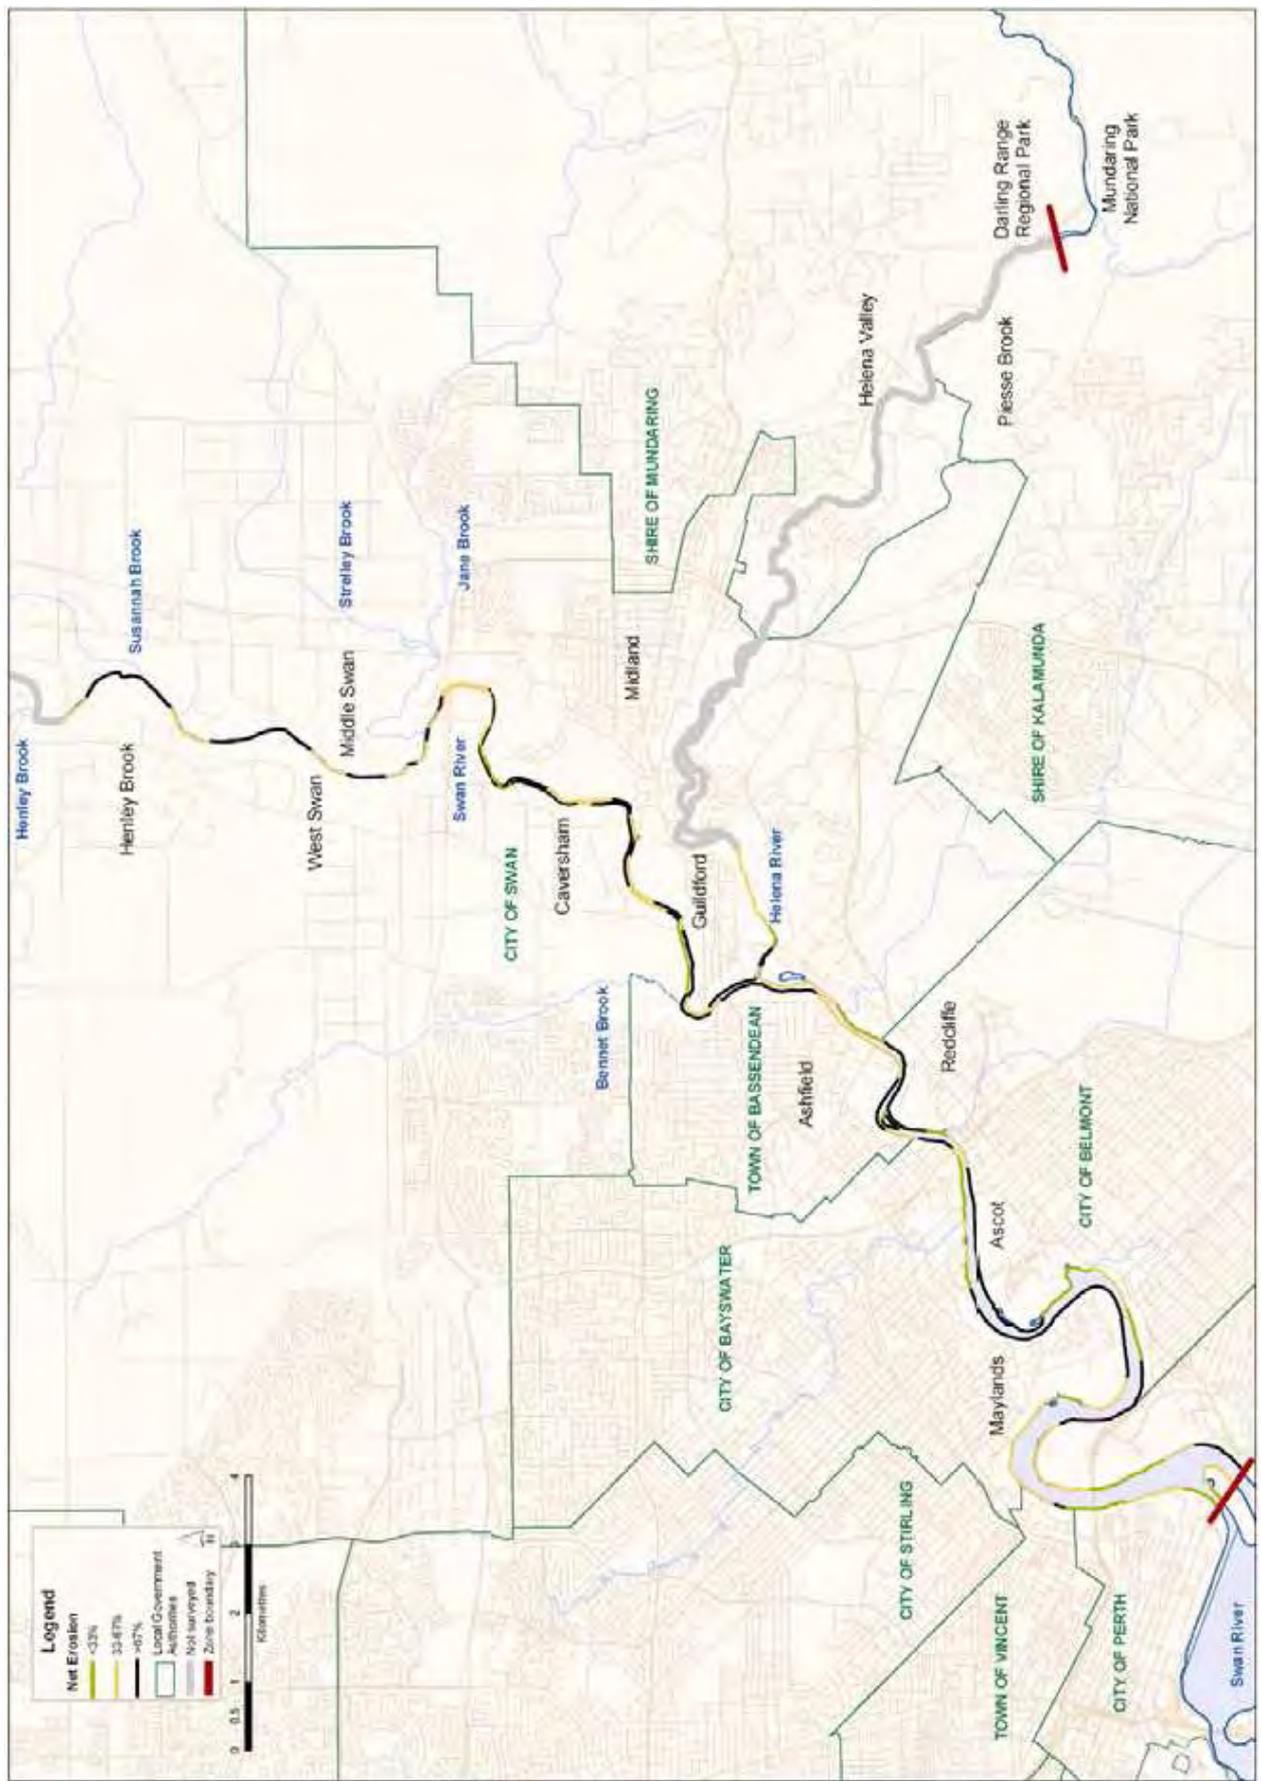
Figure 3.1 Extent of foreshore erosion along the lower Swan

More than two-thirds (69 per cent) of the Swan foreshore exhibits moderate to high erosion (Table 3.17; Figure 3.1, Figure 3.2). The presence of erosion on the upper bank is typically a result of significant flow events. The majority of the banks exhibited no scarping (64 per cent) with one-third of the banks showing evidence of low to moderate scarping (Table 3.18). Only 3 per cent of upper shores had high levels of erosion with scarping, with the majority occurring on the outside of meander bends.

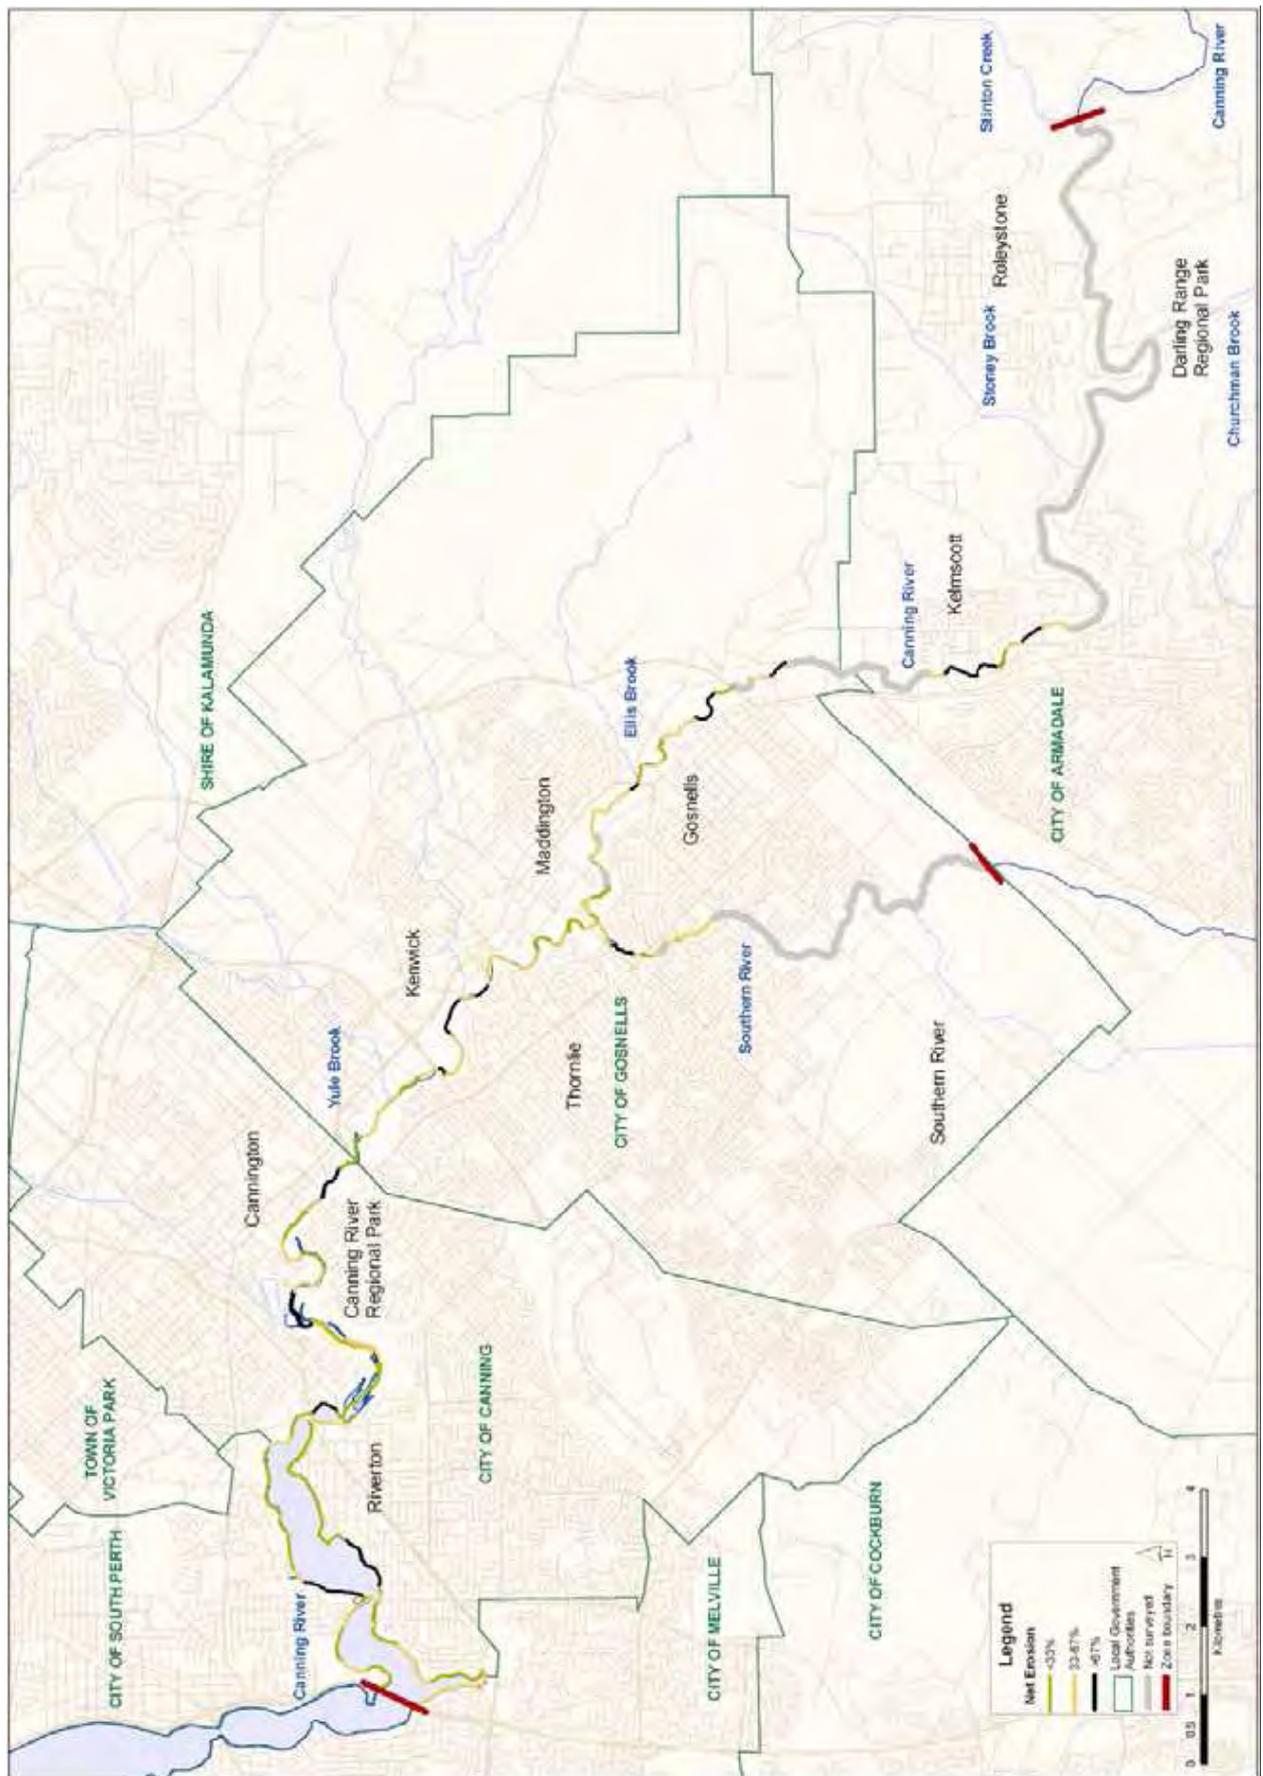
Figure 3.5 Extent of foreshore erosion along the Canning

Along the Canning, evidence of erosion can be masked due to the extensive weed coverage obscuring the view. Approximately half (47 per cent) of the Canning foreshores exhibited a low level of bank erosion and only 11 per cent of the foreshores exhibited a high level of erosion (Table 3.19; Figure 3.5). Evidence of erosion was typically observed on the outside of meander bends, at tributary confluences, in active floodplain areas, adjacent to woody debris and immediately upstream of riffles.

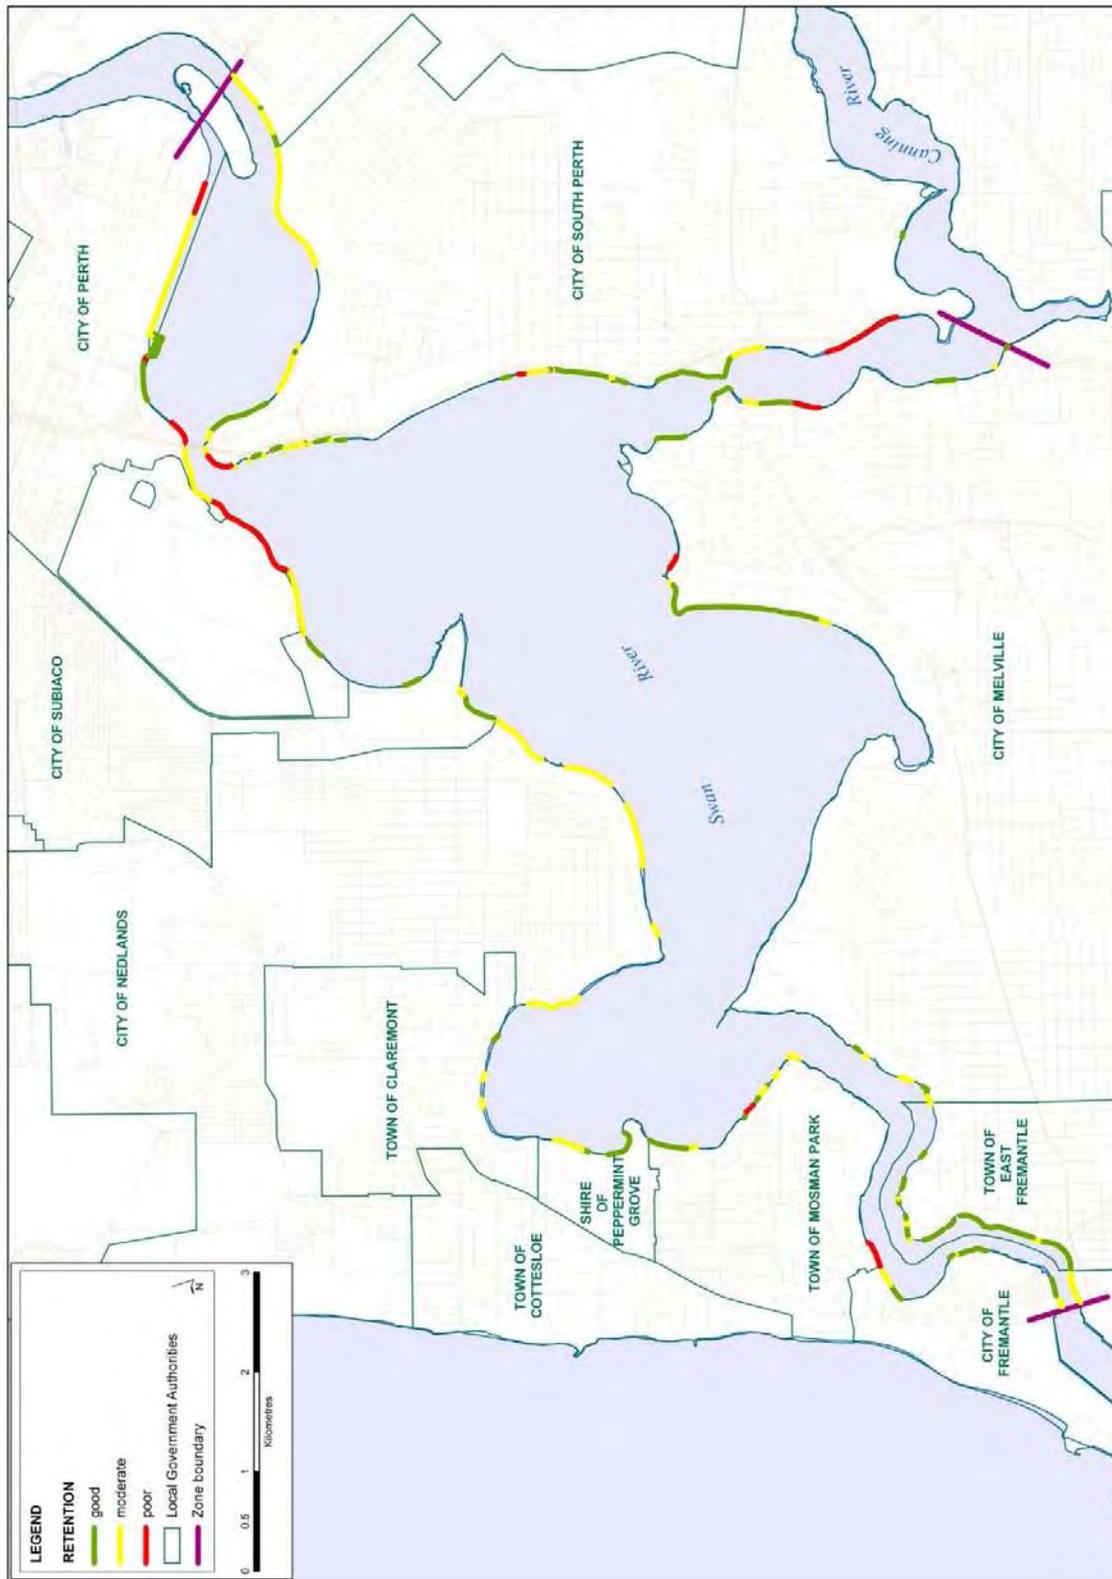
Figure 3.7 Function of foreshore protection structures along the estuary

Some 174 foreshore protection structures were identified along the estuary shoreline, covering approximately 25 km of foreshore (Appendix 7). Considering the structures by length of protected shore, 48 per cent of structures were identified as functioning well under existing conditions, with 41 per cent experiencing only minor sediment loss (Figure 3.7). Approximately 11 per cent of the structures were performing poorly. The majority of poorly performing structures are believed to have reached the effective limit of their structural life.

The function of the existing foreshore protection structures along the Estuary Zone is generally better than their condition. In most cases, this is because even a badly degraded structure will assist in the retention of foreshore sediments. As a result, even a poorly designed or constructed structure may function adequately for a number of decades. However, foreshore protection structures are susceptible to damage due to changing bed levels, whether through undercutting or downdrift erosion. Foreshore protection structures therefore require careful design where there may be large variations in alongshore sediment supply, or variations in shore orientation. The most critical areas with regard to variation in alongshore sediment supply are Como foreshore, South Perth western foreshore and Lucky Bay, Applecross. Construction of a foreshore protection system in these areas is likely to have implications further alongshore, and in fact each of these areas has a long history of progressively added works.

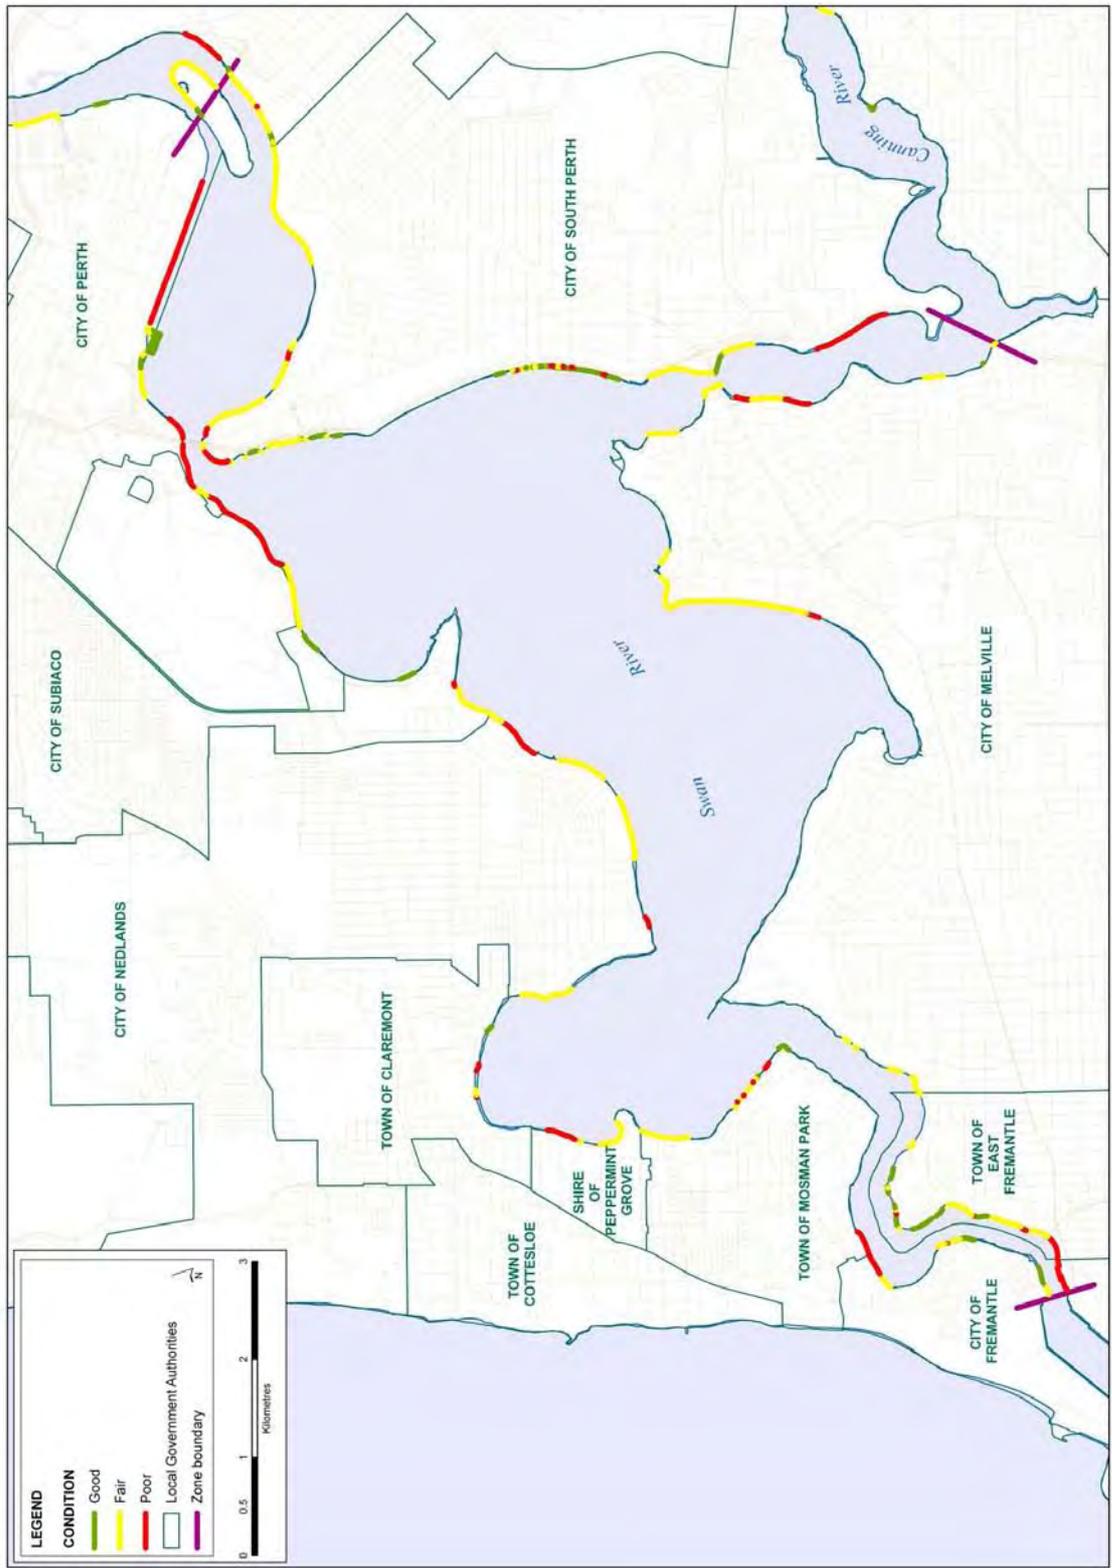
Figure 3.8 Condition of foreshore protection structures along the estuary

On the basis of the length of protected shore, 27 per cent (6.7 km) of structures were in good condition and would benefit from an annual maintenance program, 32 per cent (8.2 km) were in fair condition and in need of immediate maintenance, and 26 per cent (10.6 km) were in poor condition, requiring rebuilding or removal (Figure 3.8). The majority of structural damage appears commensurate with the age of the structures and their expected pattern of degradation.

The majority of structures that are in poor condition have reached the effective limit of their structural life. Notable exceptions include gabion walling along Mounts Bay Road and the series of armoured groynes along Como Foreshore. It appears that inadequate design and construction are responsible for the gabion failure along Mounts Bay Road. For Como foreshore, the design required ongoing foreshore renourishment, which has not occurred with the originally intended frequency.

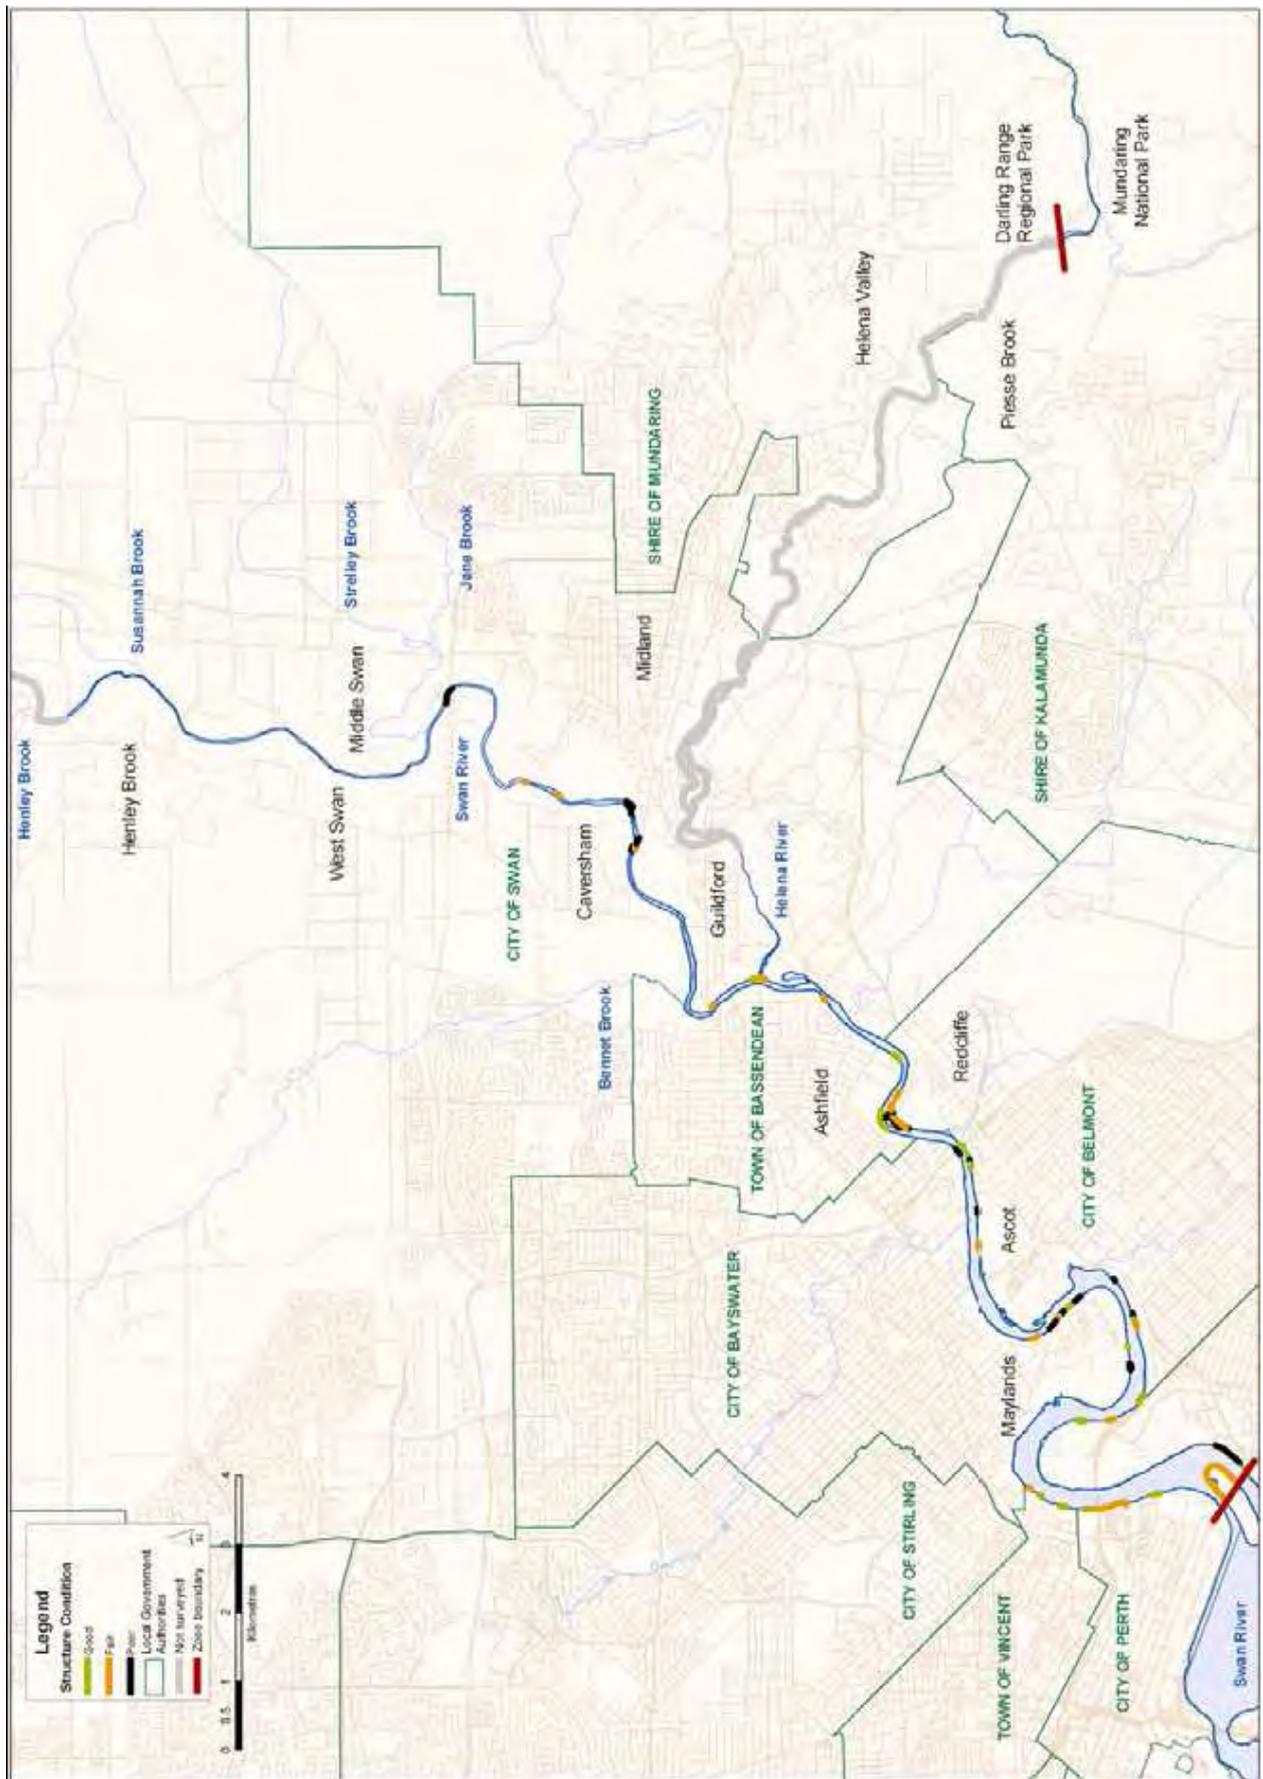
Figure 3.9 Structure condition along the lower Swan

A total of 6.75 km of structures on public land were surveyed in the Swan (Table 3.21; Appendix 7). The highest proportion of structures was generally in a fair condition (40 per cent) with 32 per cent in a poor condition (Table 3.22; Figure 3.9; Figure 3.10). The highest proportion of structures exhibited a poor function (40 per cent) (Table 3.23; Figure 3.11; Figure 3.12). This degraded condition and function can be largely attributed to the age of the structures, insufficient maintenance and inappropriate height / type of structure for the active processes at that location.

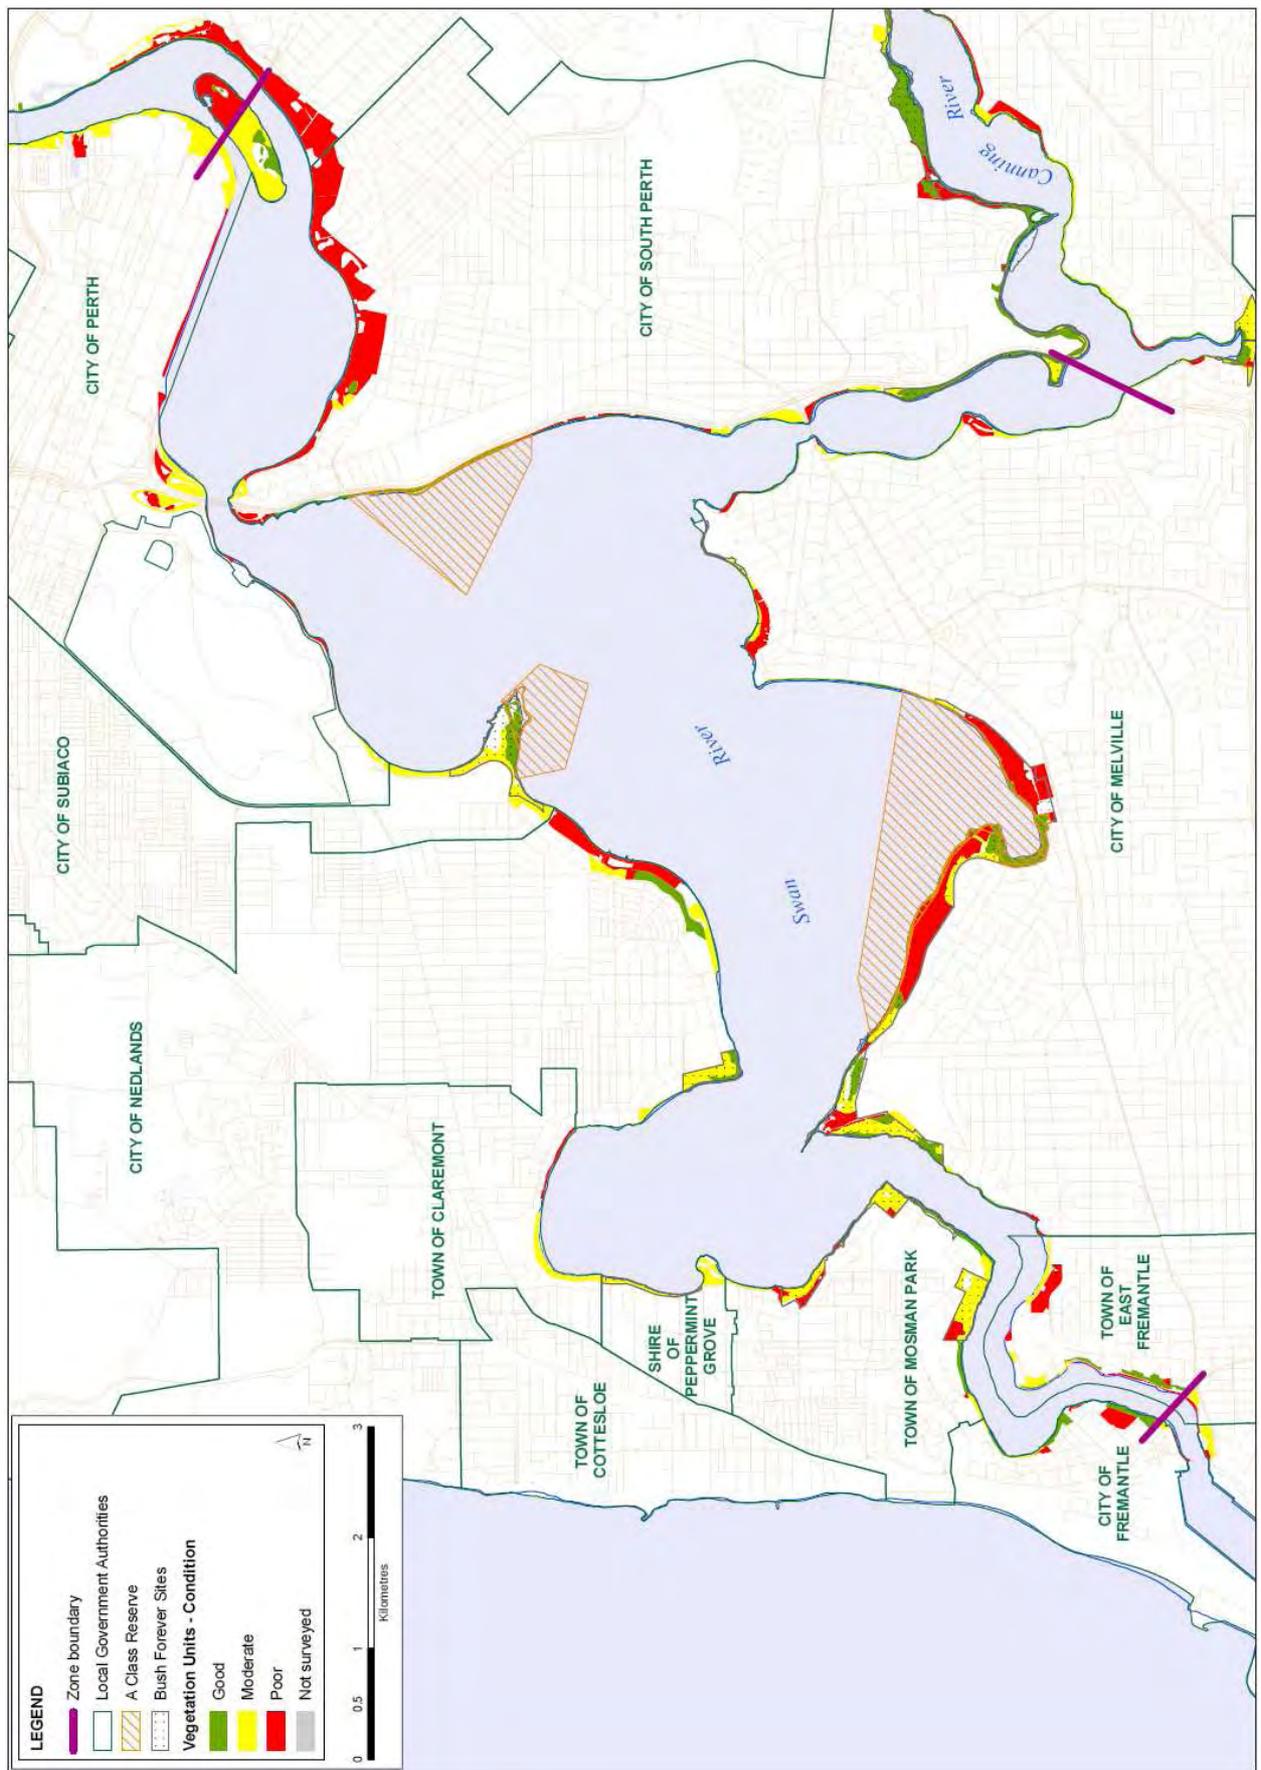
Figure 3.22 Summary of vegetation condition along the Estuary Foreshore

Based on the simplified categories of condition, 45 per cent of the foreshore vegetation along the estuary was rated in poor condition, followed by 37 per cent as moderate and only 18 per cent as good (Figure 3.22; Appendix 10).

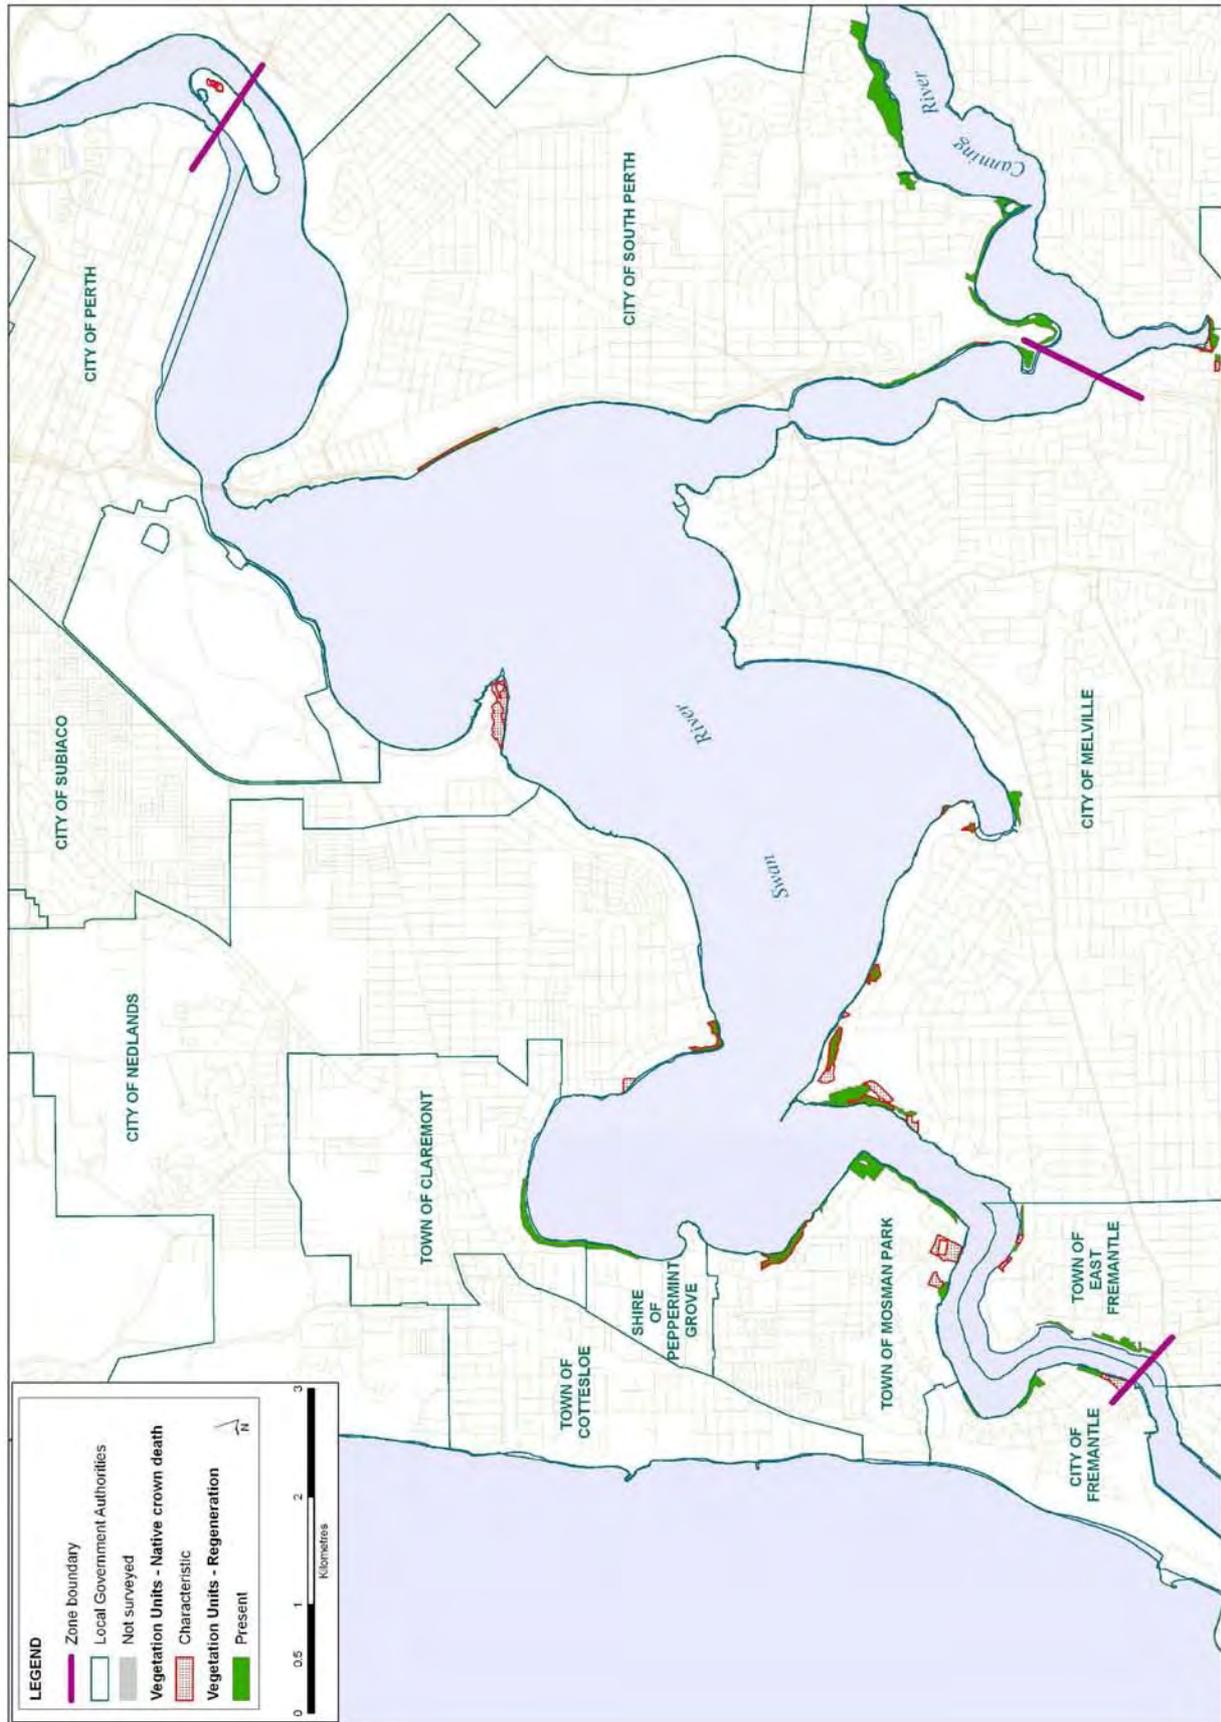
Figure 3.24 Crown death and local species regeneration along the Estuary Foreshore

Of the 287 ha of foreshore recorded to contain trees as a structural layer, a staggering 75 per cent was observed as not showing any evidence of local species tree regeneration. Occasional regeneration was recorded within 64.6 ha (23 per cent), where as only 6.9 ha (2 per cent) was recorded as supporting common to abundant regeneration of local tree species. Overall, 11.9 ha (4 per cent) showed signs of significant crown death (Figure 3.24).

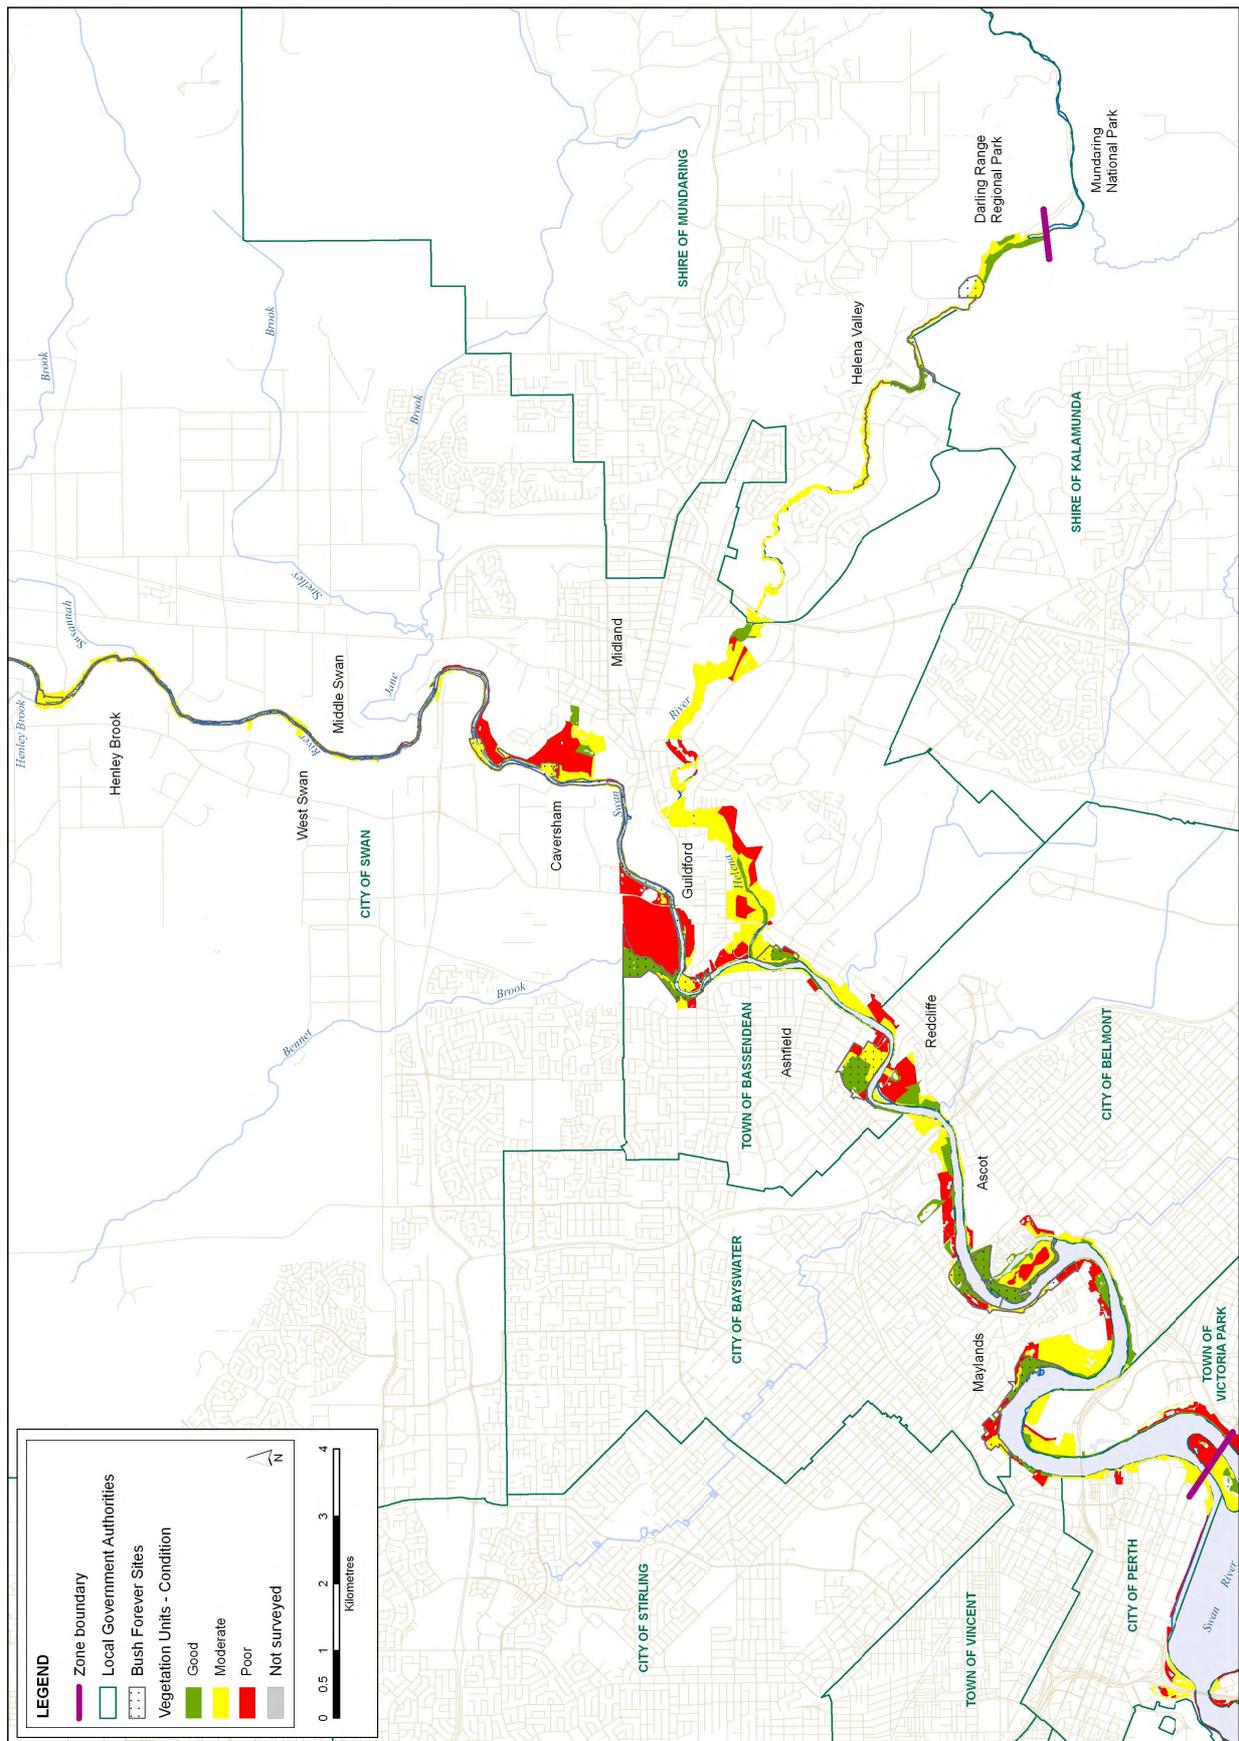
Figure 3.25 Summary of vegetation condition along the lower Swan Foreshore

Only 15 per cent of vegetation was considered in good condition along the Swan, with 58 per cent considered to be moderate and 27 per cent poor condition (Figure 3.25, Figure 3.26; Appendix 10).

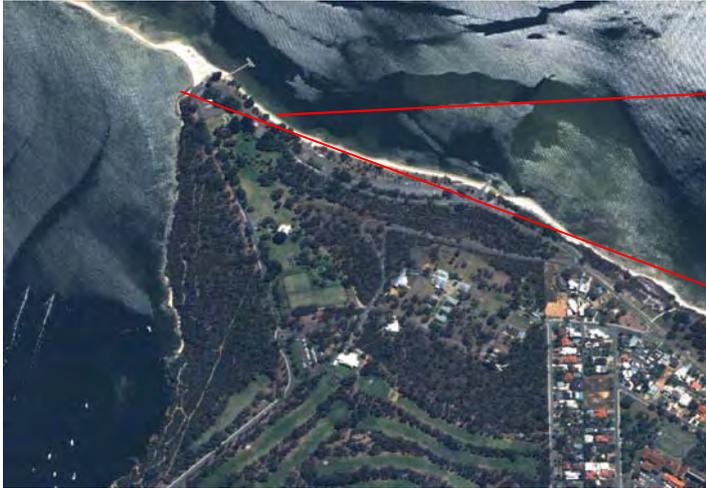
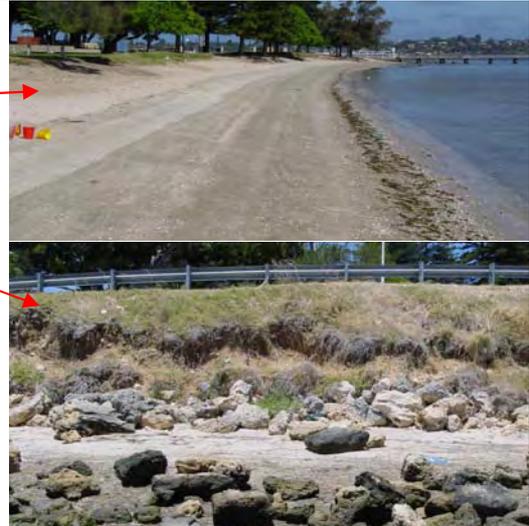
Description: Point Walter is characterised by a large sand spit adjacent to the tidal channel between Fremantle and Freshwater Bay. Historically, dredging has occurred in the basin adjacent to the Point Walter jetty.

The impervious nature of the Point Walter jetty exacerbates erosion problems of the foreshore immediately east of the jetty. Other impermeable structures, particularly the two Point Walter boat ramps, are subject to updrift accretion and downdrift erosion, which may reverse direction seasonally.

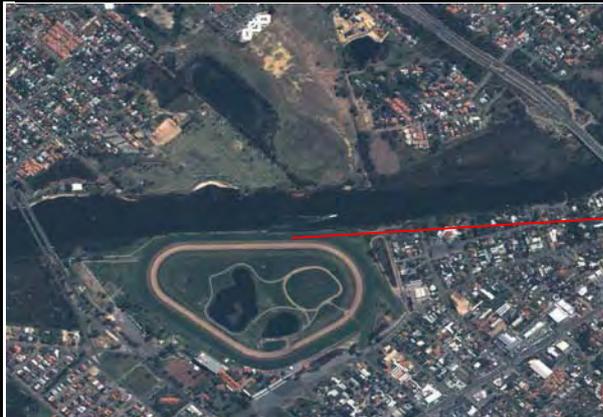
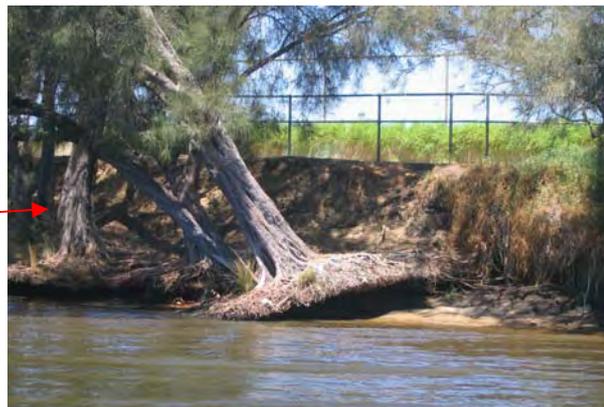
Description: There is a narrow band of riparian vegetation along this straight length of foreshore. A dual use path and Ascot Racecourse are located directly adjacent to the bank. The banks are exhibiting retreat (with undermining and scarping) due to a combination of boat wakes, wind waves, river currents and increased mean water levels. In addition, bank instability has occurred in some locations due to water draining off the path and racecourse onto the bank. The path is being undermined in some locations with tree collapse also evident (see picture). Undermining of the path is a concern for public safety.

A revegetation program should be conducted to widen the vegetation buffer of trees and sedges, improving the bank stability. However, if the bank retreat is resulting in undermining the path, and the path cannot be moved, structural mitigation measures may be required.

This site may benefit from an education program for the public (including signage) about how to minimise boat wake impacts on the bank by modifying boat usage and through the potential modification of speed limits.

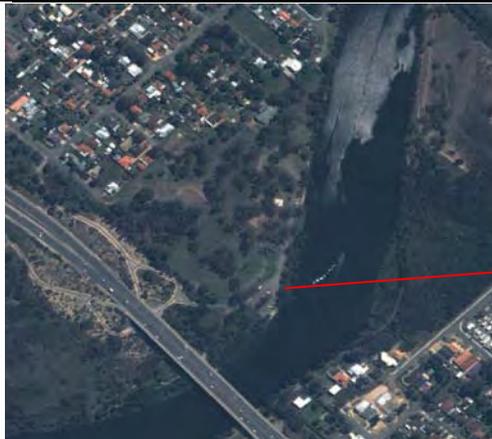
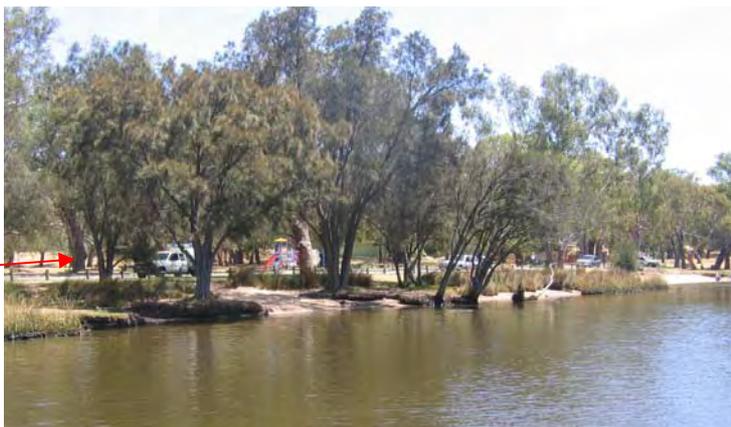
Description: Cloughton Reserve is on the inside of a bend adjacent to the Redcliffe Bridge and containing the Katanning Street boat ramp. This is an area of high recreation usage for boating as well as other land-based recreation. This is a low-lying site that is regularly inundated during surge and high rainfall events. A large car park is located directly adjacent to the foreshore.

The bank sediments are sandy loams often overlying a clay base. There is a narrow band of vegetation present, characterised by a single line of trees that exhibit undercutting of the roots. Tree collapse is evident.

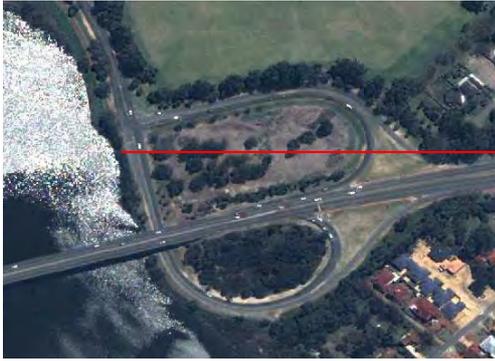
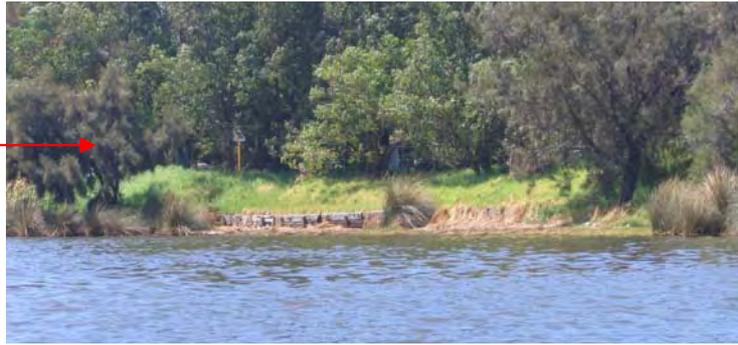
Description: The Leach Highway Offramp onto Centenary Avenue in Wilson is located close to the Canning River Foreshore. In this location, the road and dual use path are located less than 10 m from the shoreline. The dual use path is separated from the shoreline by a grassed section of foreshore with wave baffles placed at the toe. This site is susceptible to wind waves and surge.

Install a new structure that provides appropriate protection for the dual use path and roads in conjunction with removing the baffle boards. One option could be a revetment with sedge planted in front of the structure. The structure would need to be deeply embedded as this site is likely to be a separation point in wave-induced sediment transport.

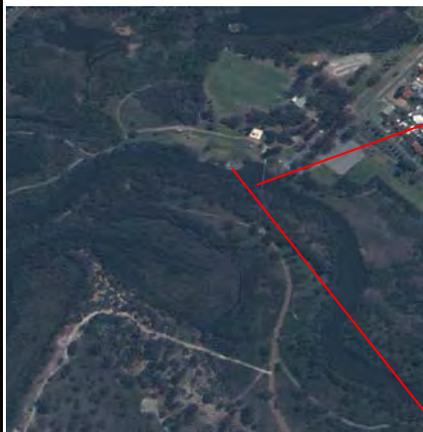
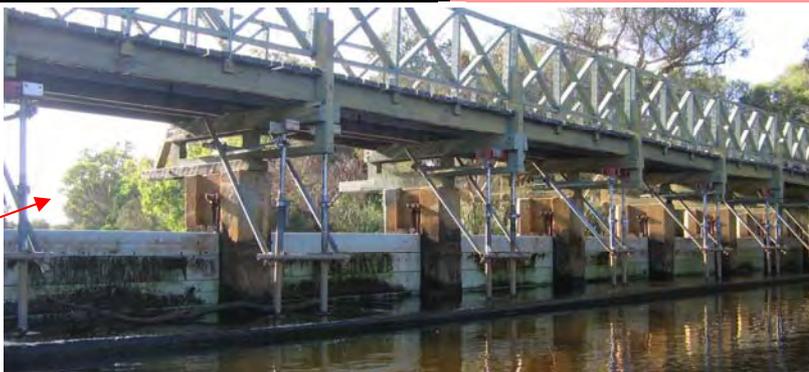
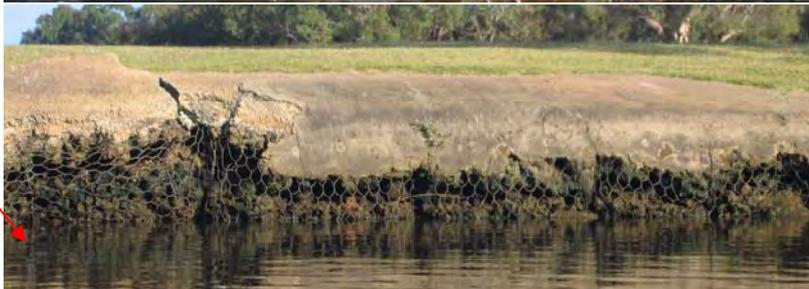
Kent Street Weir was installed to sustain both a freshwater environment upstream of the weir, and the water levels in the Canning for abstraction purposes. The weir can result in an elevation step up of 0.5 m in summer upstream of the structure. Maintenance of the structure is required for the ecosystem balance upstream. As at January 2007, the weir was in general disrepair with bowed weir boards (leaking water) and structural strain on the wooden path above the weir.

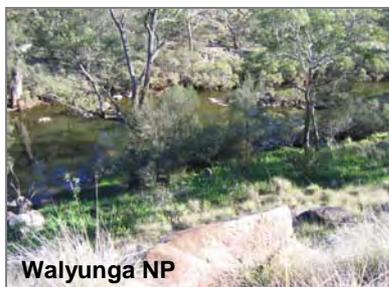
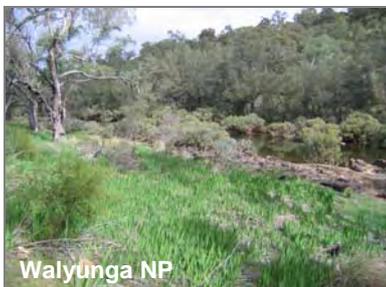
Walyunga NP

In 1969, the pastoral property was purchased by the state and the Walyunga National Park was established. The area provides a relatively natural river setting, although the understorey has been degraded by cattle grazing and introduced weeds and feral pigs threaten to further degrade the area.

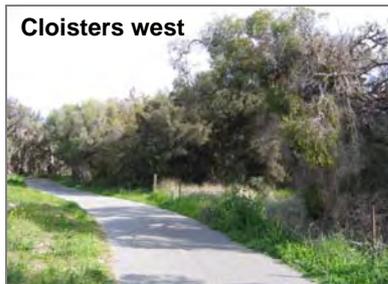
Cloisters west

In the early 1900s, the area was a popular camping and swimming spot. Permanent camps were set up during the Depression years of the late 1920s to 1930s as families evicted from their homes took refuge under the paperbarks at Cloister. Various land use associated with the development of Aquinas College resulted in vegetation clearing, however the most significant impact near the peninsula has been construction of the Narrows Bridge (opened in 1959) and freeway extensions (1977). Despite variable land uses and degradation, considerable remnant vegetation remains. The area is recognised as high regional conservation value, with management plans and rehabilitation proceeding (Ecoscape 2004).

- Increasing the width of the riparian corridor and increasing the structural complexity in nodes where trees and shrubs have been removed.
 - Undertaking infill planting to address breaches in sedge vegetation, allowing designated points for managed access to the river for recreation activity. In particular, provide adequate controlled access to the river for the Curtin Rowing Club site at Salter Point and rehabilitate degraded riparian vegetation within the immediate vicinity.

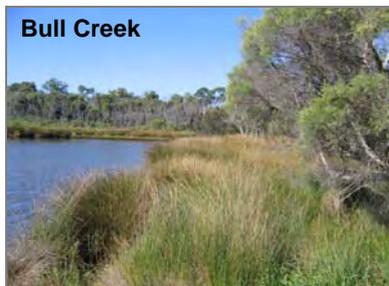
The area contains some fringing woodland vegetation and has been the focus for considerable restoration effort. However, the site is threatened by various invasive species, and an increase in boat moorings in the Bull Creek inlet has resulted in greater recreational activity with the potential to degrade the foreshores.

- Promote the use of fishing platforms as focal points for responsible recreational fishing.
 - Address issues of vegetation trampling and degradation resulting from inappropriate pedestrian movement to boat moorings at Bull Creek.
