Swan and Canning Rivers Foreshore Assessment and Management Strategy

March 2008

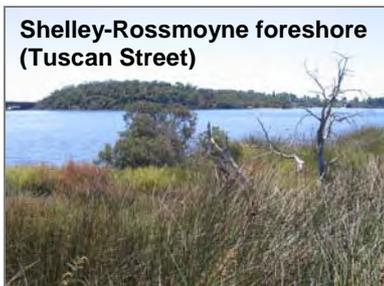
Shelley-Rossmoyne foreshore (Tuscan Street)

A narrow foreshore area of good condition vegetation, which has been rehabilitated and is maintained by the Canning River Residents Environmental Protection Association and the City of Canning.

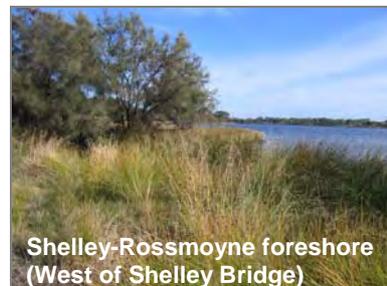
Shelley-Rossmoyne foreshore (West of Shelley Bridge)

A narrow foreshore area of good condition vegetation, which has been rehabilitated and is maintained by the Canning River Residents Environmental Protection Association and the City of Canning.
