Department of **Biodiversity,
Conservation and Attractions**

Saint Leonards Creek Foreshore Condition Assessment

Version: 2

Last Updated: November 2020

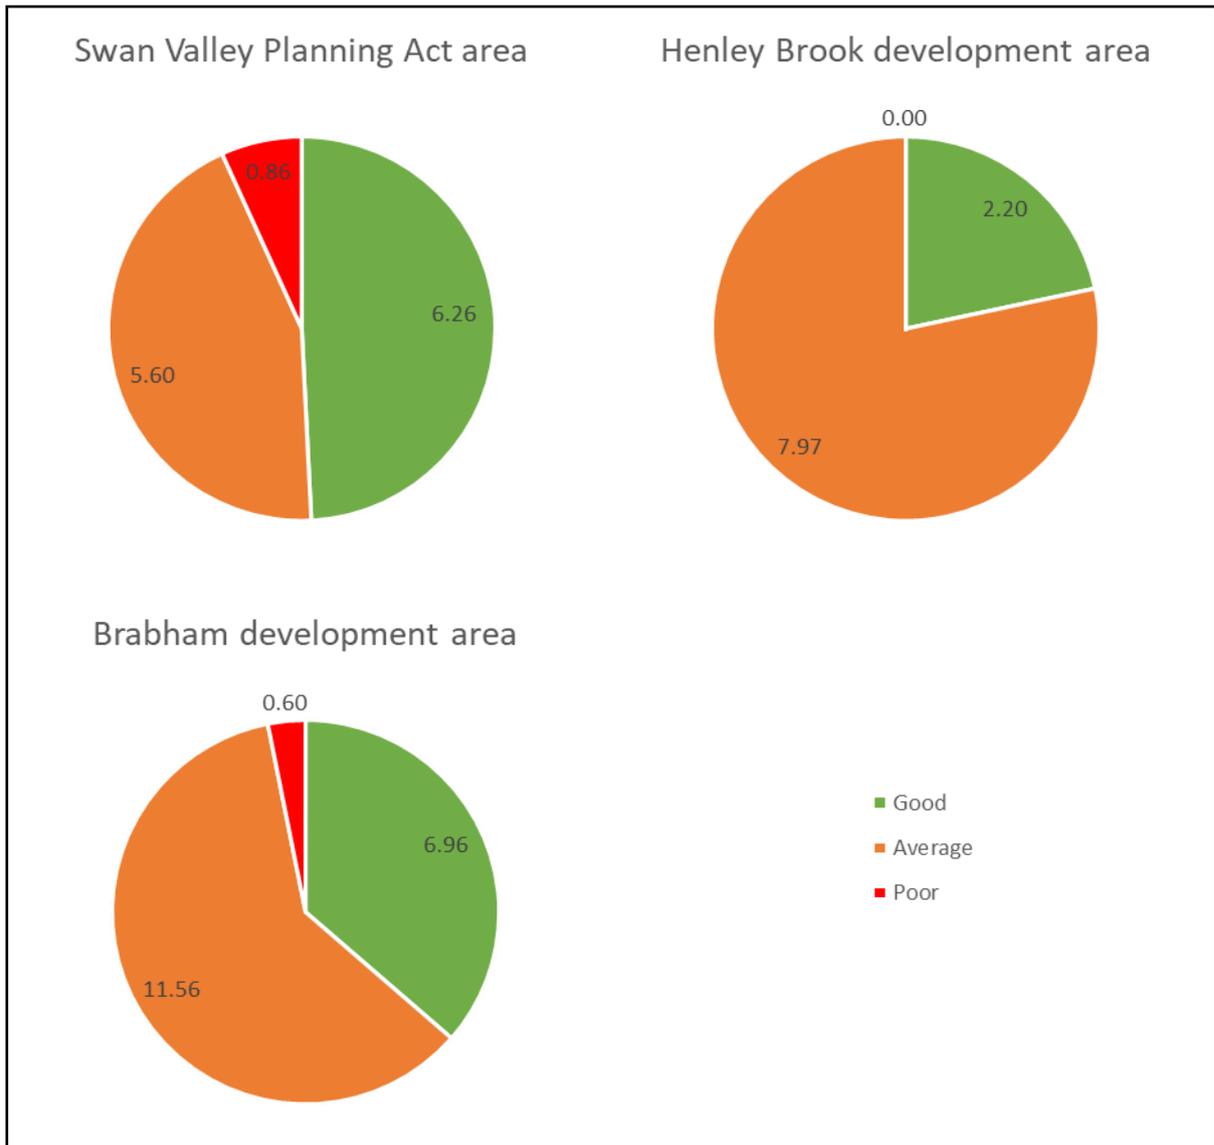
Bank stability is good to average across most of the creek system (Figure 6). It is important to note that bank stability was considered independently of weed cover, so the bank may be stabilised by weeds. If weed control works are planned, the impact on bank stability needs to be considered and addressed.

Figure 6: Bank stability in each assessment zone by length of streambank (km).

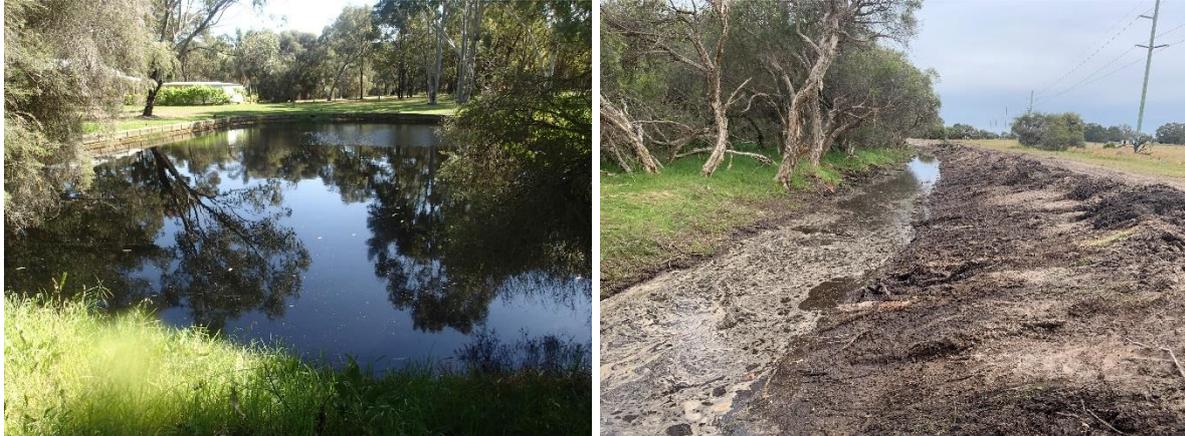
The creek system is made up of several channels in this zone. Moving upstream from the confluence with the Swan River, the creek is a single channel with steep to medium banks more than 1m high, until the junction of segments 14 and 71 (Figures 7 and 11). At this point a channel flows in from Brabham. It has been piped by the landholder at the outlet.

The channel from Brabham has been modified into a series of ditches. Localised flooding of roads is an issue for the local government during wet months. At the time of assessment the City of Swan was grading and deepening some of the ditches to alleviate flooding (Figure 8). Unfortunately, the process of grading also damaged some of the native overstorey of *Melaleuca pressiana*.

Figure 7 and 8: A channel flows in from Brabham at segment 14 and has been piped by the landholder to form a small waterbody (left); Banks have been graded in an attempt to reduce localised flooding (right).

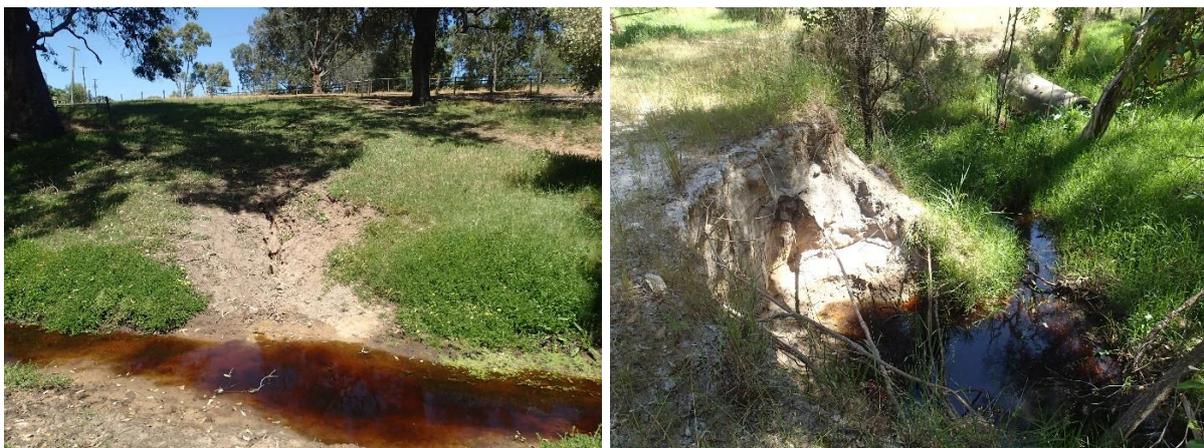
This zone had some areas of localised erosion. This included a steep area where horses have constant access to the creek and have exposed the soil resulting in some gully erosion and undercutting (Figure 9). On part of the easement in the suburb of Henley Brook, adjacent private property landholders have installed culverts on the creek, changing the flow and leading to erosion around the culverts (Figure 10). The concrete culverts have mostly broken away from the banks.

Figure 9 and 10: Gully erosion on the lower banks of Saint Leonards Creek (left); Erosion near broken culverts in Henley Brook (right).

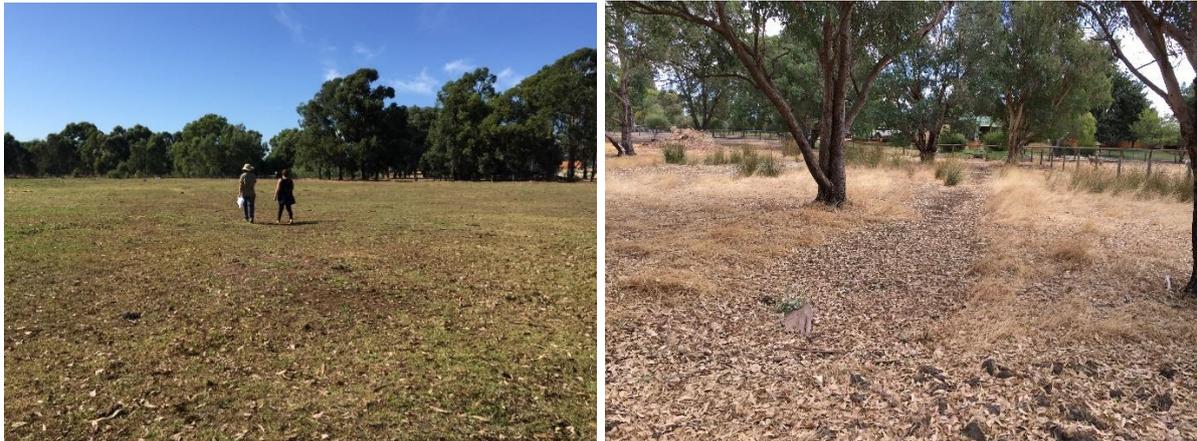
In this zone the creek system has been highly modified, mostly into straight ditches. The flat landscape is likely to have been palusplain wetlands that were cleared and modified to take local drainage when the land was developed into small hobby farms. Many landholders reported a lack of flow since the Morgan Fields residential estate was built in 2002. The creek alignment is almost impossible to follow on many hobby farms as much of it is a shallow depression only 0.1-0.2m deep with no riparian vegetation (Figures 13 and 14).

Figures 13 and 14: The creekline is a very shallow depression on many properties in Henley Brook (left and right).

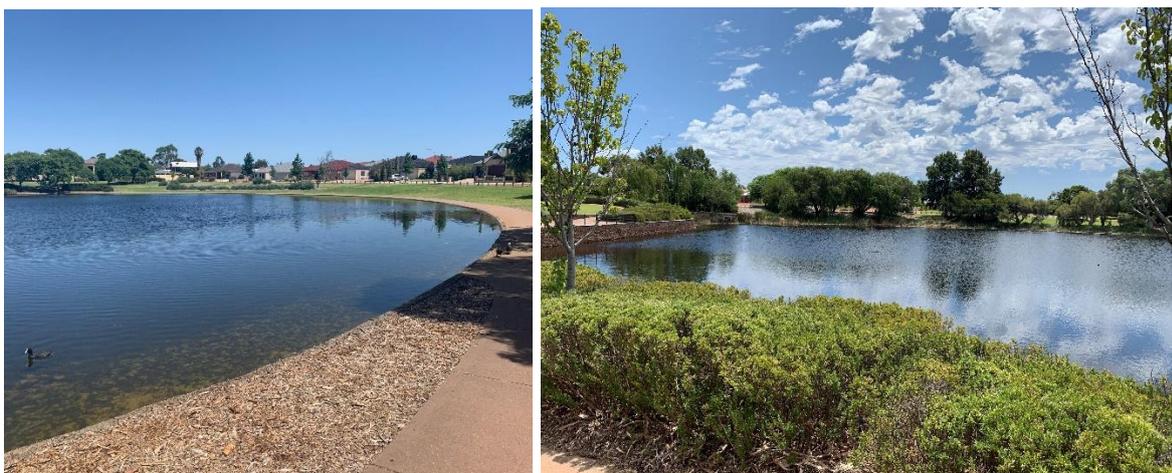
The upper lakes of Sandown Park are a series of three lakes lined with concrete and surrounded by hard footpaths. The lower lake is unlined and contains some native vegetation that is likely to have been planted.

Figure 15 and 16: Upper lake in Sandown Park, Henley Brook (left); Lower lake in Sandown Park (right).

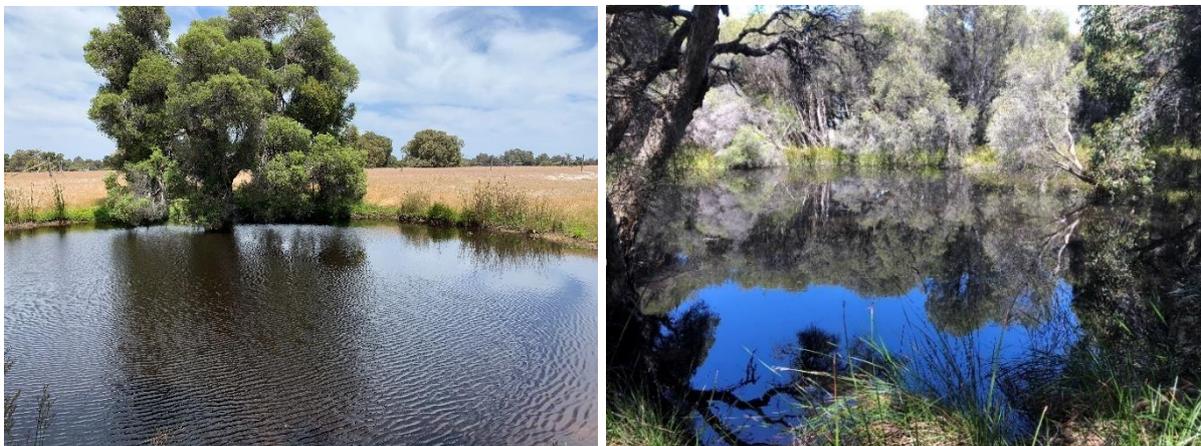
The other branch flowing in from Brabham also flows across DoC land (segments 56-63) but is not as highly modified. It incorporates a main channel and a series of palusplain wetlands (segments 46-51) including Pannage Wetlands (Resource Enhancement Wetland 8804) and several waterholes. These waterholes are likely to have been excavated when the area was farmed but have since become refuges for native flora and fauna (Figures 19 and 20). Two of these waterholes were monitored by North Metro TAFE.

Figures 19 and 20: Waterholes in segment 56 (left) and segment 61 (right) on DoC land.

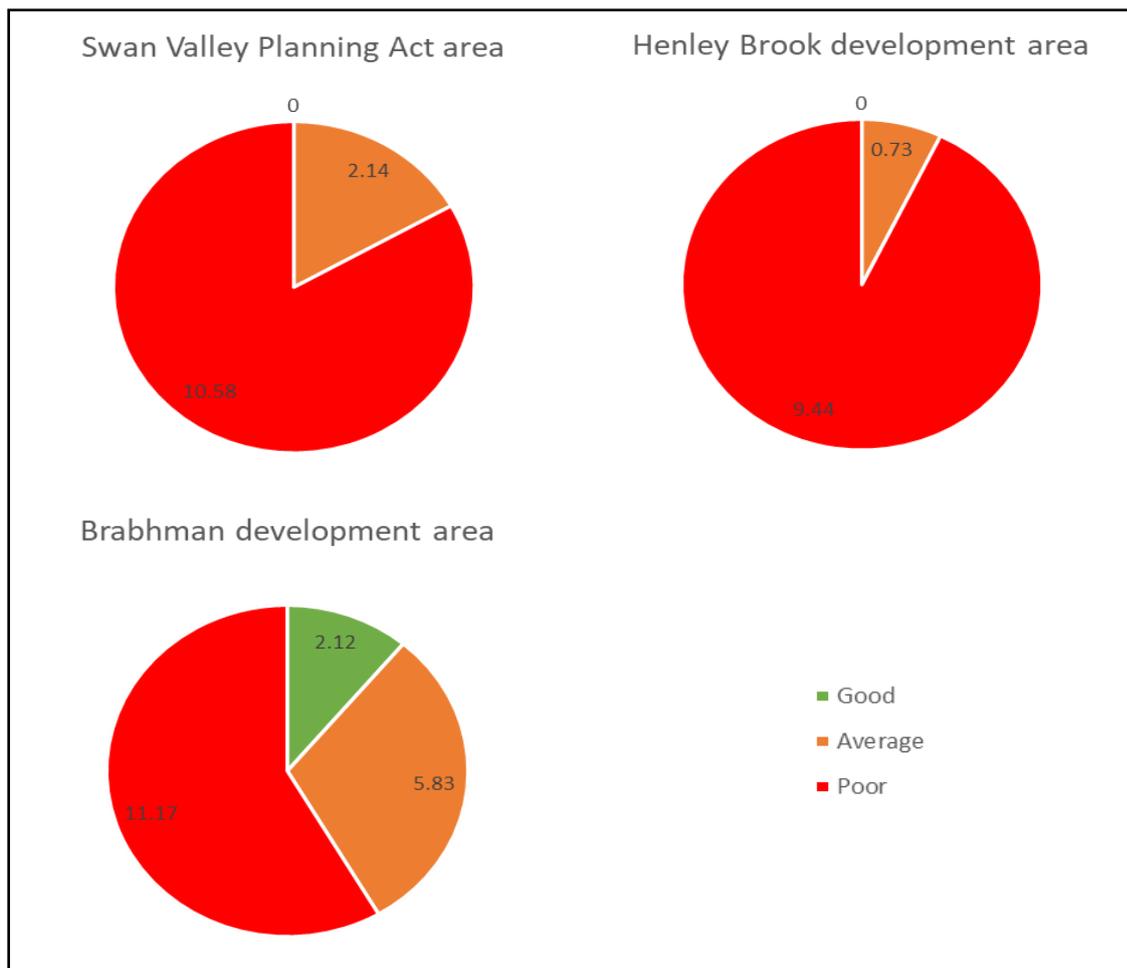
Most of the riparian vegetation across Saint Leonards Creek is in poor condition. Much of the area has been cleared and farmed since early European colonisation and very few segments resemble pre-European remnant vegetation. The only areas of good condition vegetation are in the Brabham development area (Figure 23).

Figure 23: Vegetation condition in assessment zones by length of streambank (km).

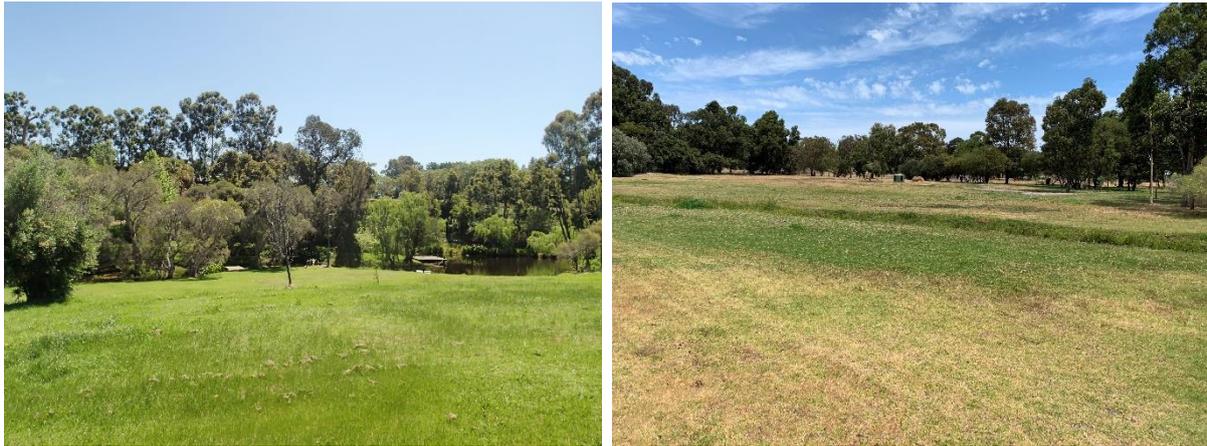
Vegetation type varies depending on the style of gardening and property maintenance of each landholder. Many landholders have added exotic species to remnant vegetation, such as Willows and other deciduous trees (Figure 24). There are many highly maintained and manicured gardens where lawns are mown regularly and native plants do not have a chance of recruitment (Figure 25).

Figures 24 and 25: Willow trees and other deciduous trees over grassy banks in West Swan (left); Mown lawn up to the banks of the creek, Henley Brook (right).

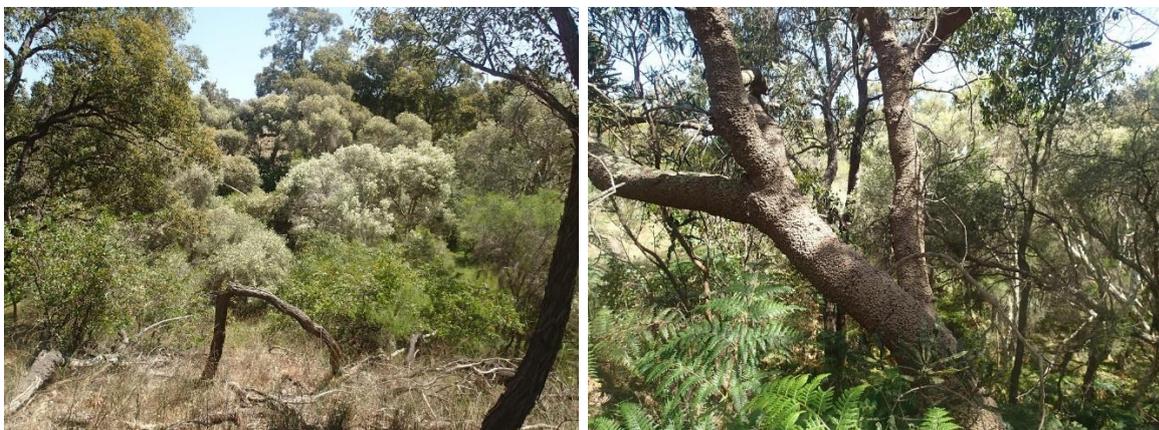
On the City of Swan easement between West Swan Road and Lawson Road, the vegetation is remnant *Melaleuca raphiophylla* woodland with an understorey of weedy grasses and native shrubs. It is in average condition (Figure 26). Some well-established *Banksia* trees remain (Figure 27). Some revegetation has occurred with several species now not found elsewhere on Saint Leonards Creek: Mangles Kangaroo Paw (*Anigozanthos manglesii*), Harsh Hakea (*Hakea prostrata*), Prince of Wales Feather (*Ptilotus polystachys*) and Blueboy (*Stirlingia latifolia*).

Figure 26 and 27: Remnant woodland (left) and several well-established *Banksia* trees remain (right) on the City of Swan easement near West Swan Road.

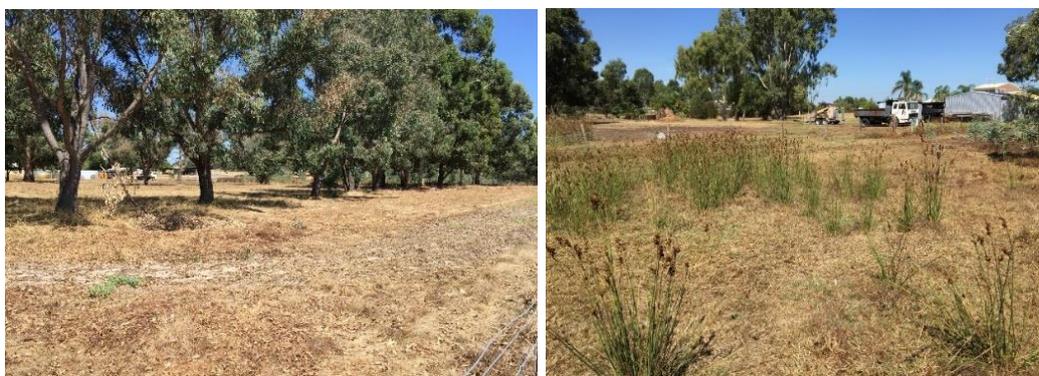
The overstorey is the most intact vegetation layer, but on many properties it is sparse to absent. Flooded gum (*Eucalyptus rudis*) and Eastern States Eucalyptus are the most common trees (Figure 29). If non-local Eucalypts are not outcompeting local natives, they should be retained to provide shade and habitat in new estates.

There are some small, isolated stands of sedges (Figure 30) but these are not common. The understorey is nearly all mixed weedy grasses and there is virtually no mid-storey present. Small dams are present on some properties, mostly planted with exotic garden species.

Figures 29 and 30: Established Eastern States Eucalyptus (left); Isolated stand of Juncus pallidus in grassy paddock (right).

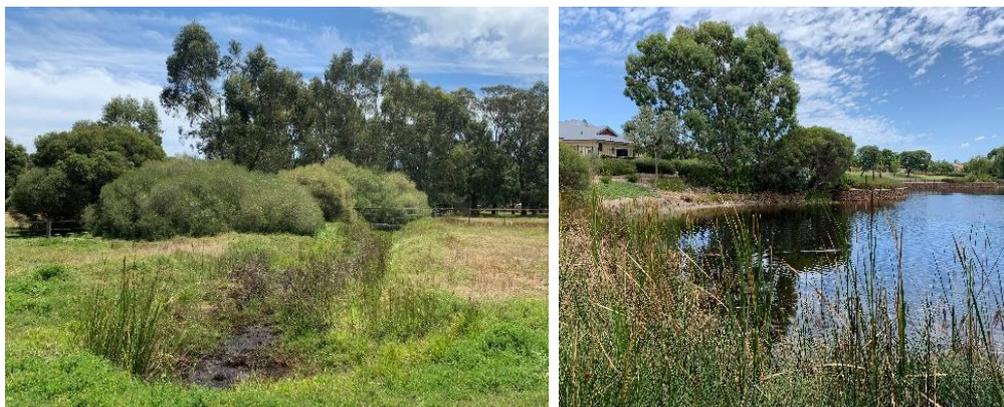
Native riparian vegetation was only apparent immediately west of the *Swan Valley Planning Act* area (segment 24), and around the lower lake in Sandown Park (segment 92). Both segments were in average condition (Figure 33).

Segment 24 is near the corridor for the proposed Henley Brook Avenue and was the only segment in this zone where *Melaleuca viminea* was dominant (Figure 31). Sandown Park is parkland maintained by the City of Swan and comprised of three upper lakes (segment 92) and a lower lake (segment 91). Vegetation around the upper lakes is landscaped with exotic and non-local species. The lower lake is surrounded by a narrow strip of remnant *Melaleuca raphiophylla* and sedges (Figure 32). Local natives were mostly planted around the lower lake.

Figures 31 and 32: Remnant sedges and Melaleuca viminea in segment 24 (left); Native vegetation on the lower Sandown Park lake (right).

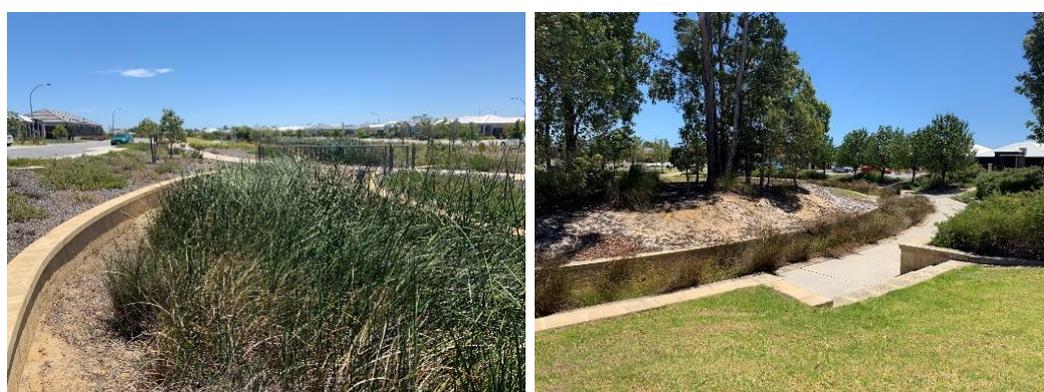
In Whiteman Edge Estate the creek has been modified into drainage channels (e.g. segment 86, Figure 34) or piped. Native plants have been used in the landscaping. The overstorey has not yet established but over time will provide shade and habitat.

Some small parks in Whiteman Edge are dry compensation basins that have been revegetated with native plants. Most of these are in average condition and will need ongoing maintenance as they are vulnerable to weed incursion and rubbish. Savello Park (segment 89; Figure 35) was in poor condition as a limestone wall prevents a transition to the remnant Marri woodland and weeds are establishing.

Figure 34 and 35: Native vegetation planted in drainage channels in Whiteman Edge Estate (segment 86) (left); Savello Park in Whiteman Edge Estate (right).

In the revegetated drainage channels in Whiteman Edge, weed cover is mostly minimal as weeds are actively managed. However, in Savello Park (segment 89) weedy grasses and herbs are starting to outcompete natives and should be controlled.

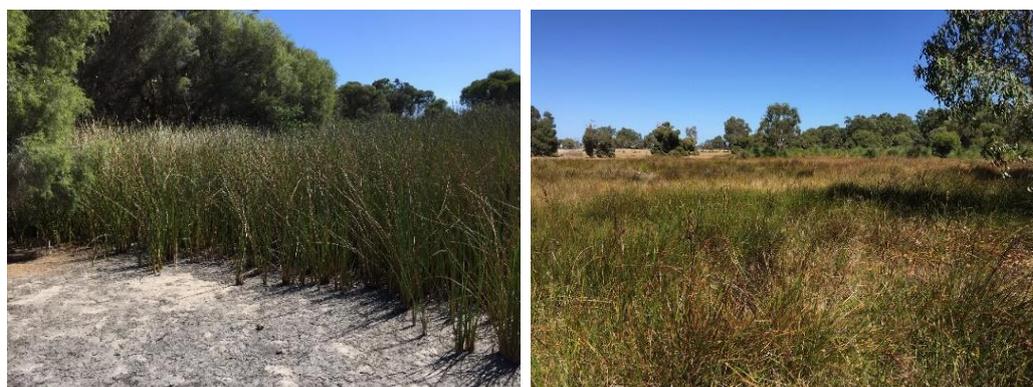
This is the only zone where good condition vegetation was found. However, it is located on land proposed for residential development or has been cleared since the assessment (e.g. segment 69, Figure 37). Remnant vegetation has been impacted by past land practices but in areas has regenerated and is in good condition. No good condition vegetation was found where urban development has taken place.

In particular, segments 48, 49, 59 and 61 have high diversity with dominant genera including *Corymbia*, *Astartea*, *Lepidosperma* and *Baumea* (Figure 36). Given the overall degraded nature of Saint Leonards Creek, this vegetation is highly valuable and should be protected. Remnant stands of *Xanthorrhoea brunonis* also occur on DoC land. With revegetation and weed and access control, areas in average condition will regenerate and can be restored to good condition.

Figures 36 and 37: Baumea articulata sedgeland on DoC land (left), and diverse sedgeland on a proposed estate which is now cleared (right).

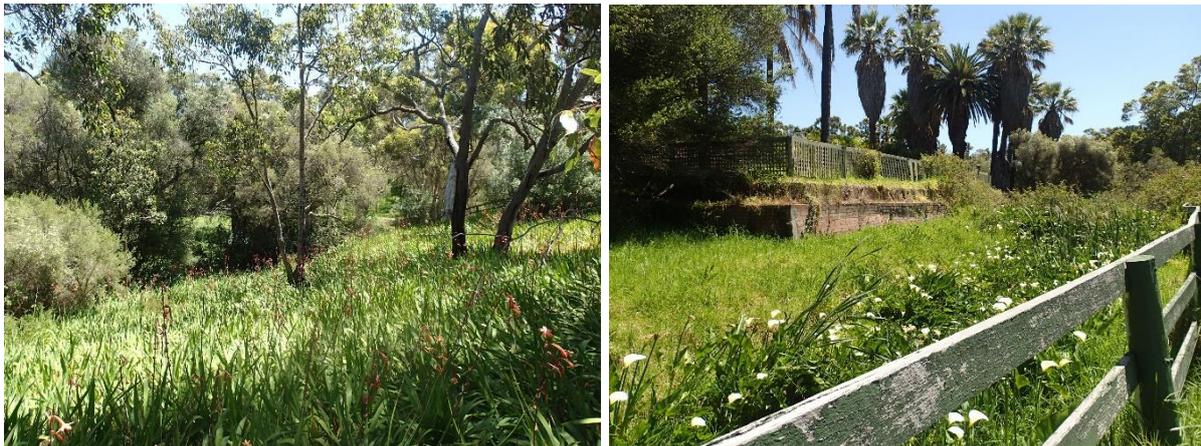
Most of this zone had extensive weed cover (Figure 44). Kikuyu grass is dominant throughout the whole zone and it makes up the bulk of the understorey in many segments. Most of the zone has been farmed since European settlement and much of it is now grazed by horses. *Watsonia* was common south of West Swan Road (Figure 40) and Arum lily was common south of Lawson Road (Figure 41). Other widespread understorey species throughout this zone were Dock (*Rumex* sp.), *Persicaria*, Trefoil (*Lotus* sp.) and Ryegrass (*Lolium* sp.).

Figures 40 and 41: *Watsonia* (left) and *Arum Lily* (right) are common on the lower reaches of Saint Leonards Creek.

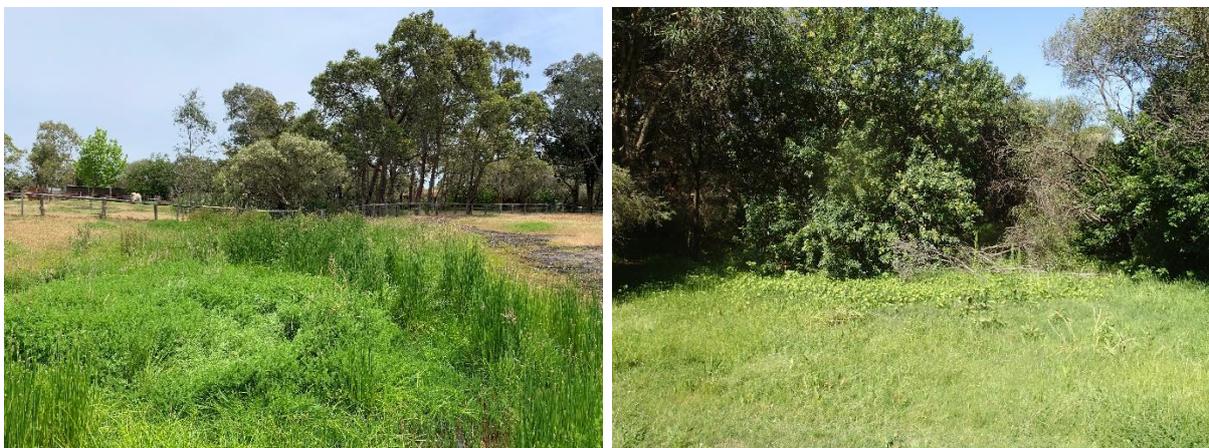
In the upperstorey, exotic trees and Figs have partly replaced the native flooded gum and swamp paperbark woodland (Figure 42). Dense infestations of Brazilian Pepper were found south of Park Street and near the City of Swan easement south of Lawson Road (Figure 43). The Brazilian Pepper trees at Park Street have now been removed by the landholder with funding from DBCA.

Figures 42 and 43: Extensive weed cover of *Juncus microcephalus*, *Trefoil* and *Isolepis prolifera* (left); Dense infestation of *Brazilian Pepper* over *Kikuyu* (right).

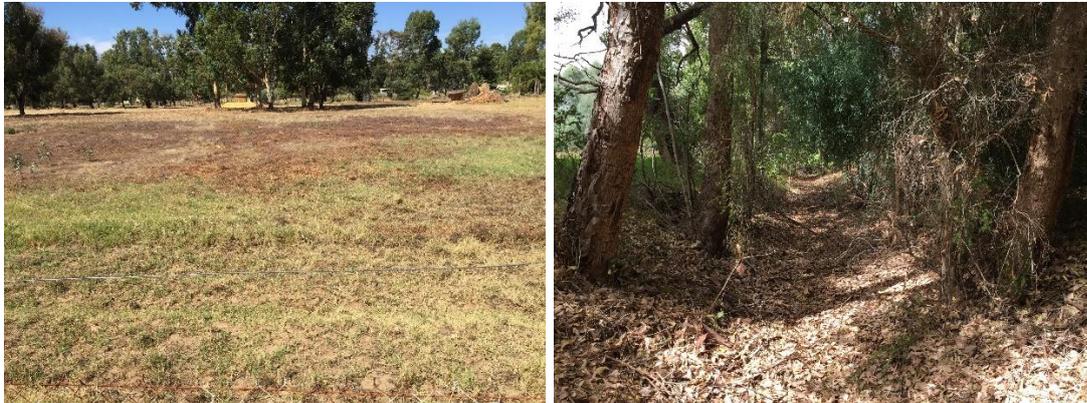
Most of this zone had extensive weed cover (Figure 49). Similar to the *Swan Valley Planning Act* area, the zone has been farmed and weedy grasses are common in the understorey. The most widespread weedy grasses are Kikuyu, Couch and Perennial Veldt Grass (Figure 45). Very few native plants remain in the under- and mid-storey.

Figure 45 and 46: Kikuyu and other weedy grasses are common and widespread (left); Flooded gum and weedy Eastern States Acacias in Segment 30 (right).

- A shallow drainage channel, which has native mid-storey species and a dense population of Marri trees mixed with weedy Eastern States Acacias (segment 30, Figure 46); and
- The lower lake in Sandown Park, which is regularly maintained by the City of Swan and has concrete kerbing in place to delineate lawn from the native vegetation surrounding the lake (segment 91, Figure 47).

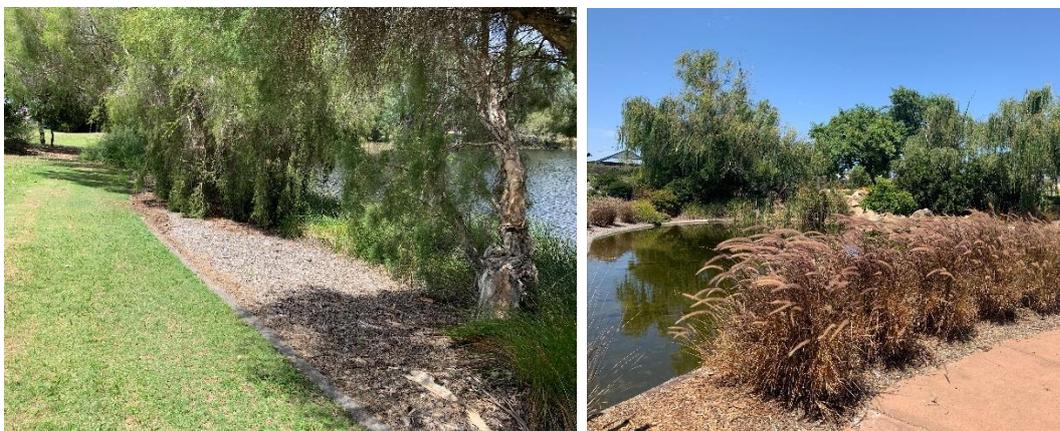
The upper lakes of Sandown Park have been planted with exotic landscaping species that have the potential to become weedy if not monitored and contained, including Fountain Grass (Figure 48) and Lantana.

Figures 47 and 48: Concrete kerbing delineates mowed grasses at the lower Sandown Park lake (left); Planted Fountain Grass in the upper lake (right).

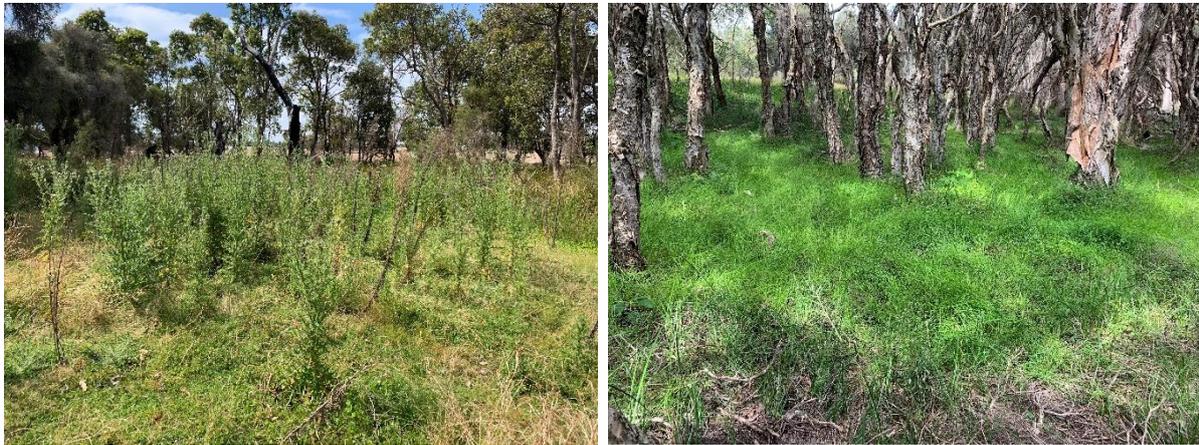
The drain outlet from Dreng Park is a major source of weeds (*Isolepis prolifera*, Spear thistle, various grasses) to downstream high value areas and is a priority for management (Figure 50). A dense infestation of *Isolepis prolifera* immediately upstream of the triangular piece of vegetation should also be controlled urgently (Figure 51). In the south of the DoC land, the understorey is entirely comprised of weedy grasses and herbs such as Cotton Bush. The focus should be on preventing the existing weeds from being further disbursed, particularly during the construction phase of development.

Figures 50 and 51: A drain outlet from Dreng Park is a significant source of weeds including Spear Thistle (left) and Isolepis prolifera (right).

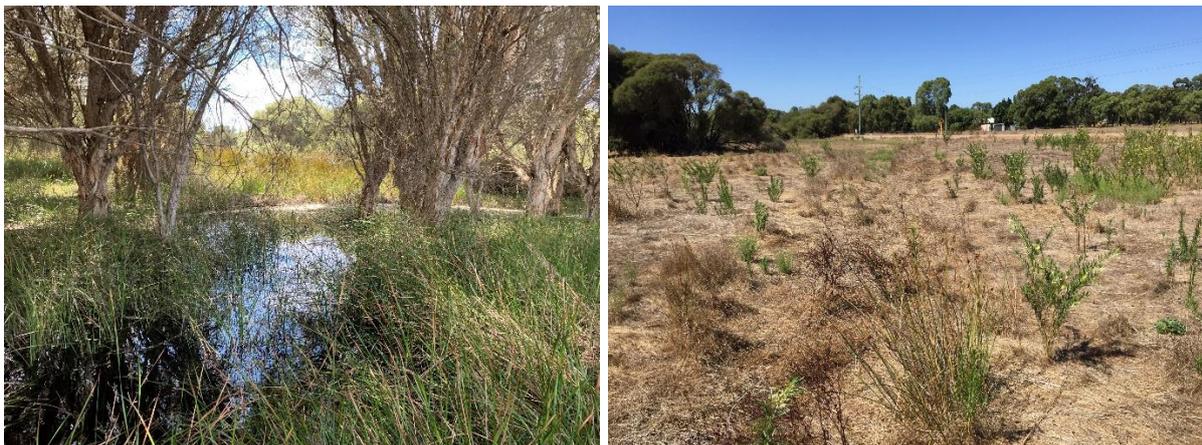
Although there were areas of high condition in the Brabham development area, there were still significant stretches of streambank rated C1 (2km), D1 (3.9km) and D3 (6km). Most of the streambank rated D3 was located on the south of the DoC land (segments 78 and 79) (Figure 55).

Figure 54 and 55: Segment 61, rated A2, near pristine (left); Segment 78, rated as D3, a weed dominated drain (right). Both segments are located in the Brabham development area.

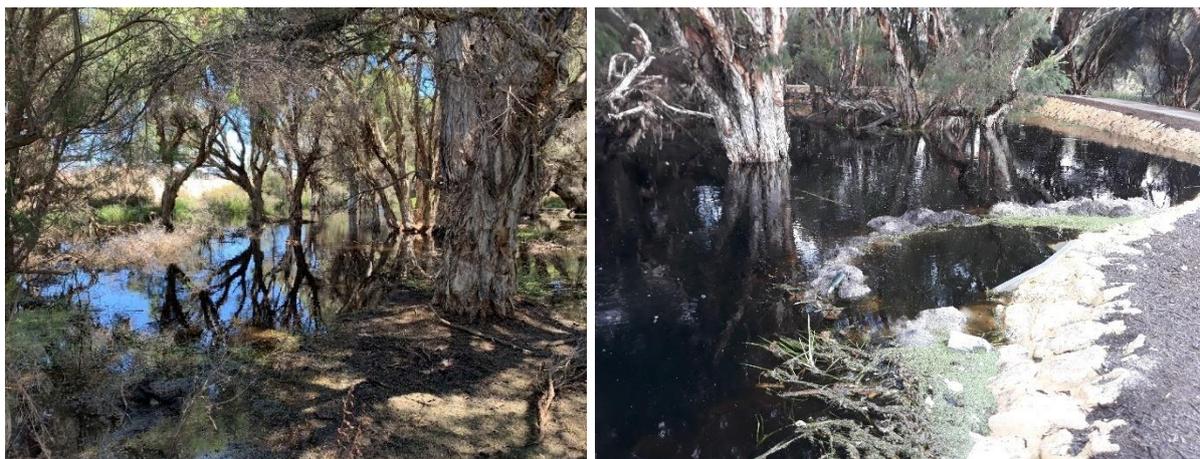
During the monitoring period, a concrete footpath was constructed through Watervalley Boulevard Park (site 2, Figures 59 and 60), bisecting the wetland. Sand infill and limestone revetments were part of the construction. No culverts to enable water flow were included in the design, which may eventually lead to stagnation, algal issues, sedimentation, mosquito breeding and death of the *Melaleuca* trees. This needs to be addressed with the developer.

Figures 59 and 60: Site 2 Watervalley Boulevard Park prior to pathway construction, January 2019 (left) and the completed pathway showing high levels of inundation, May 2020 (right).

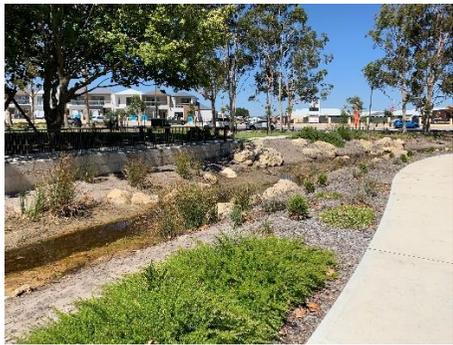
Part of an urban drainage system. Modified remnant wetland with areas of disturbance among native vegetation.	<ul style="list-style-type: none"> ▪ Some indications of potential acid sulphate soils, with seepage from the sediment, which should be further investigated. ▪ pH remained within acceptable limits and all other physical measures for conductivity, turbidity and dissolved oxygen were within ANZECC guidelines. There was an unconfirmed algae bloom during monitoring. ▪ Bacteria was measured on 29 February 2019 and Site 1 had the lowest mean <i>E. coli</i> concentration of 25.4 mpb/100 mL. ▪ Overall, this site was in good condition.
2	Watervalley Boulevard Park	81

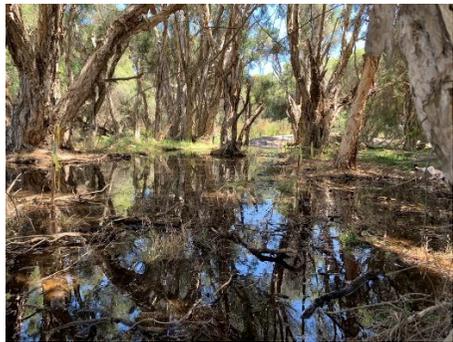
An area of large, old <i>Melaleuca</i> trees, with areas of disturbance. During the monitoring period, several mature trees were removed and sandy infill was placed into the wetland to build a footpath.	<ul style="list-style-type: none"> ▪ An increase in salinity was observed, possibly as a result of disturbance during footpath construction. ▪ Overall, the water quality at this site was within ANZECC guidelines for pH, conductivity, turbidity and dissolved oxygen. ▪ Bacteria was measured on 29 February 2019 and Site 2 had the third lowest mean <i>E.coli</i> concentration of 165.2 mpb/100 mL which exceeded the ANZECC guidelines. ▪ Overall, this site was in good condition.

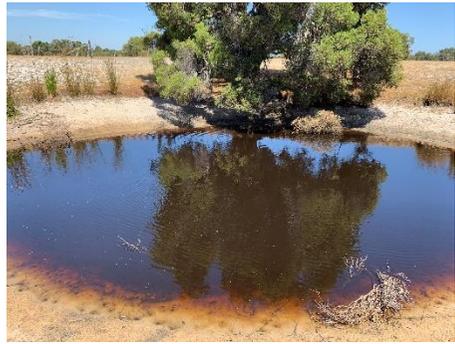
A groundwater fed water source, with remnant vegetation along the creek line, with areas of disturbance.	<ul style="list-style-type: none"> Water quality remained stable and within ANZECC guidelines for pH, conductivity, turbidity and dissolved oxygen. Bacteria was measured on 29 February 2019 and Site 3 had one of the highest mean <i>E.coli</i> concentration of 200.5 mpb/100 mL and exceeded the ANZECC guidelines, likely a result of surrounding landuse. Overall, this site was in good condition.
4	Frog wetland	61 and 62

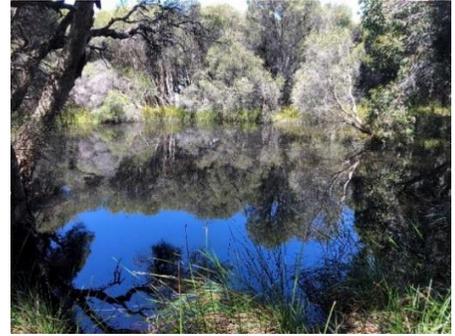
Waterhole surrounded by remnant vegetation and habitat in good condition, although there are some small areas of disturbance.	<ul style="list-style-type: none"> Water quality was within ANZECC guidelines for pH, conductivity, turbidity and dissolved oxygen. pH remained neutral and conductivity was the lowest and remained stable at this site in comparison to other sites. The presence of frogs was noted as a good indicator of ecosystem health. Bacteria was measured on 29 February 2019 and Site 4 had second lowest mean <i>E.coli</i> concentration of 94.5 mpb/100 mL which is just within the limits of ANZECC guidelines. Overall, this site was in the best condition of the eight sites monitored in terms of water quality.

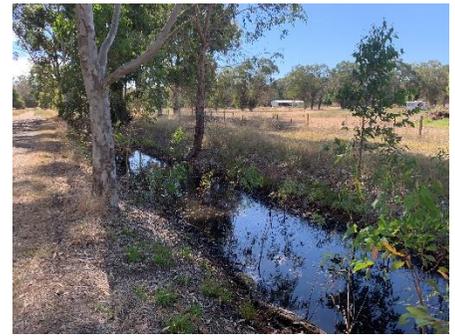
5	Bridle trail	27

Straight ditch in the Henley Brook development area.	<ul style="list-style-type: none"> Not measured because there was no surface water present at the time of monitoring.

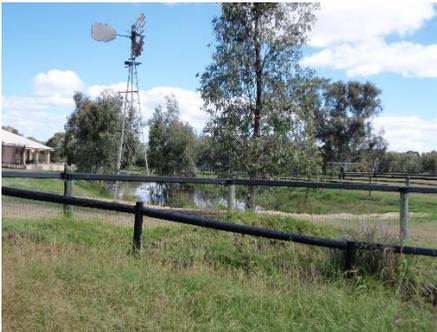
Located in Henley Brook on an undeveloped road alignment over the creek. Upstream of a small dam on private property.	<ul style="list-style-type: none"> Not measured because there was no surface water present at the time of monitoring.
7	Horse farm area	15

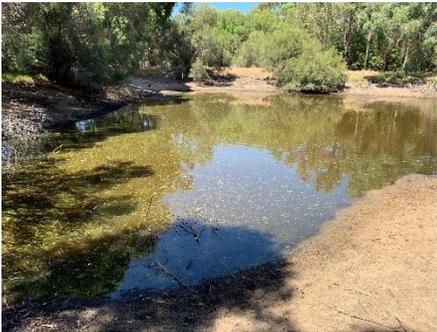
The most disturbed site, with limited remnant vegetation and large areas of disturbance. The surrounding land practices are dominated by horse properties.	<ul style="list-style-type: none"> There was a possible <i>Microcystis</i> and <i>Nodularia</i> algae bloom during monitoring. Conductivity was highest at this location and continuously exceeded the ANZECC guidelines. pH was highest at this location in comparison to the other sites and exceeded the ANZECC guidelines on the 8th May 2019 with an average pH reading of 8.66. Dissolved oxygen levels exceeded the ANZECC guidelines on 8th May 2019 with an average reading of 15.88mg/L. Turbidity at this site exceeded the guidelines with an average reading of 221 NTU. Bacteria was measured on 29 February 2019 and Site 7 had one of the highest mean <i>E.coli</i> concentration of 200.5 mpb/100 mL and exceeded the ANZECC guideline. Overall, this site was in poor condition.

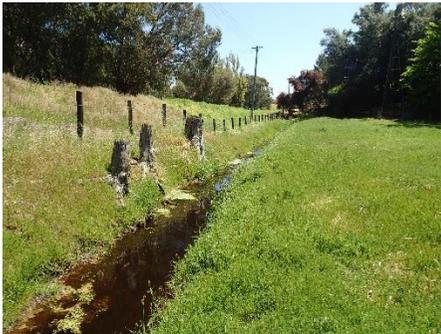
The lower reaches of Saint Leonards Creek, located on a horse property.	<ul style="list-style-type: none"> ▪ Not measured because there was no surface water present at the time of monitoring.

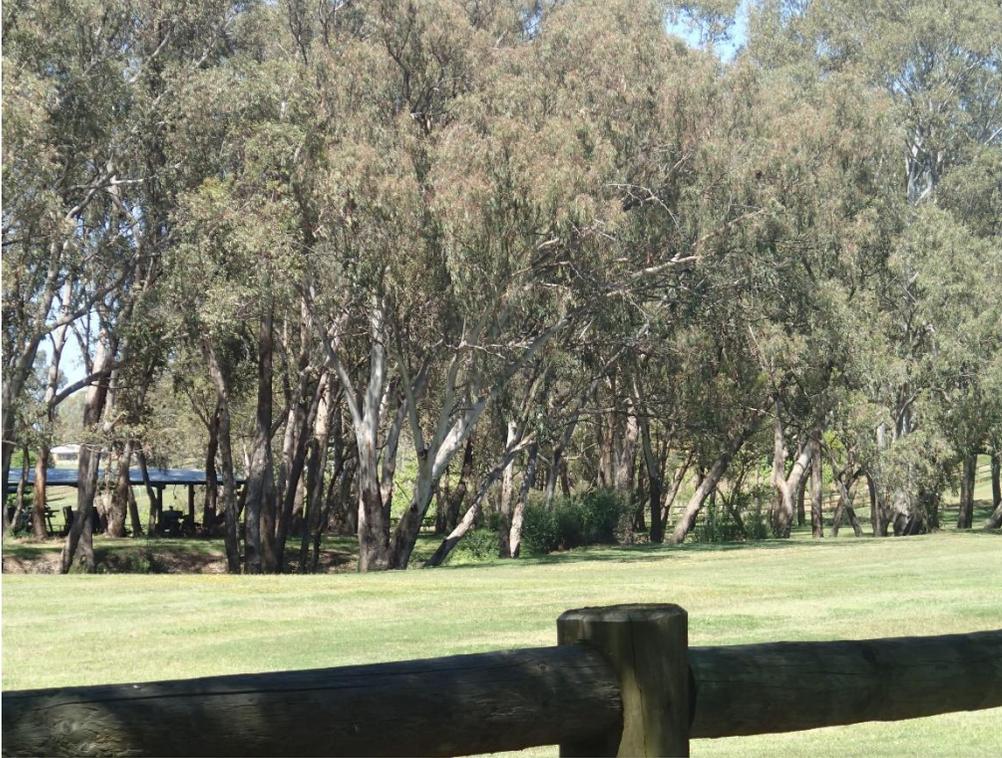
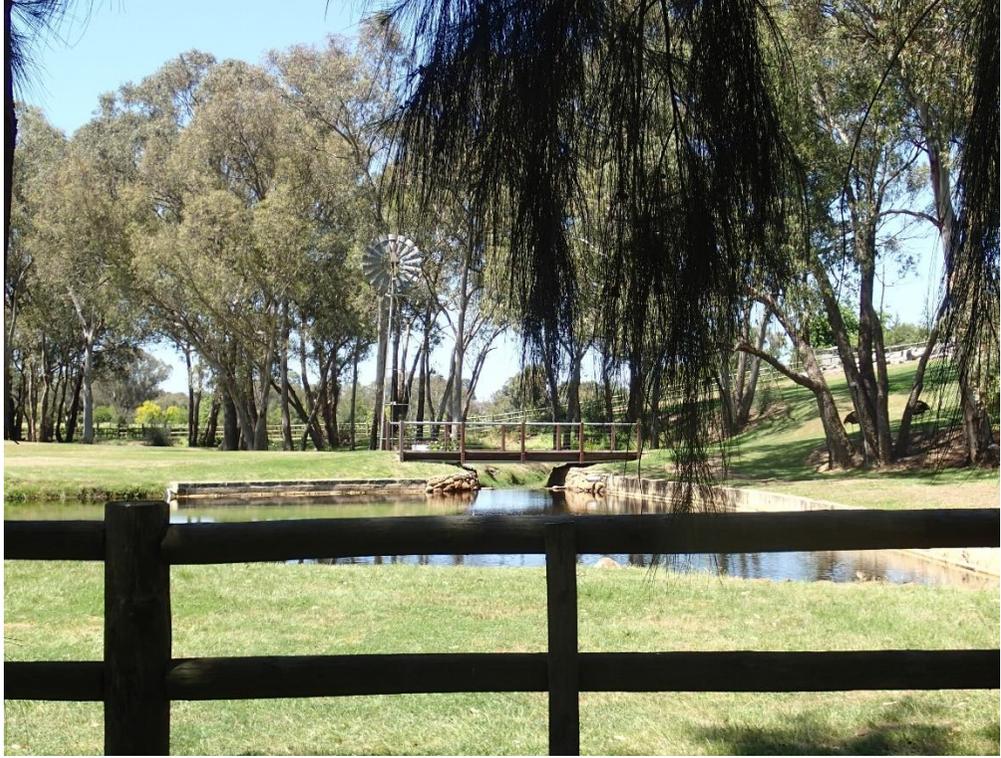
Segment 1		George St, West Swan	Segment 2		George St, West Swan

Vegetation description	<i>Eucalyptus rudis</i> over occasional <i>Olea europaea</i> and mixed weedy grasses		Vegetation description	Occasional <i>Eucalyptus rudis</i> over mixed weedy grasses	
Recommended restoration	Plant native sedges on lower banks to replace weeds. Continue to remove Olives.		Recommended restoration	Plant native trees and sedges on the unwalled bank, and native trees behind the limestone wall.

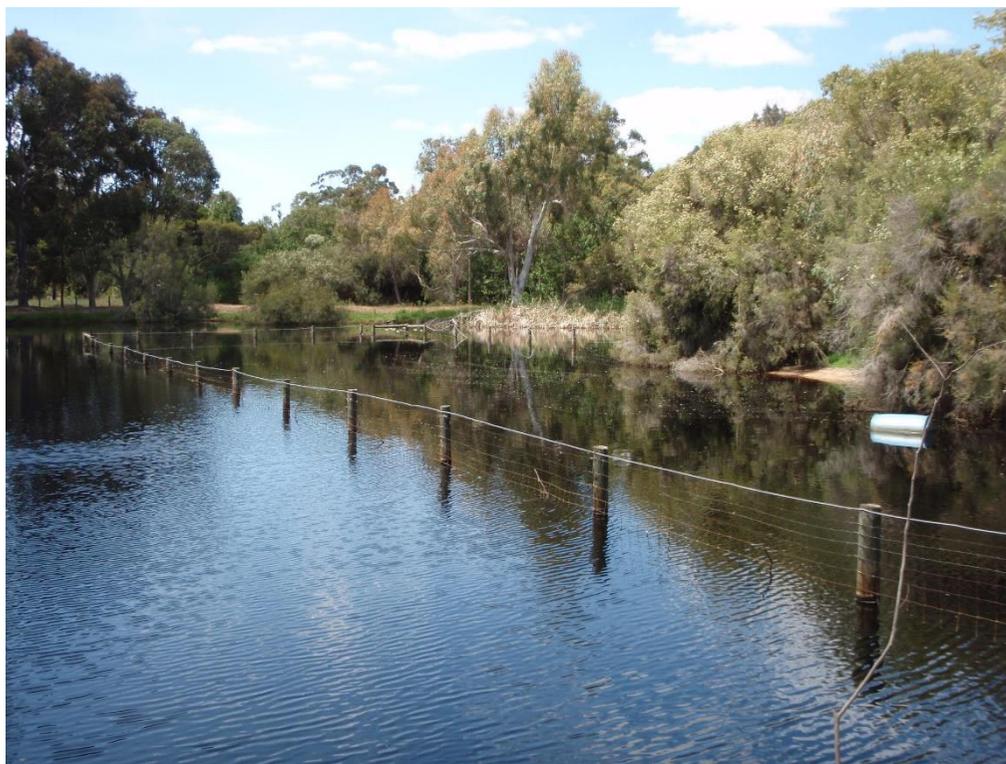
Segment 15

Eastern States *Eucalyptus sp.* and *Melaleuca raphiophylla* over *Ehrharta calycina* and other weedy grasses

Remove Brazilian Peppers on City of Swan easement. Manage *Typha**. Landholder has recommended erecting signs on Lawson Rd to warn drivers of waterbirds and other wildlife.

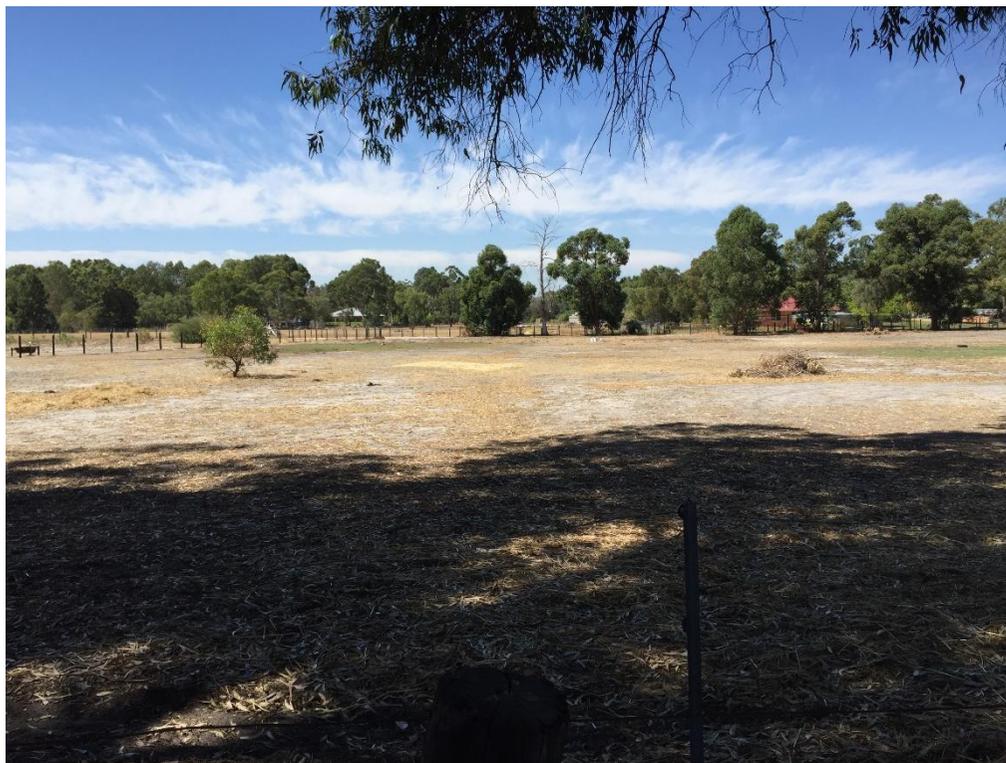
Segment 39

Vegetation description	Occasional Eastern States <i>Eucalyptus</i> sp. over dried weedy grasses
Recommended restoration	Area is zoned for development. Review drainage and development plans.

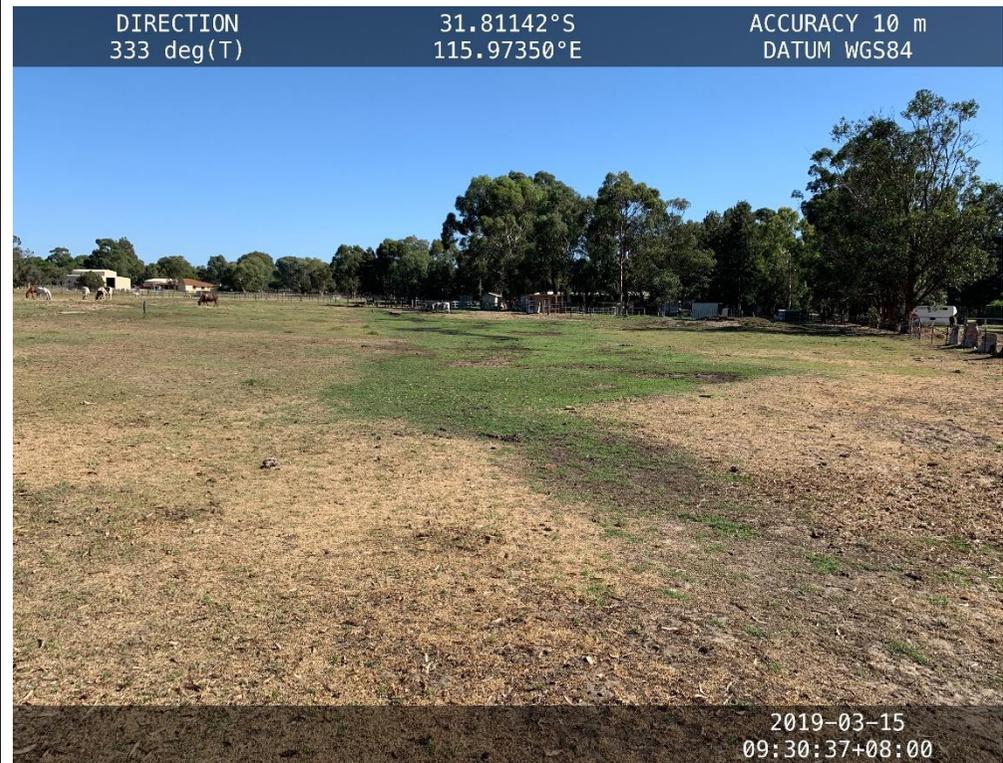
Segment 40

Vegetation description	Very open <i>Eucalyptus</i> sp. over mixed weedy grasses and herbs
Recommended restoration	Area is zoned for development. Review drainage and development plans. Mervac developers may retain the large Eastern States <i>Eucalyptus</i> .

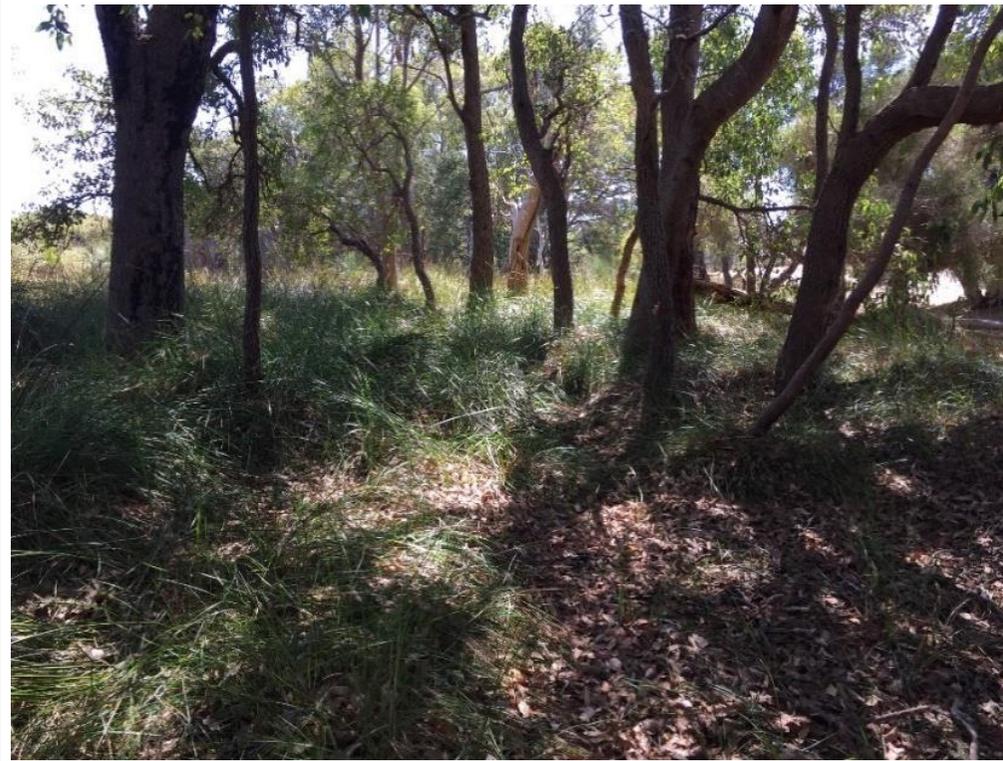
Segment 48

Corymbia calophylla and *Melaleuca preissiana* over *Lepidosperma longitudinale*

Hand pull Fleabane. Control any Arum lily on left bank. Retain remnant vegetation as it provides a corridor between high value areas and contains some Cockatoo trees.
