Department of **Biodiversity,
Conservation and Attractions**

Saint Leonards Creek Foreshore Condition Assessment

Version: 2

Last Updated: November 2020

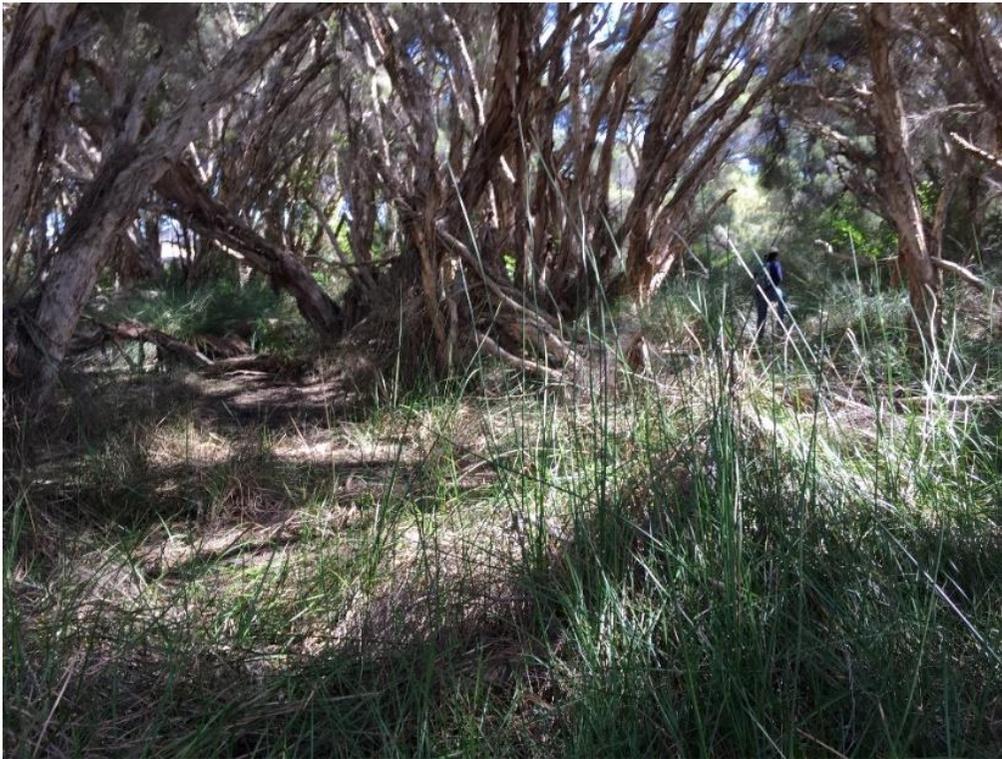
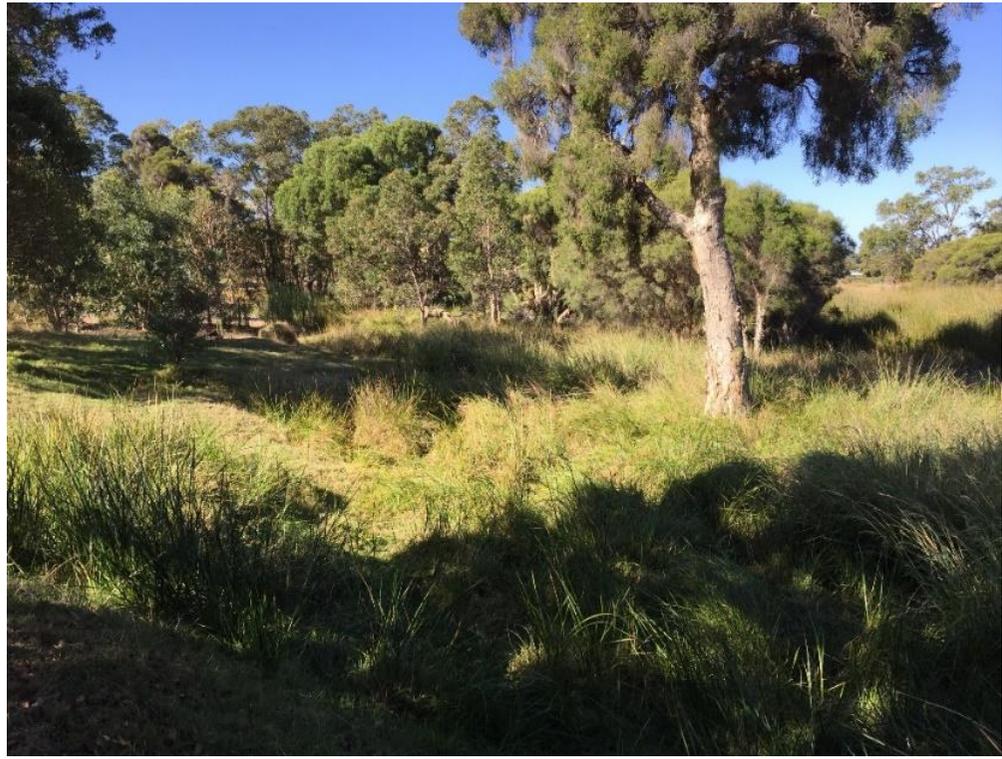
Segment 49		Pannage Wetlands, Brabham DoC land		Segment 50		Pannage Wetlands, Brabham DoC land

Vegetation description		<i>Melaleuca raphiophylla</i> over <i>Baumea articulata</i> . <i>Lepidosperma longitudinale</i> and <i>Xanthorrhoea preissii</i> on edges	
Recommended restoration		High priority to protect and retain. Remove Lantana, Blackberry, Tree fern and Figs. Engage the community in protecting this area.		Recommended restoration		Hand pull Fleabane and Dock. Grass selective weed control. Manage small pockets of <i>Typha</i> *.

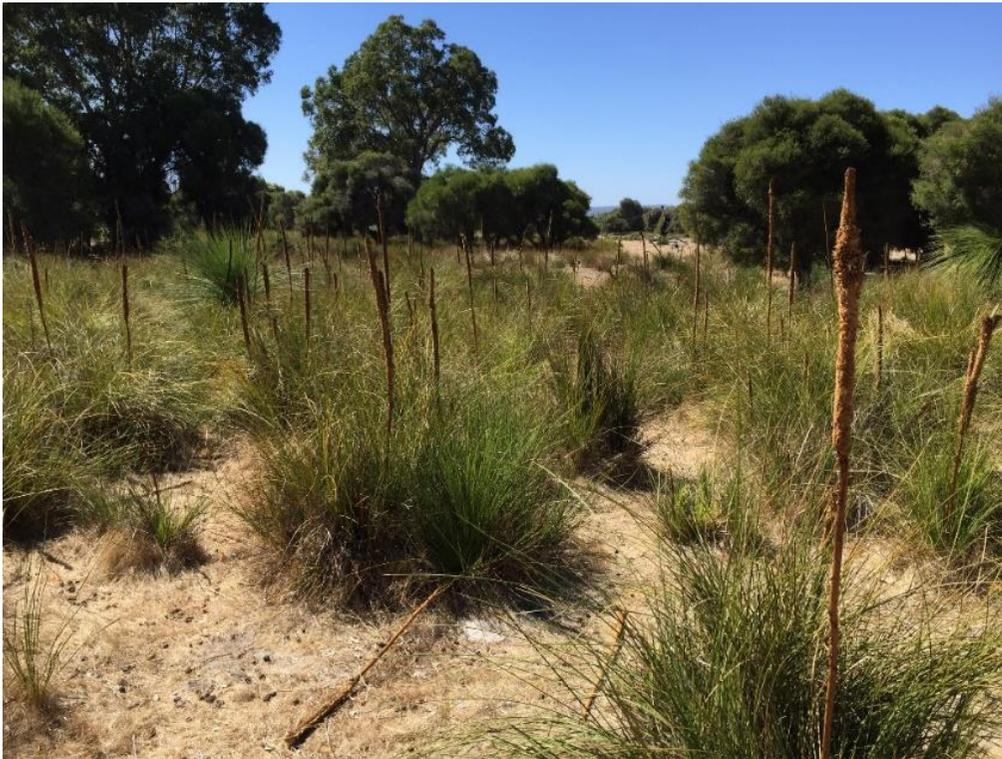
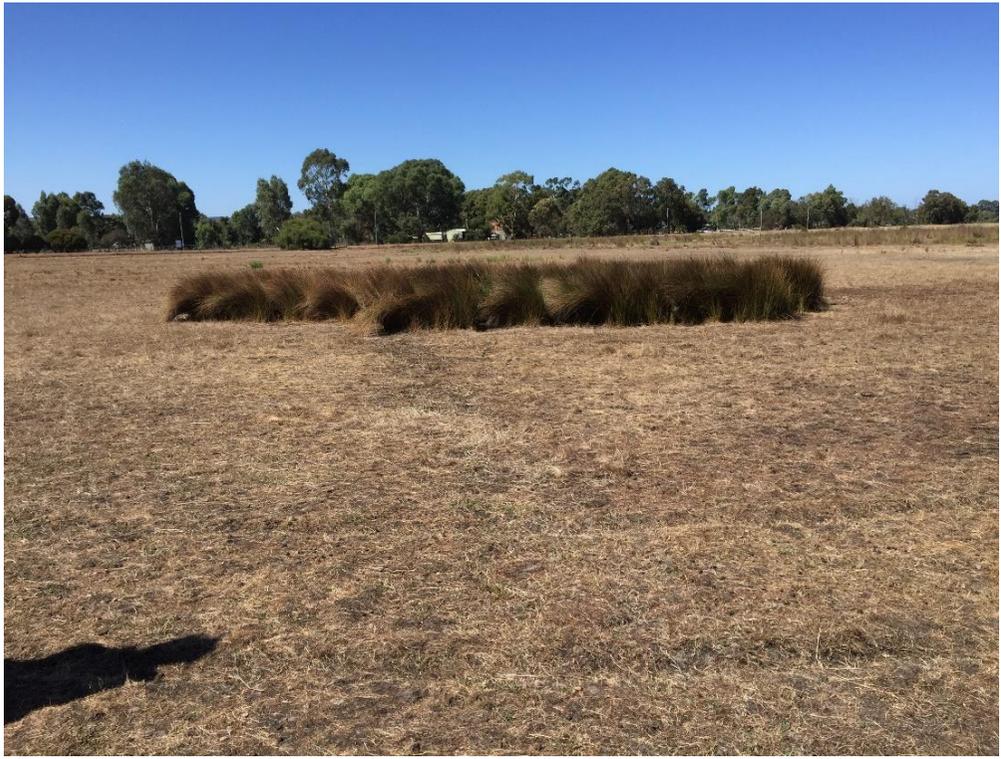
Segment 51		Murray Road, Brabham DoC land		Segment 52		Murray Road, Brabham DoC land

Vegetation description	<i>Melaleuca preissiana</i> over <i>Xanthorrhoea preissii</i> , <i>X. brunonis</i> and <i>Lepidosperma longitudinale</i>	Vegetation description	<i>Juncus kraussii</i> stand				
Recommended restoration	Transplant <i>Xanthorrhoea brunonis</i> if this area is to be cleared. Remove Figs and Apple of Sodom.	Recommended restoration	If this section of sedges is to be removed during development, transplant to a suitable restoration site.

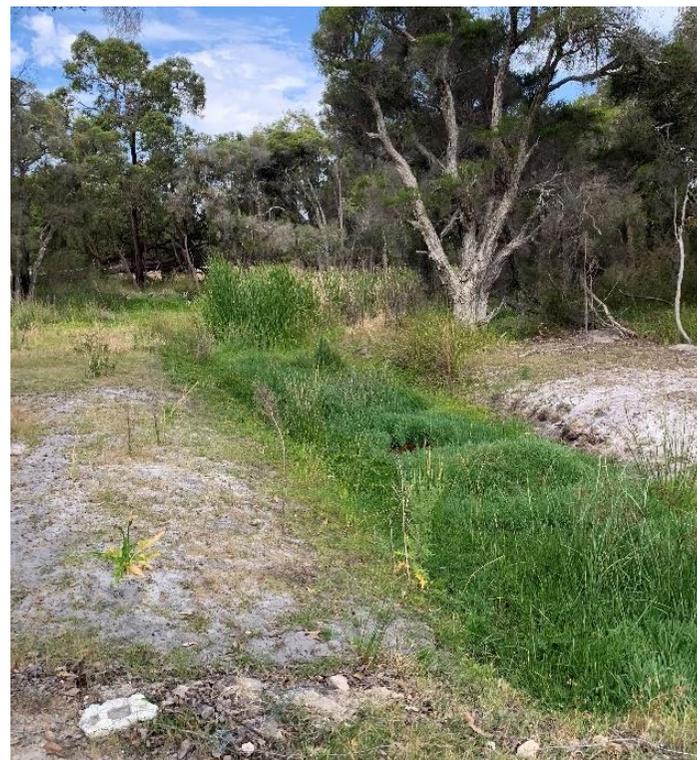
Segment 60

Melaleuca preissiana over *Typha*, *Cenchrus clandestinus*, *Cirsium vulgare* and other weedy grasses and herbs

Remove weeds as a priority as they are a major source of infestations downstream and threaten high natural values.

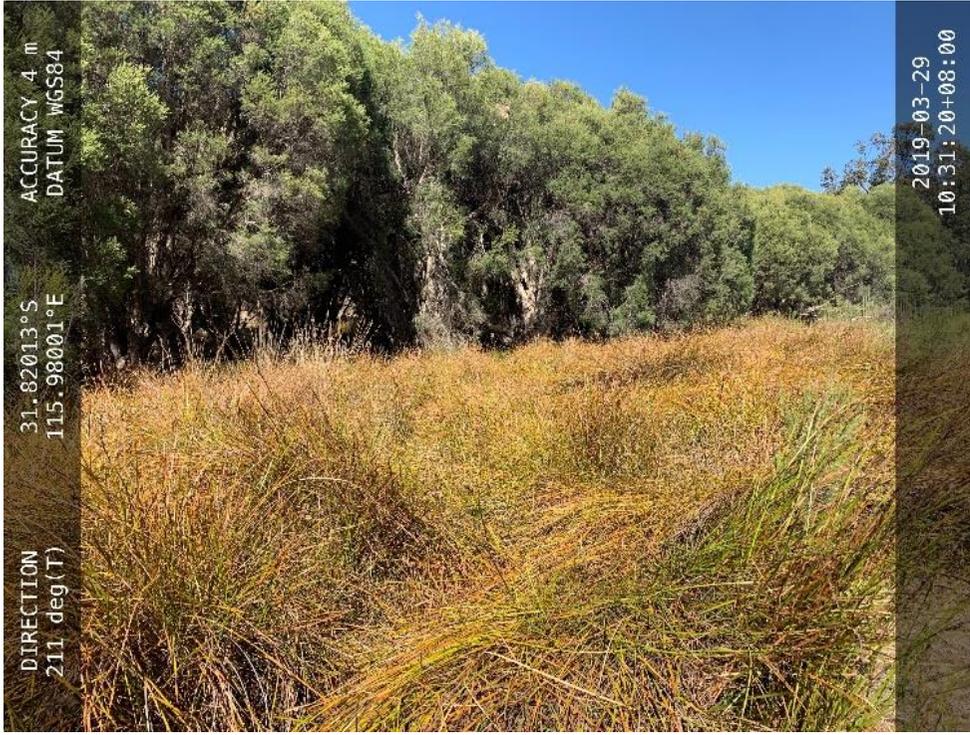
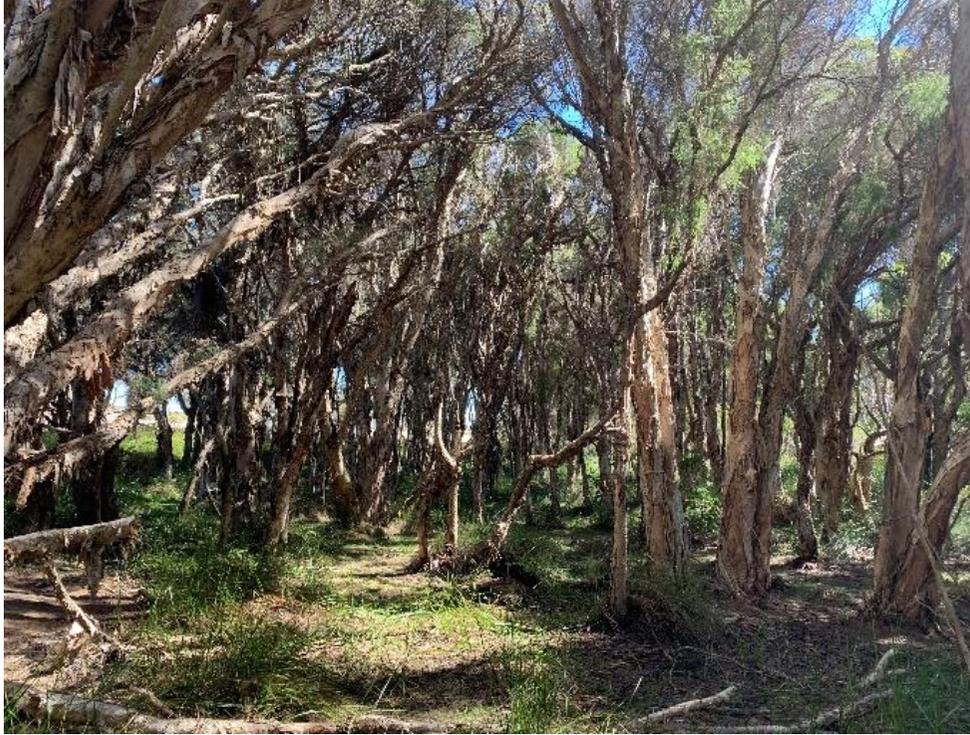
Segment 61		Palfrey Street, Brabham DoC land		Segment 62		Palfrey Street, Brabham DoC land

Vegetation description	<i>Melaleuca raphiophylla</i> over <i>Lepidosperma longitudinale</i>	Vegetation description	<i>Melaleuca viminea</i> over <i>Isolepis prolifera</i> , <i>Centella asiatica</i> , <i>Ficus carica</i> and <i>Lepidosperma longitudinale</i>				
Recommended restoration	Selectively control grasses on edge of riparian zone. Monitor for weeds from drain upstream. Install boardwalks and trails to connect residents to local natural values.	Recommended restoration	Remove <i>Isolepis prolifera</i> as a high priority as it threatens high condition vegetation. Consider a solarisation trial with UV stabilised black plastic. Remove Figs.

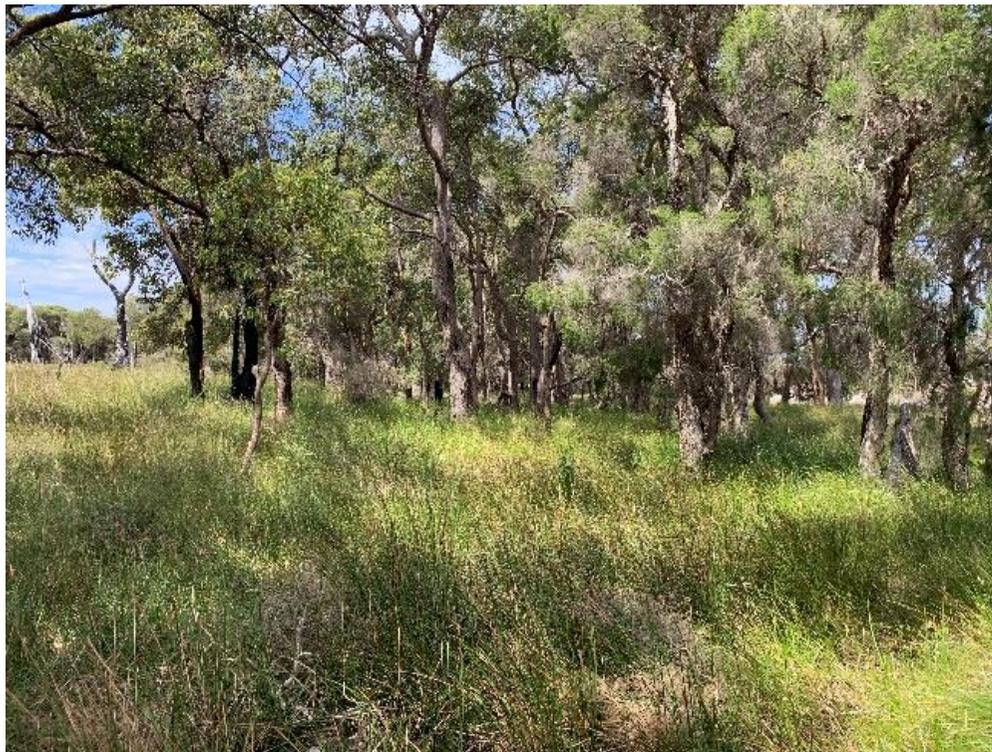
Segment 63

Vegetation description

Corymbia calophylla over *Melaleuca viminea*, *Astartea scoparia* and *Lepidosperma longitudinale*

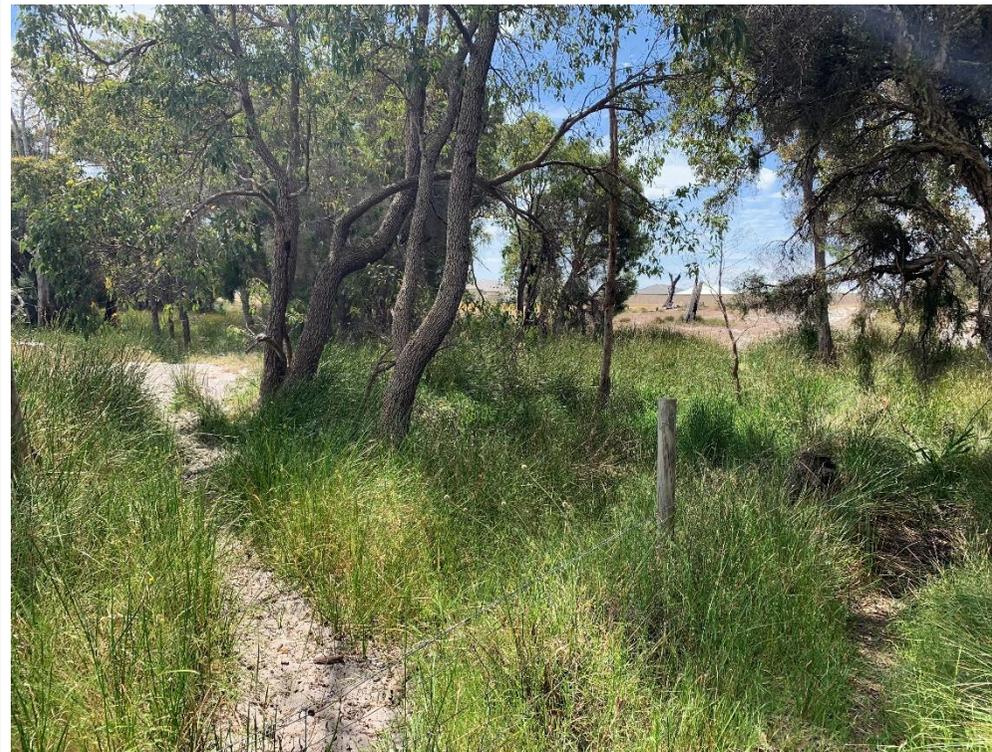
Segment 64

Not assessed as access wasn't possible due to construction. Some remnant riparian vegetation is present.

Retain remnant vegetation and ensure adequate buffers.

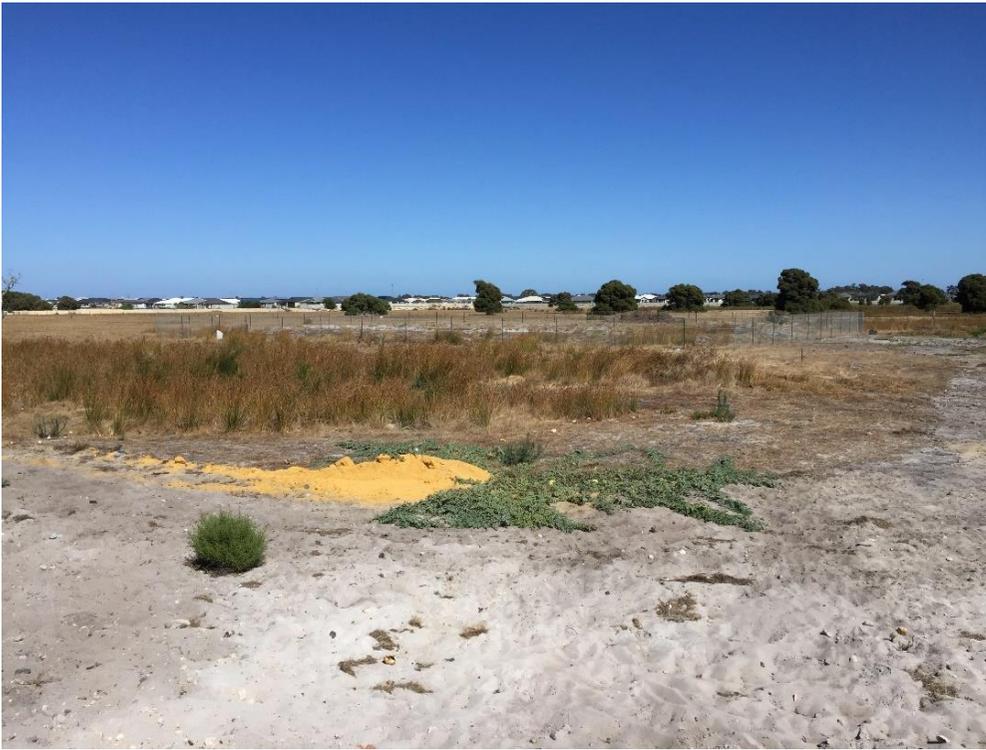
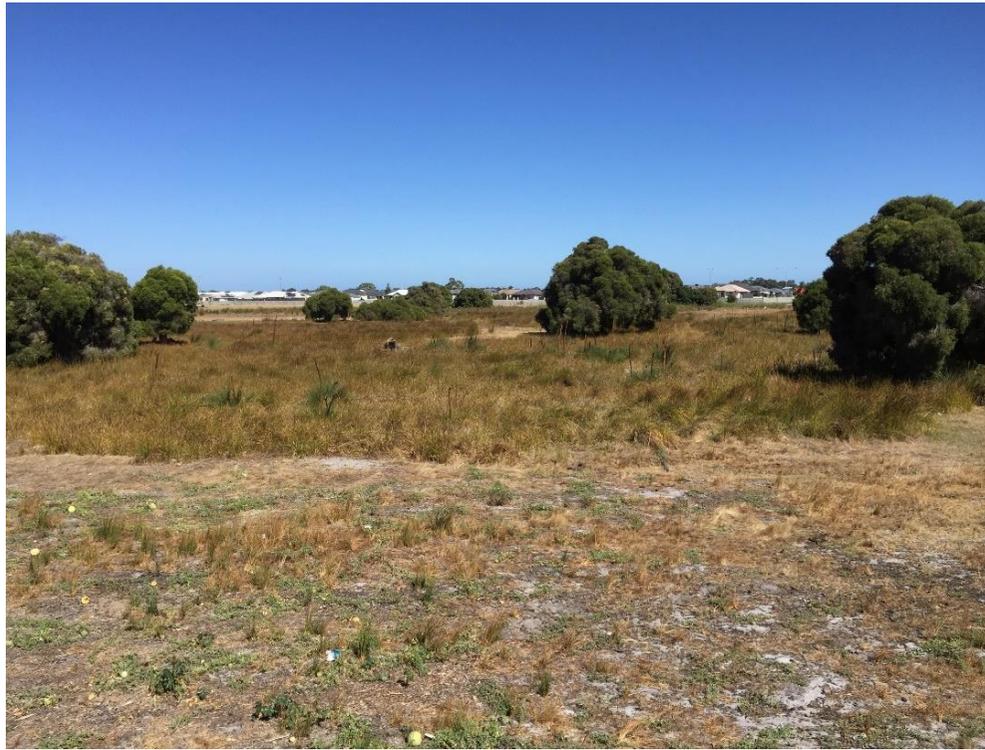
Segment 65		Fairmount Boulevard, Brabham Ariella estate		Segment 66		Fairmount Boulevard, Brabham Ariella estate

Vegetation description	Very scattered <i>Melaleuca preissiana</i> over <i>Juncus pallidus</i> in patches, mixed pasture grasses and other weedy herbs	Vegetation description	<i>Melaleuca preissiana</i> over <i>Lepidosperma longitudinale</i> and <i>Xanthorrhoea brunonis</i> in low-lying area, surrounded by <i>Corymbia calophylla</i> and <i>Banksia</i> over <i>X. preissiana</i> , <i>X. brunonis</i> and weedy grasses				
Recommended restoration	Retain <i>Melaleuca preissiana</i> . Maintain the compensation basin and remove weeds. Revegetate with local native species where possible.	Recommended restoration	Retain as much vegetation as possible. Contains some of the best condition vegetation on the creek system. Translocate <i>Lepidosperma longitudinale</i> if any clearing is planned.

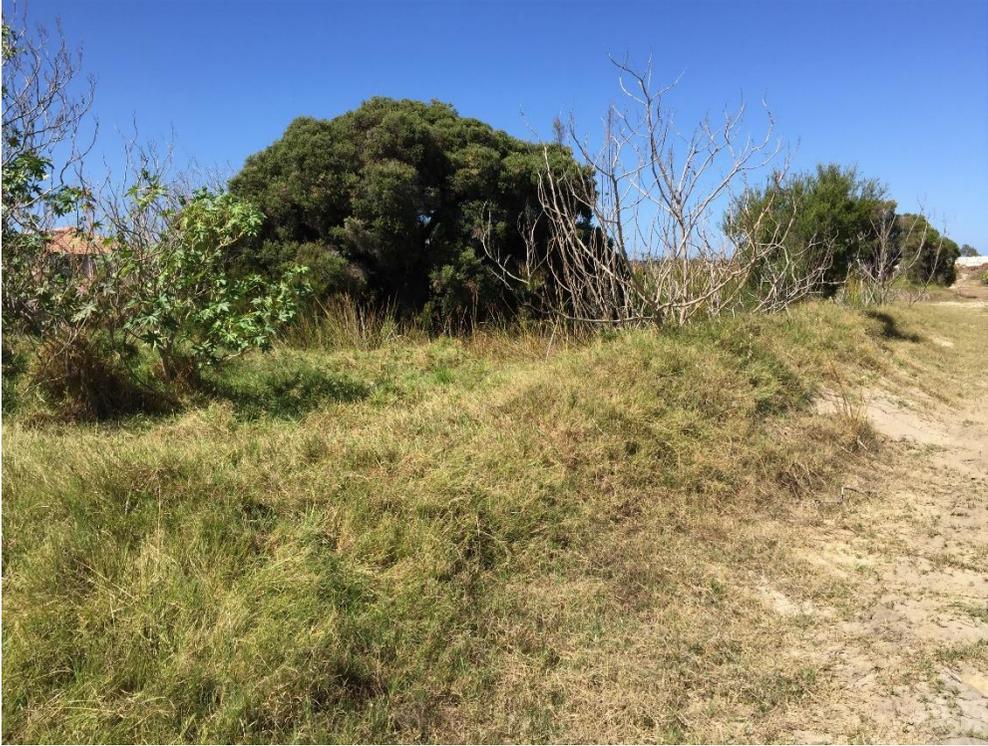
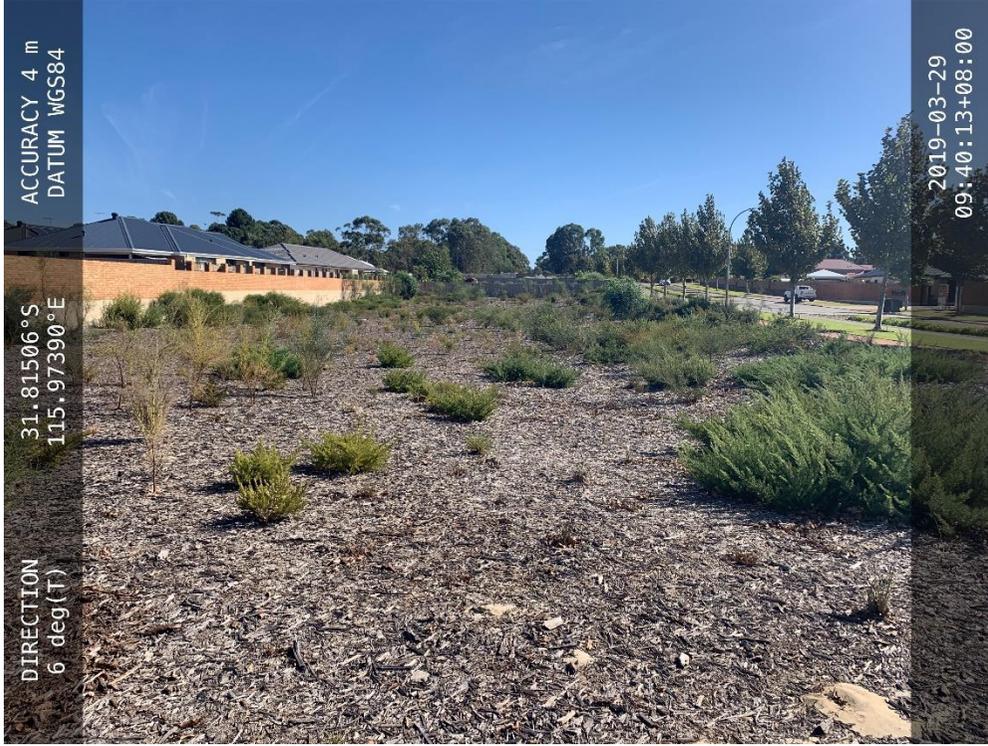
Segment 67		Constable Street, Brabham Avonlee estate		Segment 68		Arpent Link, Brabham Avonlee estate

Vegetation description	<i>Ricinus communis</i> over <i>Cenchrus clandestinus</i> ; <i>Verbesina encelioides</i> and other weeds. Small stand of <i>Melaleuca preissiana</i> , <i>Typha</i> sp. and <i>Lepidosperma longitudinale</i>	Vegetation description	Revegetated mixed native species				
Recommended restoration	Review drainage and development plans. Retain Jarrah, Marri and <i>Melaleuca preissiana</i> . Prevent spread of weeds. Water and infill plant revegetation on gas pipeline easement.	Recommended restoration	Maintain current management regime.

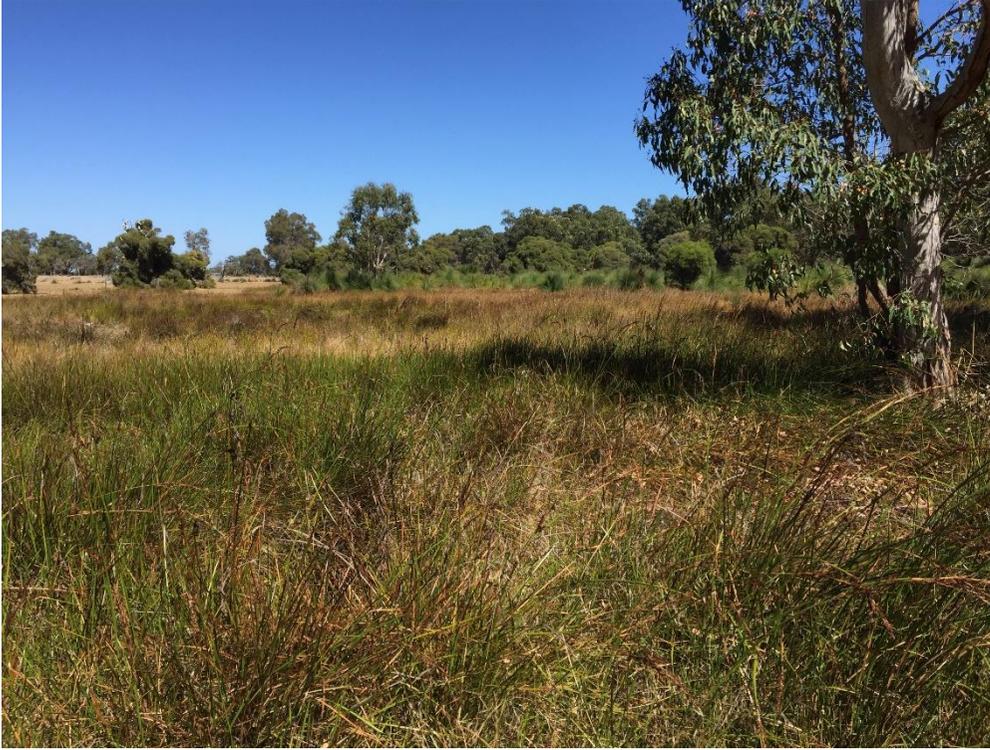
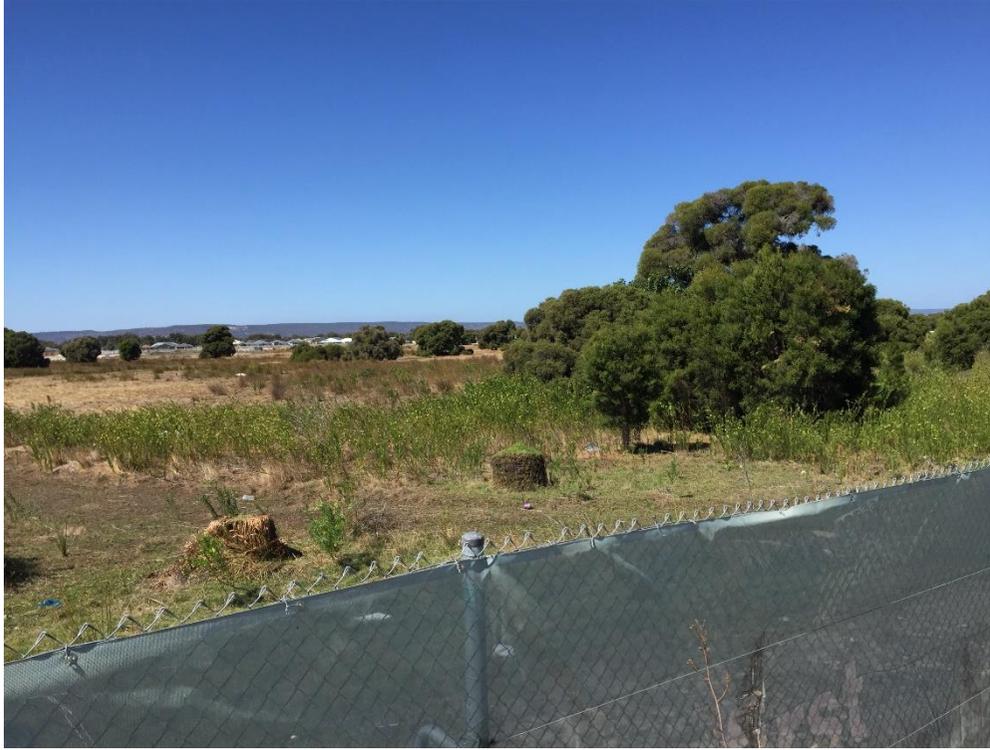
Segment 69		Park Street, Brabham Ariella estate		Segment 70		Palfrey Street, Brabham Ariella estate

Vegetation description	<i>Lepidosperma longitudinale</i> and <i>Dielsia stenostachya</i> sedgeland. <i>Corymbia calophylla</i> over <i>Xanthorrhoea preissiana</i> and <i>Dasyogon bromeliifolius</i> on edge	Vegetation description	Low <i>Melaleuca preissiana</i> over <i>Xanthorrhoea preissii</i> , <i>Gomphocarpus fruticosus</i> and other weedy grasses and herbs				
Recommended restoration	Review drainage and development plans. Contains some of the best condition vegetation on the creek system. Stage removal of Eastern States Eucalyptus and <i>Acacia longifolia</i> .	Recommended restoration	Review drainage and development plans. Retain remnant vegetation as much as possible. Remove Cottonbush as a top priority. Remove Pampas Grass and Figs.

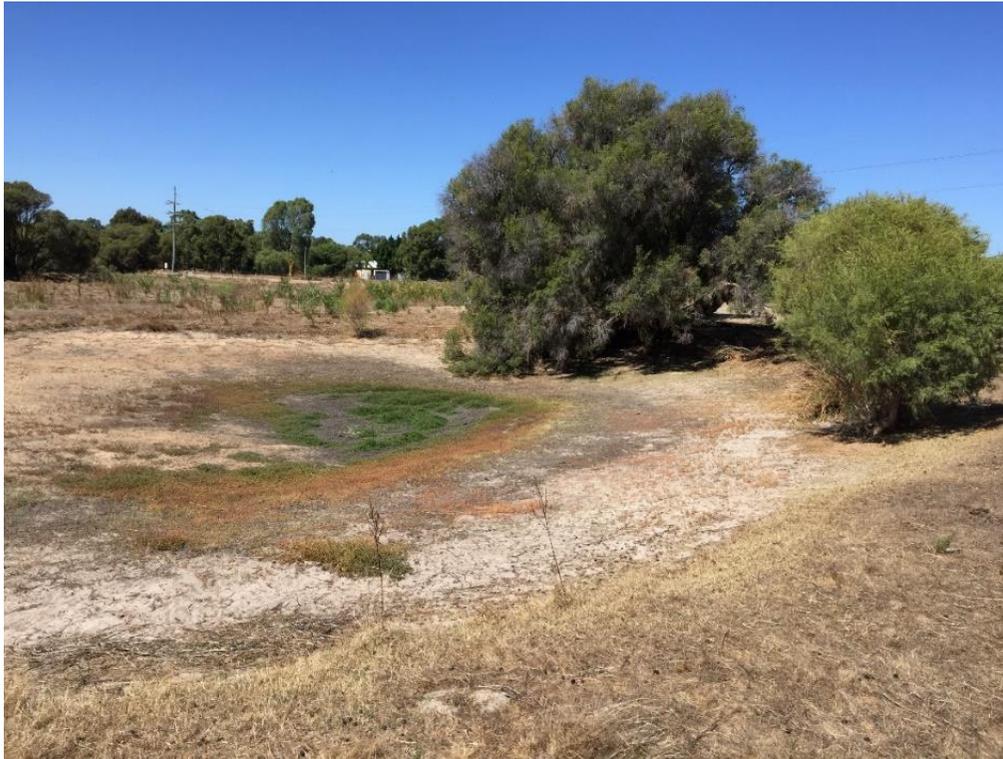
Segment 77		Woolcott Avenue, West Swan		Segment 78		Woolcott Avenue, Henley Brook DoC land

Vegetation description	Mixed planted trees and shrubs over <i>Cenchrus clandestinus</i> and mixed weedy grasses and herbs	Vegetation description	<i>Melaleuca viminea</i> over <i>Isolepis prolifera</i> , <i>Centella asiatica</i> , <i>Ficus carica</i> and <i>Lepidosperma longitudinale</i>				
Recommended restoration	Limited in ability to restore the drain because it gets road stormwater and paddock runoff and is a very narrow area.	Recommended restoration	Ensure weedy material, particularly Cottonbush, does not spread during clearing and construction.

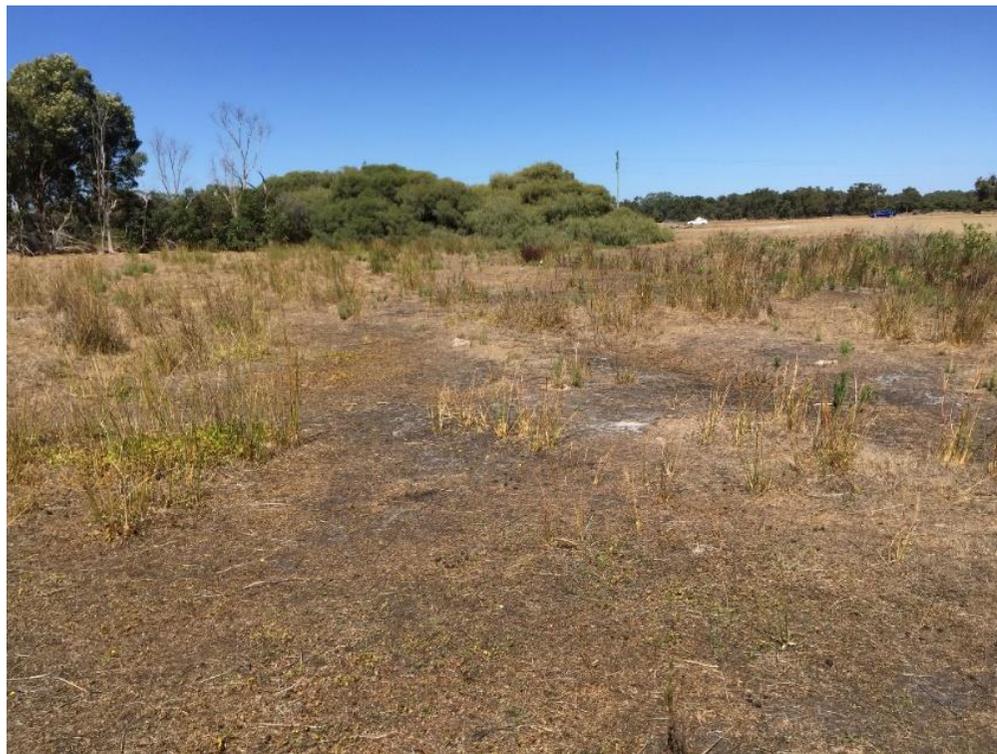
Segment 79

Scattered *Gomphocarpus fruticosus*, *Dittrichia graveolens* and *Rumex crispus* over mixed weedy grasses

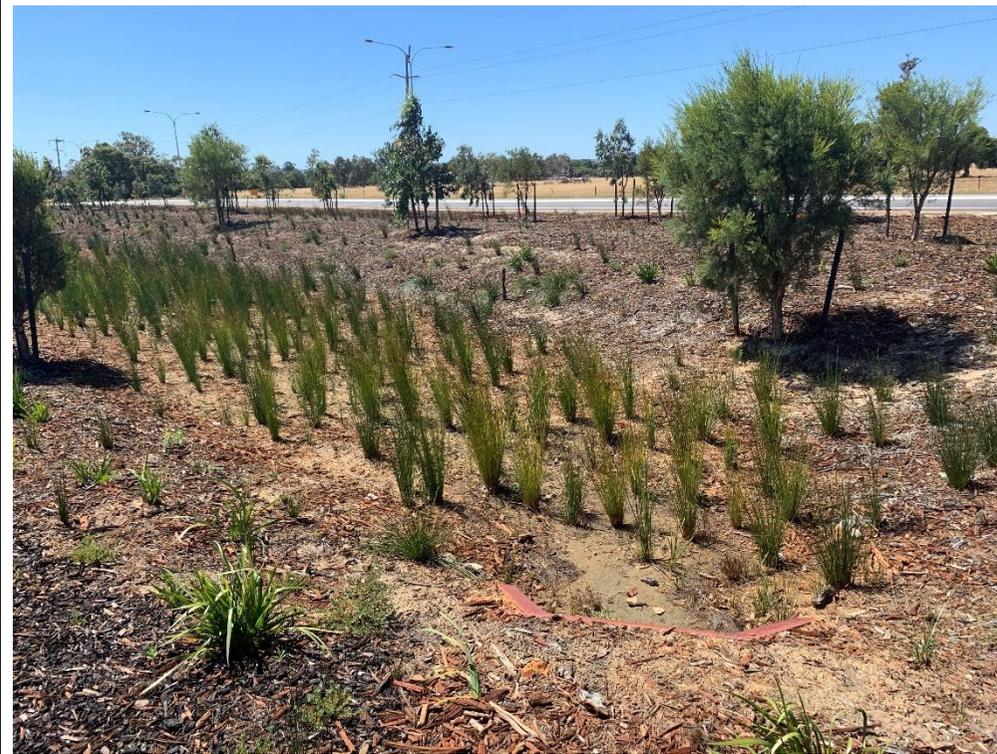
Segment 80

Mixed revegetated trees, shrubs and sedges

Contact site maintenance contractor to recommend removing emerging invasive species. Manage *Typha**.

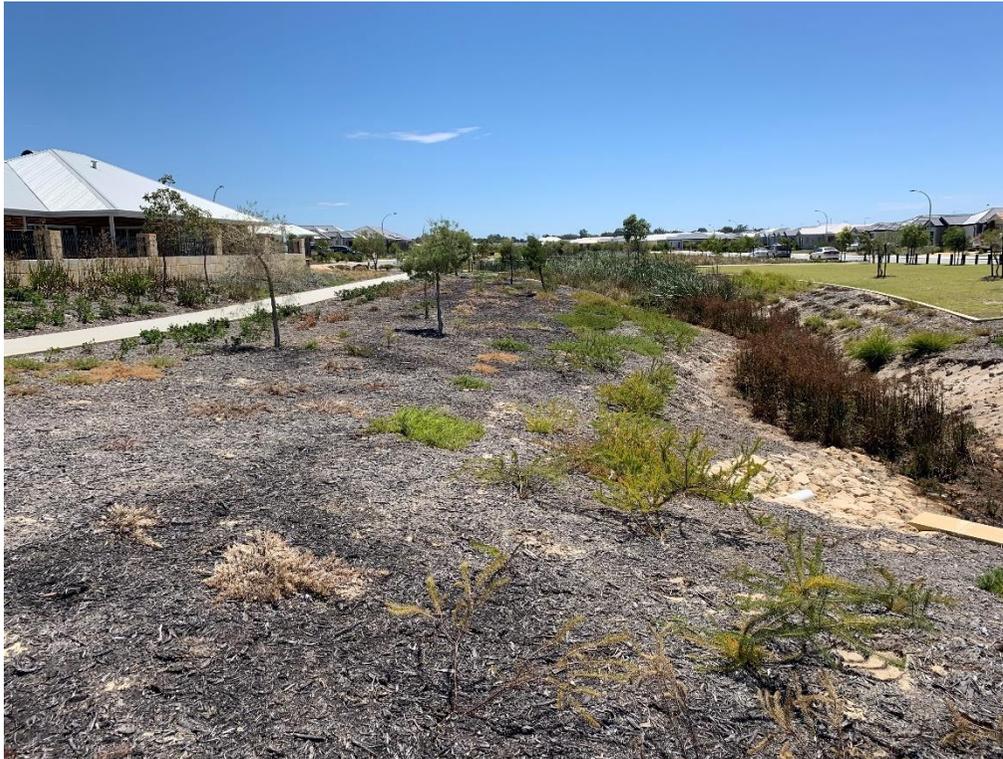
Segment 85		Jungle Park, Brabham Whiteman Edge estate		Segment 86		Mayfield Drive, Brabham Whiteman Edge estate

Vegetation description		No overstorey. Revegetated landscaped plants using natives and native hybrids	
Recommended restoration		Plant a dense sedge bed; monitor for weeds and remove. Manage young <i>Typha</i> *; manage deciduous trees (remove fallen leaves in creek periodically) and plant overstorey.		Vegetation description		Very open young <i>Melaleuca raphiophylla</i> , <i>M. preissiana</i> and <i>Corymbia ficifolia</i> over mixed sedges and native landscape plants	
Recommended restoration		Remove <i>Juncus microcephalus</i> and monitor for new weeds. Manage emerging <i>Typha</i> *. Infill plant on bank, especially where banks are subsiding. Plant more overstorey trees.		Recommended restoration		Remove <i>Juncus microcephalus</i> and monitor for new weeds. Manage emerging <i>Typha</i> *. Infill plant on bank, especially where banks are subsiding. Plant more overstorey trees.

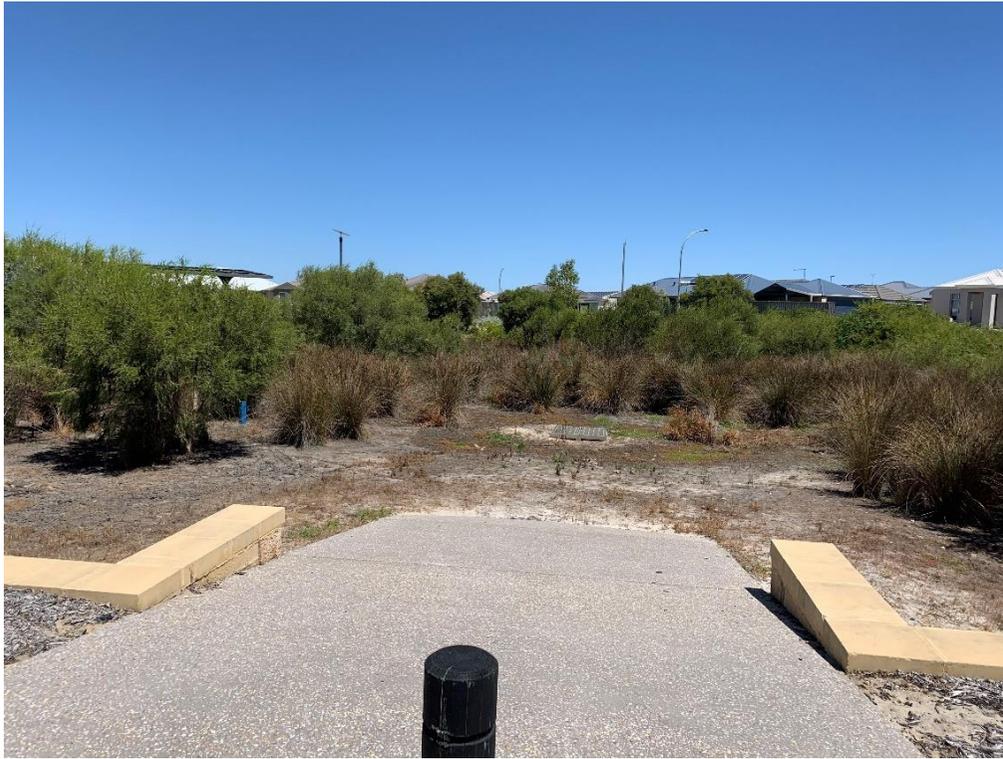
Segment 87		Jungle Park, Brabham Whiteman Edge estate		Segment 88		Portola Park, Brabham Whiteman Edge estate

Vegetation description	<i>Melaleuca raphiophylla</i> over <i>Juncus pallidus</i> in basin and <i>Baumea preissii</i> and native landscape plants on edge	Vegetation description	<i>Melaleuca thymoides</i> over <i>Juncus kraussii</i> , <i>Grevillea crithmifolia</i> and <i>Calothamnus</i> sp.				
Recommended restoration	Maintain current management – hand weed emerging weeds and allow native plant regeneration. Plant more overstorey plants. Remove blown in domestic rubbish.	Recommended restoration	Monitor for weeds and hand pull if required. Could control weeds in open area near bubble up drain.

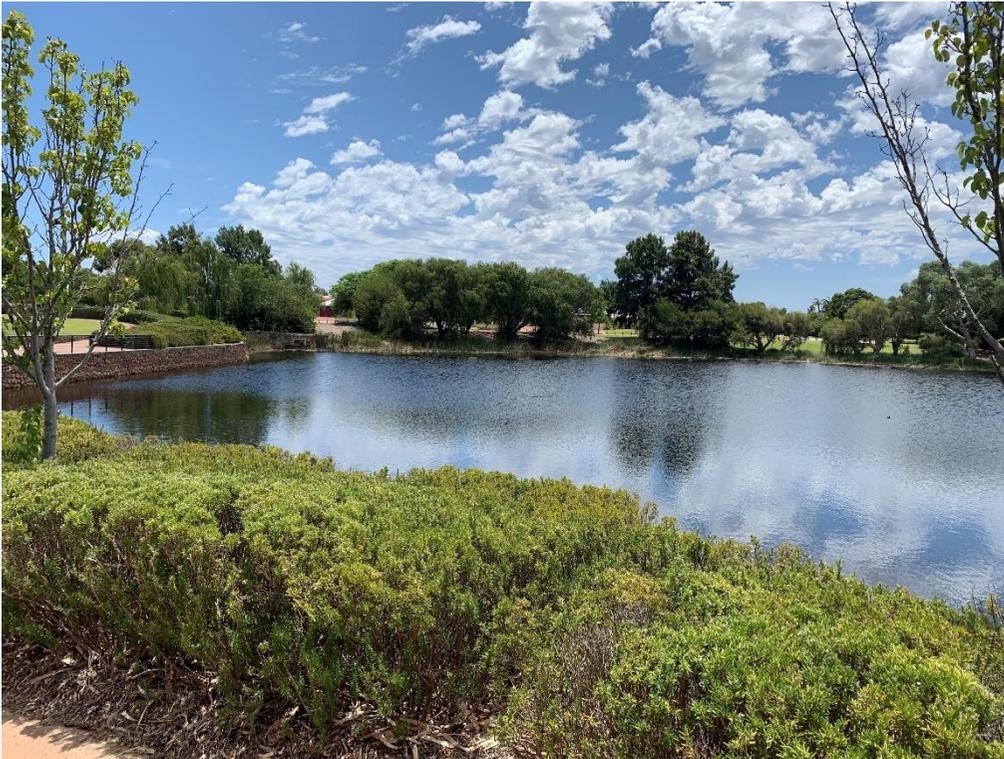
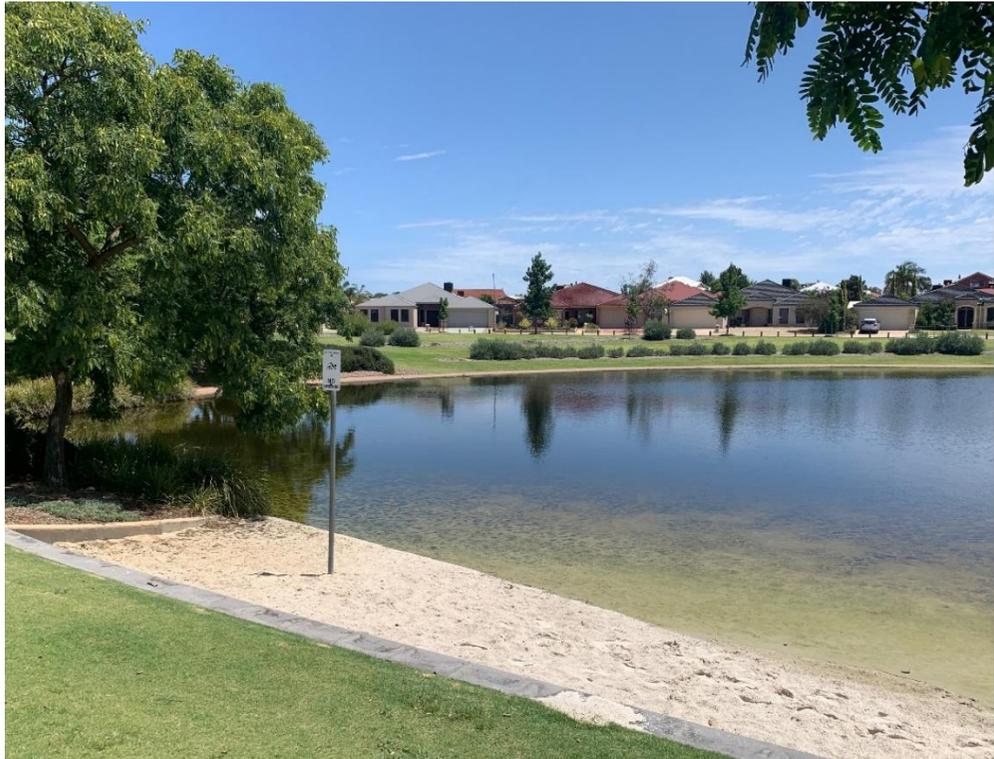
Segment 91		Sandown Park, Henley Brook Morgan Fields estate		Segment 92		Sandown Park, Henley Brook Morgan Fields estate

Vegetation description	Eastern States <i>Eucalyptus</i> sp. and <i>Melaleuca</i> sp. over <i>Ficinia nodosa</i> , <i>Baumea articulata</i> and various native plants	Vegetation description	<i>Salix babylonica</i> and ornamental trees over <i>Cenchrus setaceus</i> , <i>Gazania</i> sp. and mowed grasses				
Recommended restoration	Investigate if drain outlet can be modified to avoid trapping fauna. Maintain weed control inside the kerbed area and gradually replace non-local plants.	Recommended restoration	Gradually replace non-local species with local native plants, particularly Lantana. Notify DPIRD of Pearl Cichlids in the upper lakes [done].

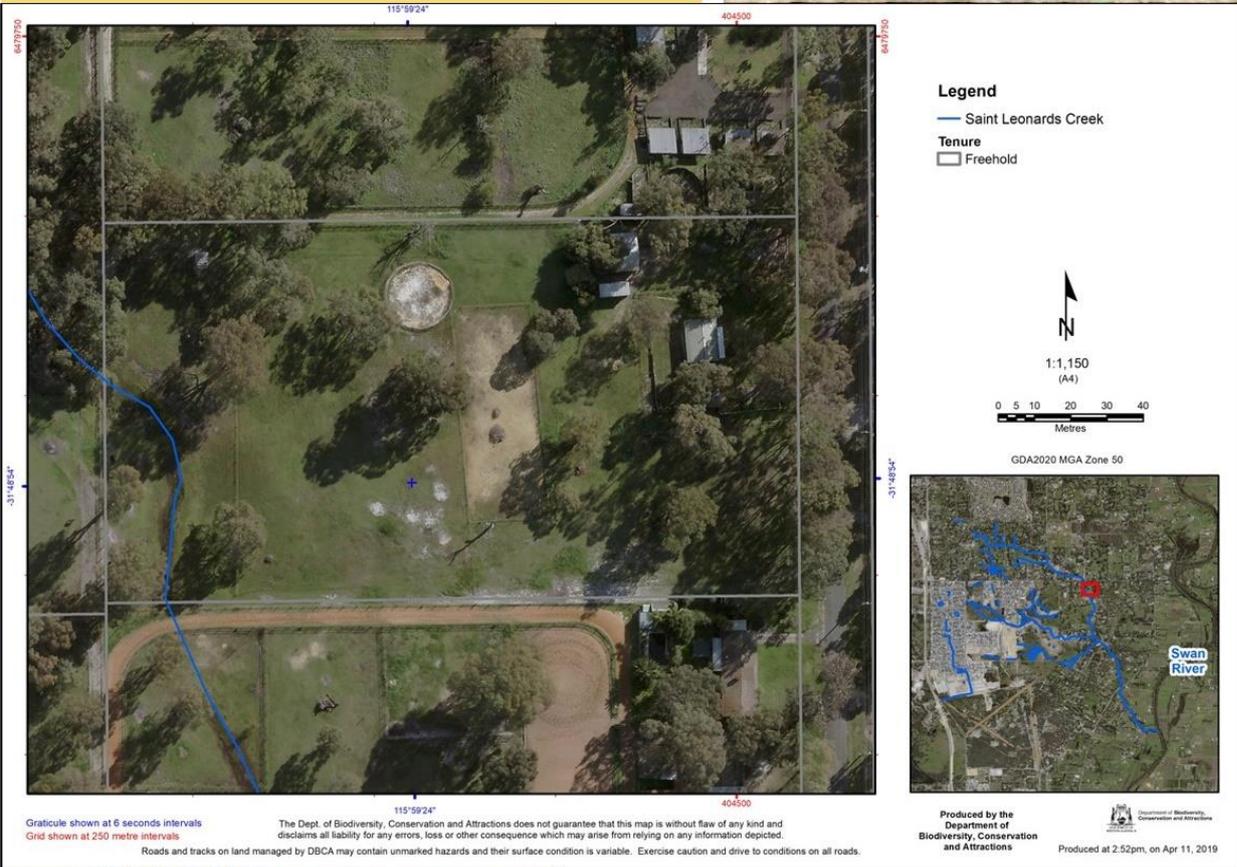
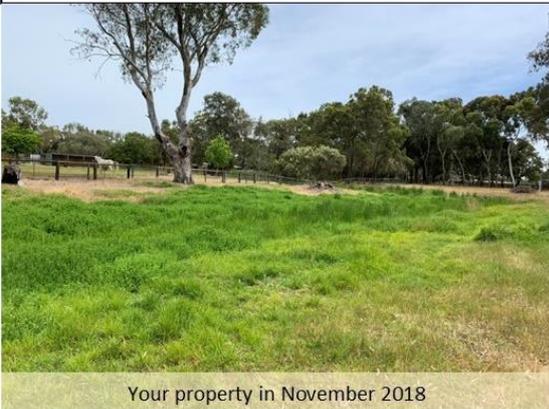
Your property in November 2018

Your property was assessed on 2 November 2018. The vegetation on your property is *Juncus microcephalus* (a rush native to South Africa) over Kikuyu and other grasses and herbs.

- Re-establish a tree canopy to cool the water and provide shade and habitat. Swamp Paperbark is a great tree to plant as they don't often drop their limbs.
- Remove *Isolepis prolifera* as it is an invasive environmental weed and can take over native plants.
- Grow native sedges and rushes to improve water quality and provide shelter for native animals.
