**Biodiversity and  
Conservation Science**

# Preliminary assessment of plastic infrastructure in the Swan Canning Riverpark

June 2024

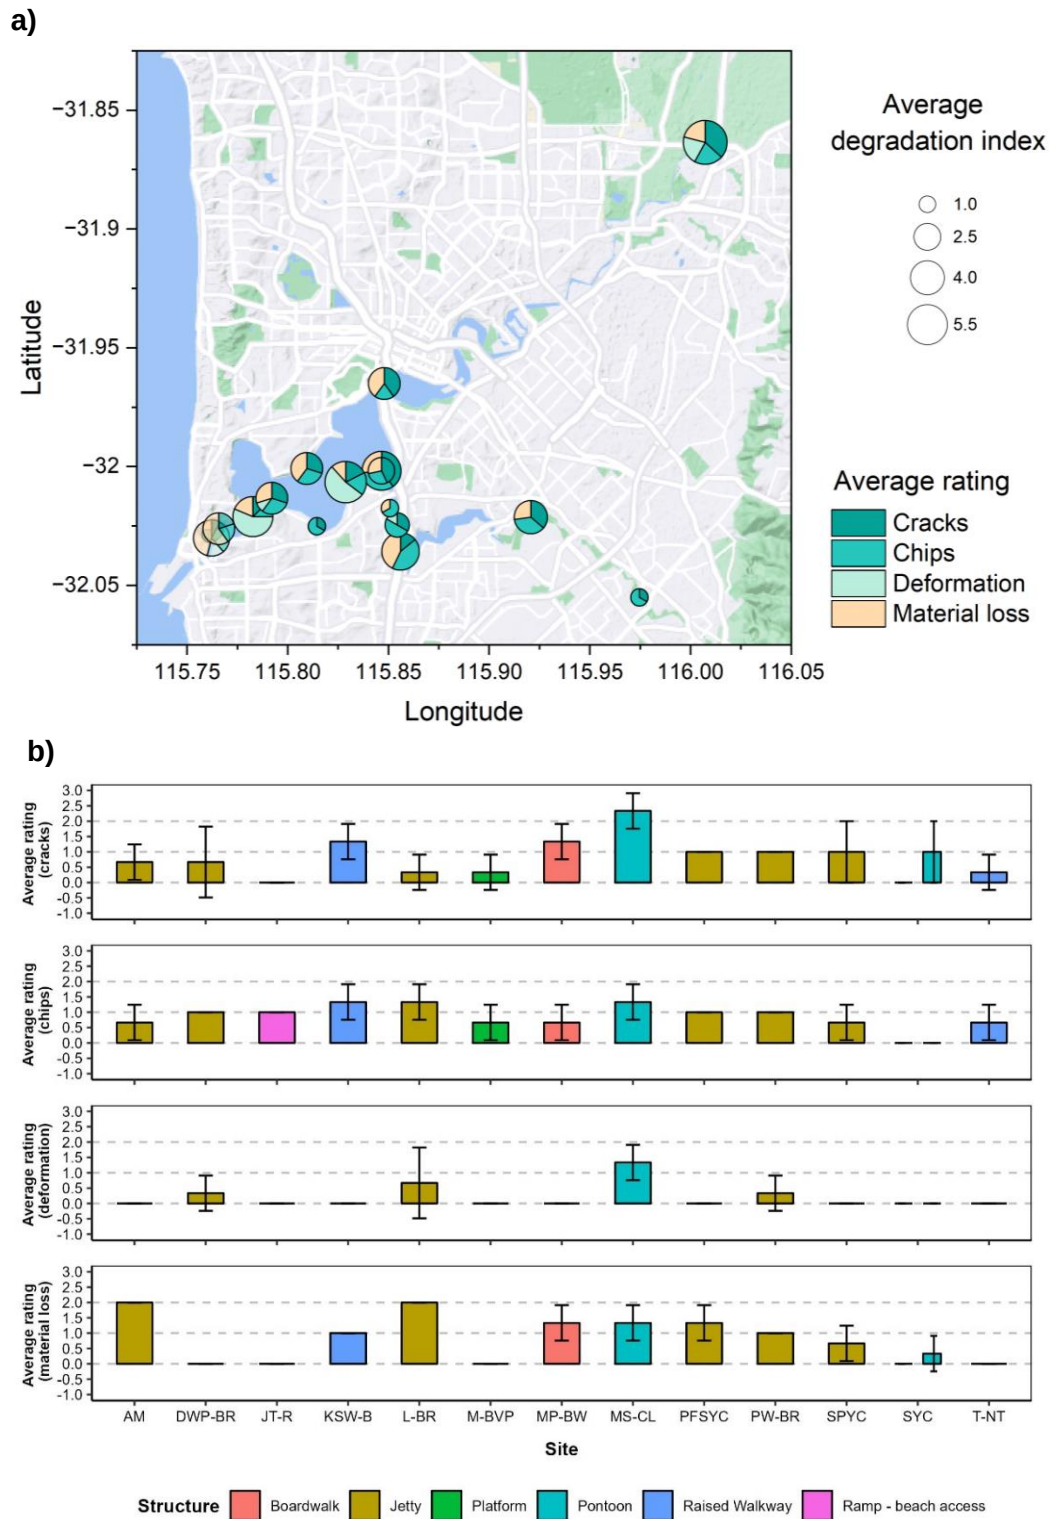
The degradation score for cracking in FRP decking ranged between minor and moderate with a mean score of 0.81 (SE  $\pm$  0.51) (average rating 0 – 3; Figure 10). However, the micromesh grated decking on the ramp and pontoon at the canoe launch in Middle Swan Reserve had moderate to severe cracking (Figure 10). Cracks were prevalent (Figure 11a) and relatively deep (cracked through at least half of the depth of the grating; Figure 11b) across the grating on the pontoon, particularly at the end of the structure. Cracking was rated as 'severe' (rated as 3) on the pontoon in quadrat 3, which was closest to the water (Figure 11b).

The characteristics of the cracking present in most FRP decking structures was often perpendicular to the intersection of joins (Figure 12a, b, c) or inside the corners of the grating (Figure 12a). These cracks were present as surface wear for most structures and rated as minor (degradation score of 1), where few cracks were observed, or moderate if cracks were prevalent (degradation score of 2) (Figure 10).

Figure 10. Average degradation rating with standard error from each assessment criteria (cracks, chips, deformation, material loss) across the three quadrats for structures where fibre reinforced plastic decking was used at different sites. Refer to Table 2 for site name abbreviations.

The mean score for chips in FRP decking was  $0.81$  ( $SE \pm 0.33$ ) (Figure 10b & Figure 13). Chips were evident in almost all FRP grated decking at all sites, except the jetty at the Swan Yacht Club (Figure 10b). Cracks often led to chipping on the edges of structures such as along the grating at the Kent Street Weir Bridge (Figure 13a) and the beach access ramp at John Tonkin Reserve where FRP panels were joined at different angles (Figure 13b).

The mean score for deformations in FRP decking was  $0.19$  ( $SE \pm 0.21$ ) (Figure 10b). The deformation was mostly negligible (0) to minor (1) for FRP decking except on the pontoon / access ramp at the Middle Swan canoe launch where minor to moderate deformation was evident (Figure 10).

The mean score for material loss in FRP decking was  $0.79$  ( $SE \pm 0.21$ ) (Figure 10b). Most of the material lost from FRP decking was evident in the loss of the surface finishes on the grating, particularly the quartz sand used as the grit for anti-slip (Figure 14). The grit finish seems to protect FRP from initial wear until chipped, scratched or cracked. However, the grit

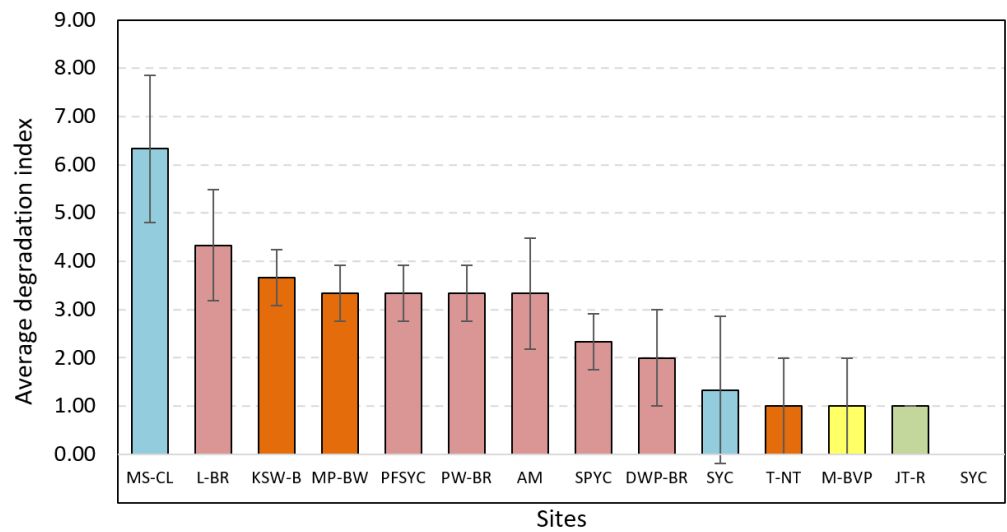
It is worth noting that some owners reported that some panels of FRP had already been replaced due to excessive degradation or damage. It is likely that the degradation observed is not an accurate representation of the total amount of degradation that occurred over the lifespan of FRP structures (Figure 15).

Figure 15. Average degradation index with standard error for structures with fibre reinforced plastic decking across sites. See Table 1 for site names. Pontoons (blue), jetties (pink), boardwalks (orange), platforms (yellow), ramps (green).

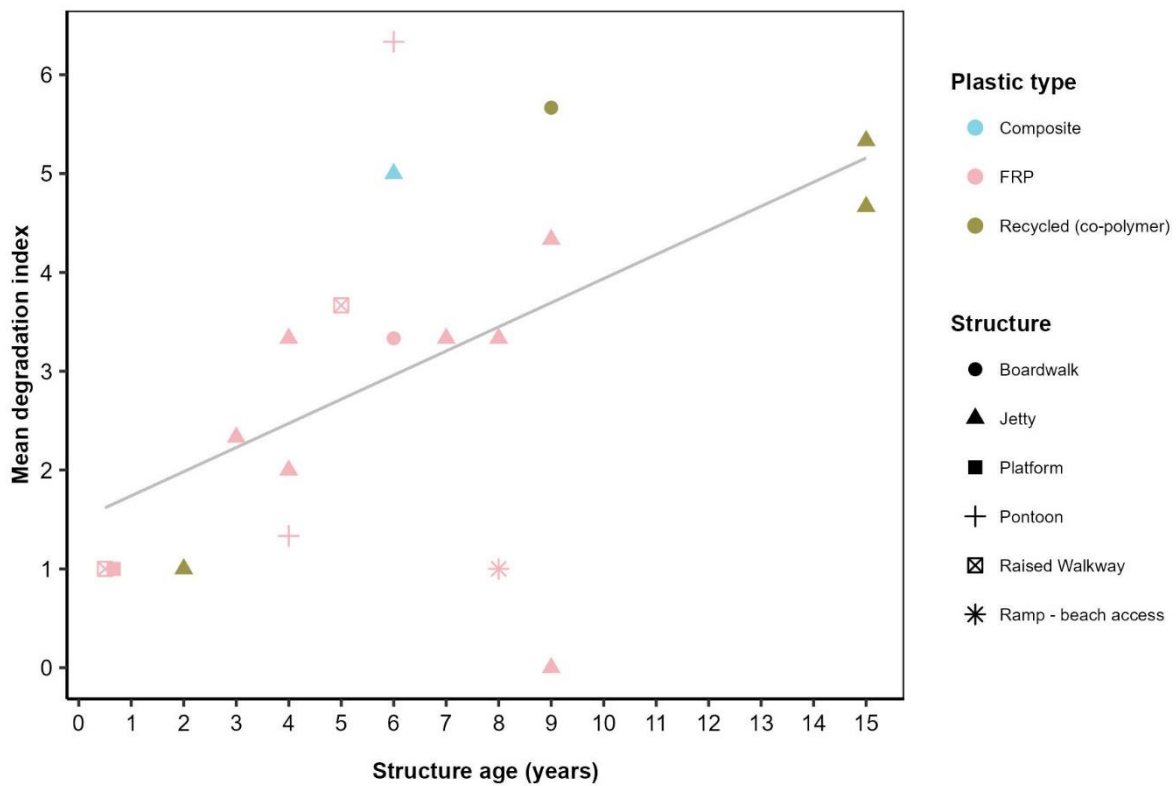
**Age:** The severity of degradation significantly increased with the age of the structure across all types of plastic decking (Figure 16). Material loss and deformation became more common when structures exceeded five years of age.

Figure 16. The relationship between the age of a structure (years) and the mean degradation index (FRP – fibre reinforced plastic) for plastic decking on different structure types with a linear trendline (grey).

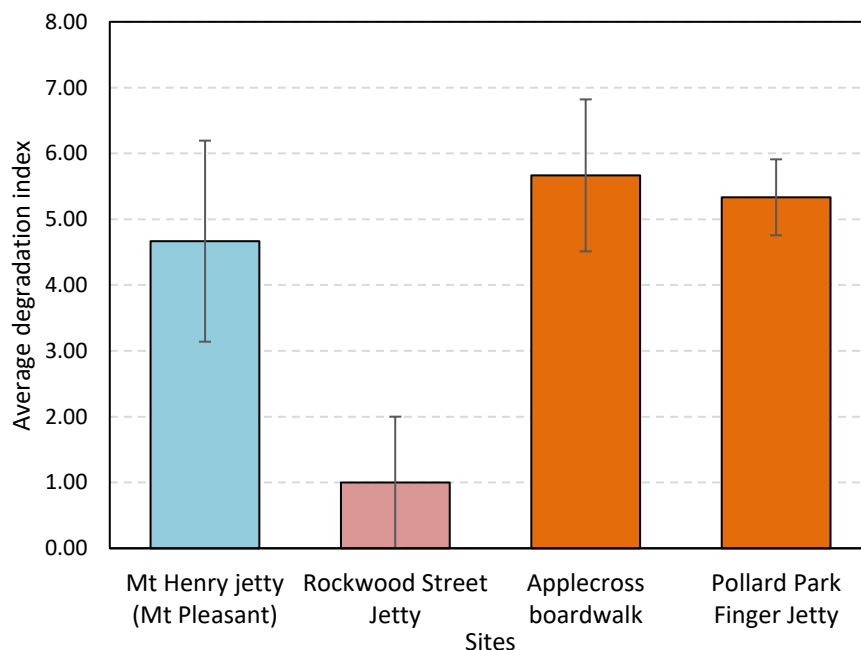
Overall, the degradation observed at Mt Henry Jetty, Applecross boardwalk and Pollard Park finger jetty were similar (Figure 23). The lowest degradation index was observed at Rockwood Street Jetty, which was the most recently installed asset, in 2021.

Figure 23. Average degradation index and standard error for structures with recycled decking. Colours indicate structure type; pontoons (blue), jetties (pink), boardwalks (orange).

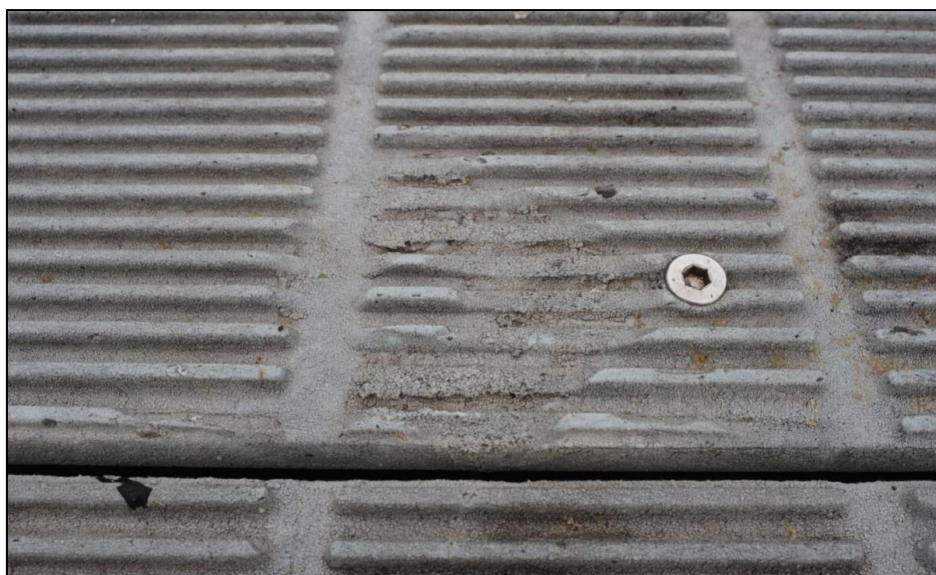
Figure 25. Correct installation of screws to install recycled plastic decking at Mt Henry Jetty.

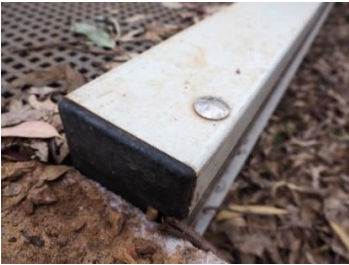
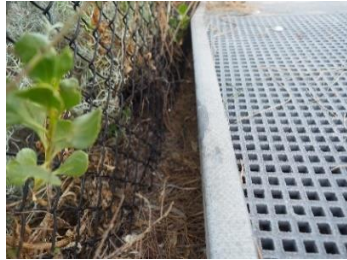
| Material | Fibre reinforced plastic | | |
|---|---|---|---|
| Observations | Scuffing evident from installation or transport. | Peeling of dark blue paint along structure exposed FRP material. | Good condition. Very narrow FRP kick rail but seemed to protect decking well. |
| Degradation index from observations | 1 (minor) | 1 (minor) | 0 (negligible) |

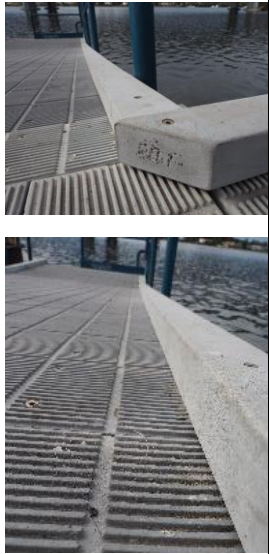
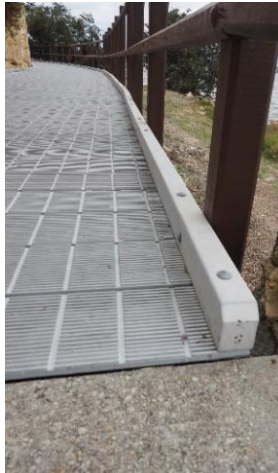
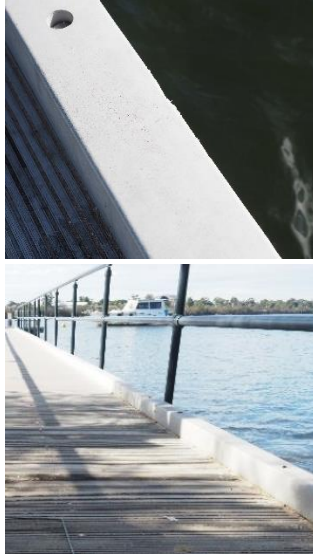
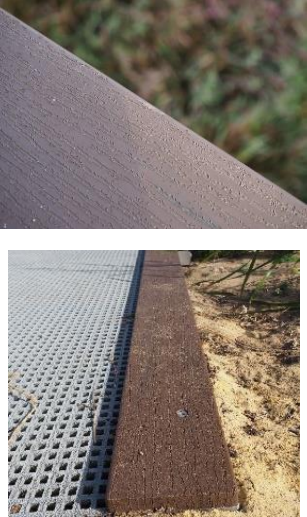
Table 4. Qualitative visual assessments of recycled and other plastic kick rails used on different structures in the Swan Canning Riverpark from May 2023.

| Material | Recycled plastic | | Other | | |
|---|---|---|---|---|---|
| Observations | Chalky / powdery texture. Solid integrity of structure for age. | Chipping and scuffing evident along edges. Powdery texture. 5mm deformation evident. | Relatively good condition with some chalky texture evident on surface. | Likely composite plastic with some minor wear (scuffing) otherwise in good condition. | Thick plank of hard brown plastic (most likely PE / PP), timber look finish which made it look etched and rough. Good condition and looked like it was installed properly. |
| Degradation index from observations | 1 (minor) | 2 – 3 (moderate – severe) | 1 (minor) | 1 (minor) | 0 (negligible) |

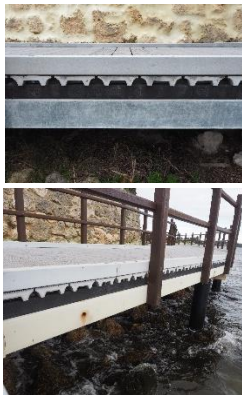
| Material | FRP sub-structure | | | | PE float bricks | |
|---|---|---|---|---|---|---|
| Observations | Good condition as evident from shoreline. | Some light wear (e.g. scratches) possibly from installation. | Fading in colour and wear on surface that was most exposed. | Good condition from side view of structure. | Good condition according to asset owner. Algae present on all bricks. | Bricks used for access ramp in good condition as evident from shoreline. |

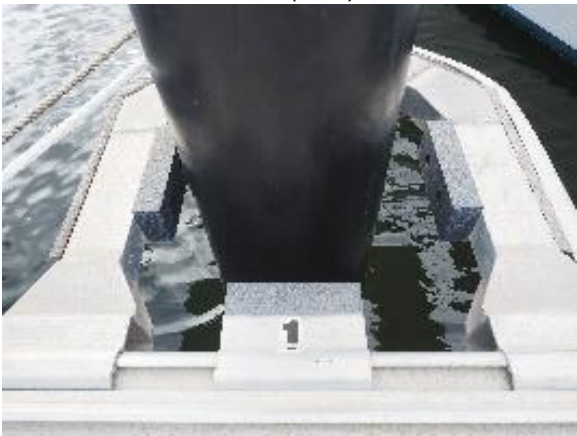
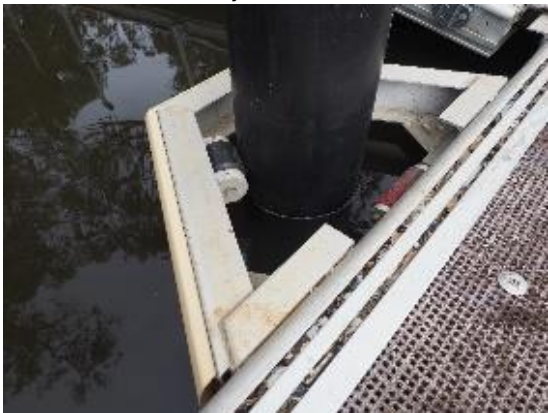
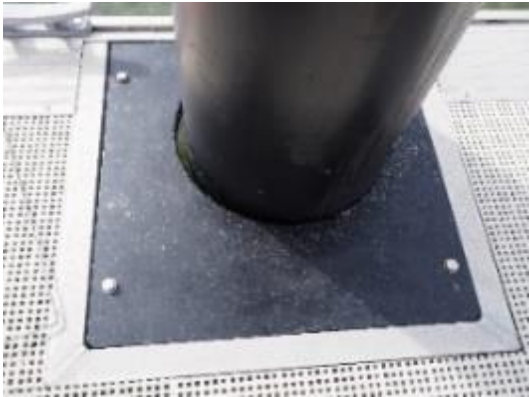
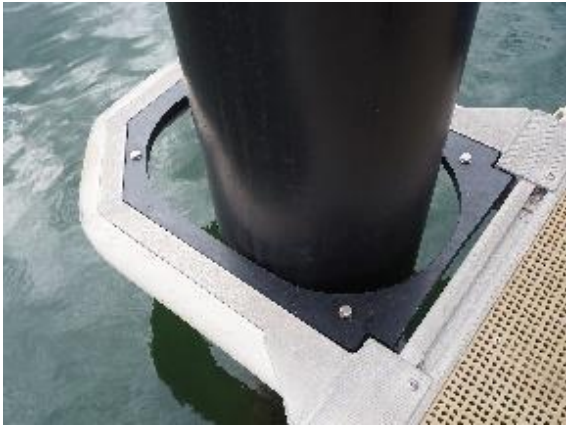
Table 6. The materials used to allow movement around piles at various sites around the Swan Canning Riverpark.

Pile capping was in relatively good condition; however, it was difficult to assess most caps properly given the height of some piles. Caps did not appear to get as damaged from boat strike as the sleeves themselves. The white colour used for all capping could help reduce UV degradation. Rollers and edging used to allow movement of floating structures around piles resulted in material loss from chaffing (Table 6). Rollers and edging were installed in various ways (Table 6) and were necessary for preventing wear to other plastic structures, such as decking.

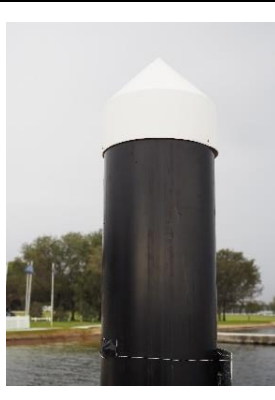
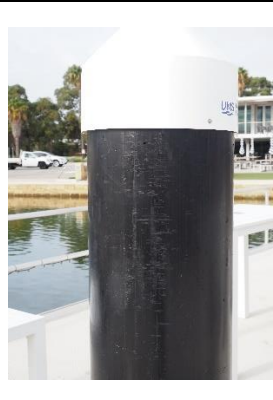
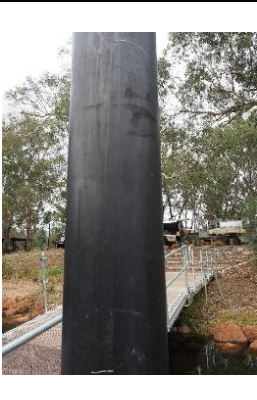
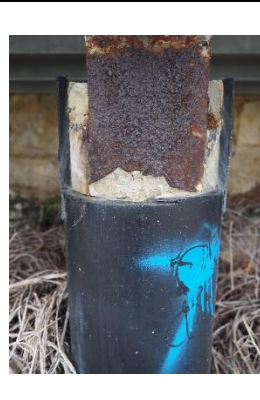
Table 7. Qualitative visual assessments of polyethylene pile sleeves and caps used on different structures in the Swan Canning Riverpark (May 2023). Degradation index applies to sleeves only since capping was often out of reach and could not be reliably assessed.

| Material | PE (Pile sleeves + caps) | | | | | |
|---|---|---|---|---|---|---|
| Observations | Slowly replacing wooden piles from 1985. Used in boat pens (not assessed) and loading jetty. Some did not have white PE caps. Scratches from boat strikes evident. Drill tailings evident from capping installation. | Only observed on central floating jetty and were in good condition with minimal scuffing and scratches evident. | Wear evident from boat strike and repairs in some places. Some wear from rollers at base of piles. | Scratches evident on pontoon piles, particularly near table settings and where boats dock. Otherwise in good condition. Could not assess piles used for boat pens. | Very damaged at the top of the piles (far out of reach) possibly from installation. Large chunks of plastic missing along the pile, particularly >2m on piles. | Roughly cut piles with metal and fibre reinforced plastic substructure. Vandalism and damage evident but difficult to assess whole structure as it was mostly inaccessible. |
| Degradation index from observations | 1 (minor) | 1 (minor) | 1 – 2 (minor to moderate) | 1 (minor) | 2 (moderate) | 1 – 2 (minor to moderate) |

**Installation:** Large scuff marks evident high on the piles at the Middle Swan canoe pontoon suggest damage was possibly caused when they were lowered for installation. Further drill tailings were present where screws were used to install pile caps (Table 10). Peeling PE was observed where edging was cut into shape around the bases of piles. Rigid edging installed around the base of piles could be causing more wear on piles than rollers (Table 6).

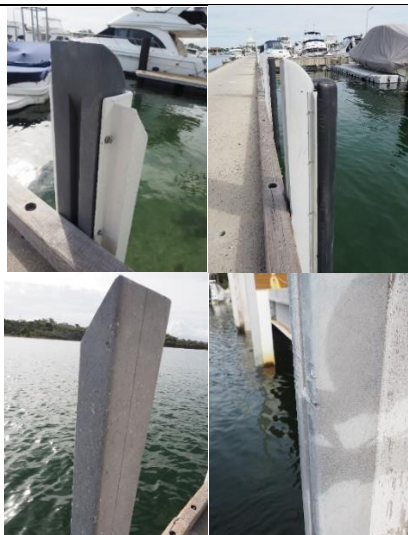
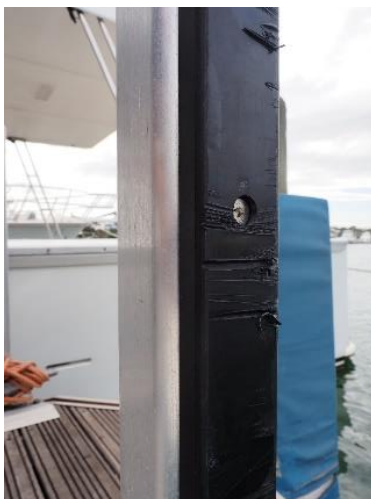
Table 8. Qualitative visual assessments of plastic (recycled plastic and polyethylene; PE) chafer posts used on jetties in the Swan Canning Riverpark (May 2023).

| Observations | Newer grey REPLAS posts (~ 2 years) showed minimal wear. Most degradation (chipping, scratches) were evident on large chafer posts used in the most exposed location at the fuelling station. Most posts had additional plastic padding on outer sides. | Black plastic attached to aluminium posts were used along smaller access jetties for boats. They were scuffed in places with plastic sloughing off. |
| Degradation index from observations | 1 – 2 (minor – moderate) | 1 – 2 (minor – moderate) |

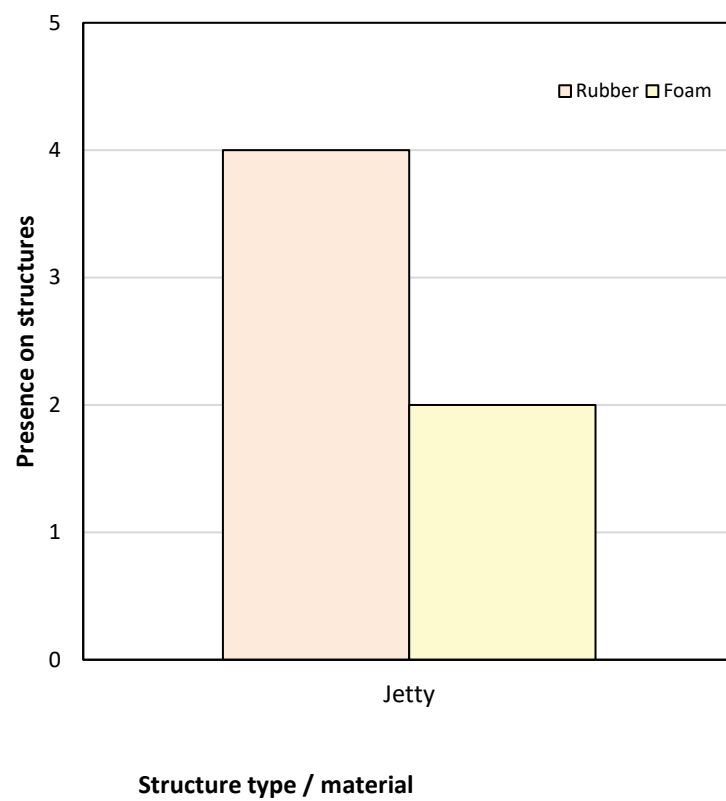
Figure 30. The different kinds of materials used as wharf fenders on jetty structures.

Fenders provided additional cushioning on chafer posts along jetties prone to boat strike and, therefore, were generally more degraded (Table 9). The softer fenders made from rubber and foam (Figure 30) also meant they were very prone to sloughing of plastic into the water under jetties. A harder unknown type of plastic was used for protecting the corners of the canoe pontoon at Middle Swan. This plastic was faded and severely damaged with larger pieces missing along the edge of the water (Figure 31).

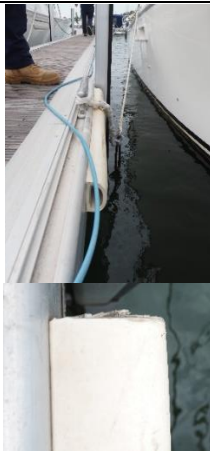
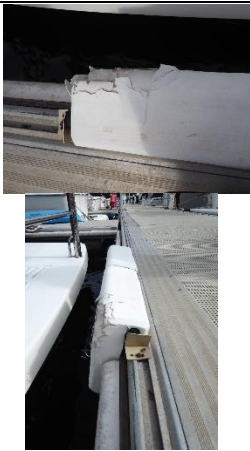
| Structure type | Jetty | | | | | |
|---|---|---|---|---|---|---|
| Observations | Faded and shedding noticed at the ends cut roughly during installation. | Faded with mild wear. | General scuffing and wear evident. | Faded with black scuff marks and chunks missing. Powdery texture. | Example in image of foam fender severely damaged with chunks of foam falling off into the river. | Faded and plastic peeling and shedding into river. Huge pieces of plastic found loose on structure. |
| Degradation index from observations | 2 (moderate) | 1 (minor) | 1 (minor) | 2 (moderate) | 3 (severe) | 3 (severe) |

**Boat strike:** Given the usual purpose of piles, chafer posts and fenders are to minimise impact from boats on jetties and pontoons, most physical damage (e.g. scuffing, scratches, scrapes) was likely caused from boat strike. Fenders were the most impacted plastic structure of all assessed given they are often the first point of contact with boats and a much softer material than the high-density PE and recycled plastic used for piles and chafer posts, respectively.

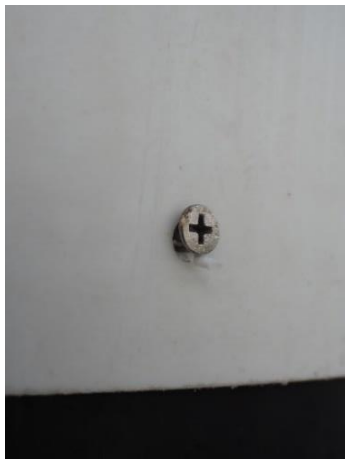
Table 10. Other signs of degradation evident on piles in the Swan Canning Riverpark (May 2023).

| Site name | Aquarama Marina | South of Perth Yacht Club |
|---|---|---|
| Observations | Drill tailings falling out under screws. | Wear noticed on nylon rollers from friction with polyethylene pile sleeve. |

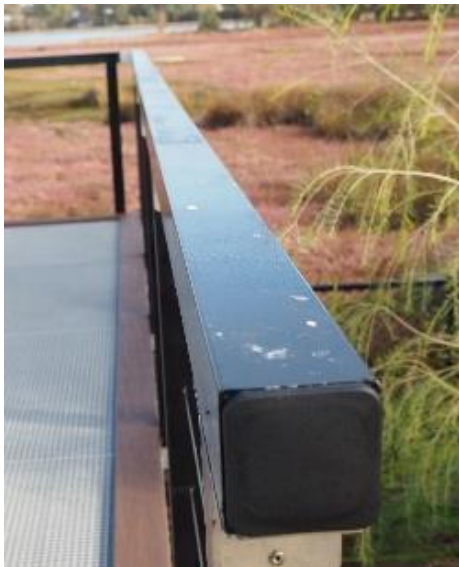
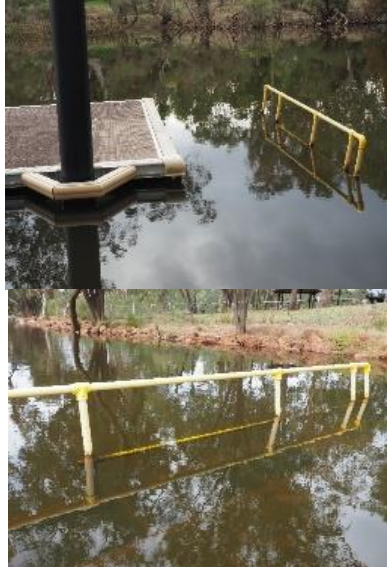
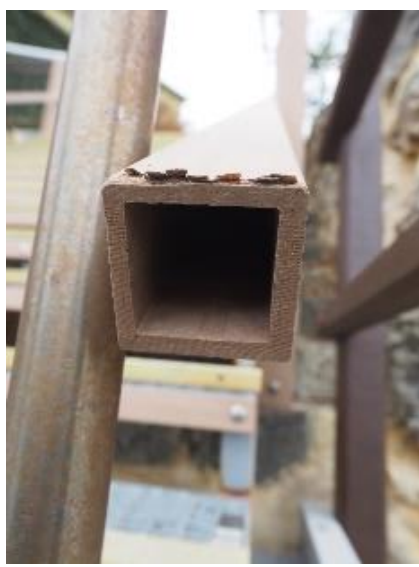
**High temperatures / UV degradation:** Fades plastic over time and creates weaknesses in structures, particularly handrails. Not as evident in seats and posts.

**Age:** Older handrails showed more signs of degradation (e.g. material loss at ends) but this would also depend on the frequency of their use.

| Material | Unknown | FRP | |
|---|---|---|---|
| Observations | Plastic type needs confirming. Black handrail with no damage present. Plastic capping on ends. | Severely degraded handrail submerged in water and attached to algae covered FRP decking. Partially metal. | Surface layer peeling on end of rail (no capping). Faded brown colour. |
| Degradation index from observations | 0 (negligible) | 3 (severe) | 2 (moderate) |

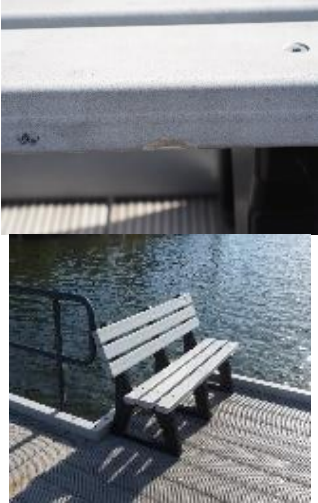
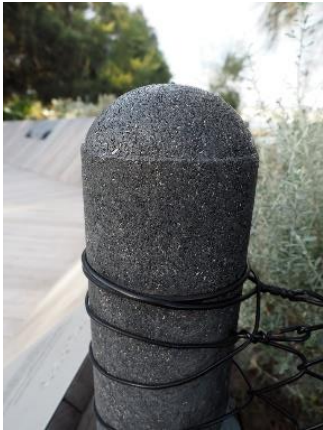
Table 12. Qualitative visual assessments of seats and posts on different structures in the Swan Canning Riverpark (May 2023).

**Vandalism:** Obvious etchings present on structures causing additional degradation, particularly on seats.

| Material | Recycled plastic | | | |
|---|---|---|---|---|
| Observations | Some chipping and scraping evident likely from vandalism. | Metal frame with plastic seat and backing. Cracking evident from screws. Some scratches present. | Black plastic seat in good condition but not thoroughly assessed. | Plastic posts observed in shaded position along the access ramp and shore front. Good condition. |
| Degradation index from observations | 1 (minor) | 1 - 2 (minor - moderate) | 0 (negligible) | 0 (negligible) |

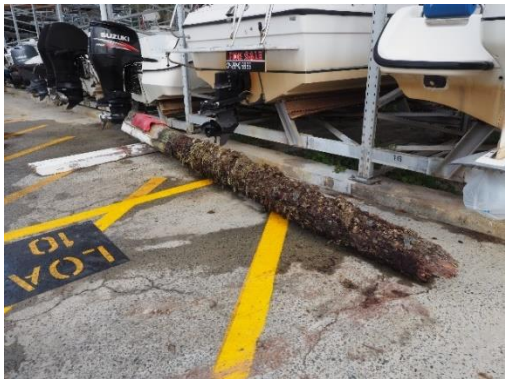
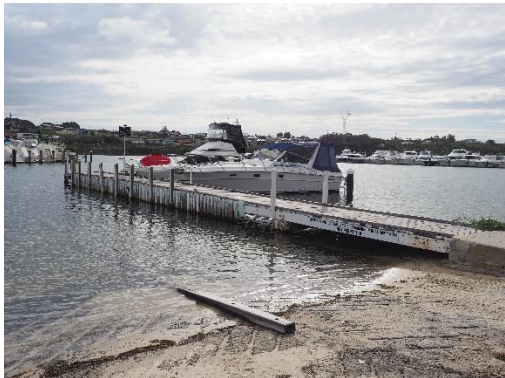
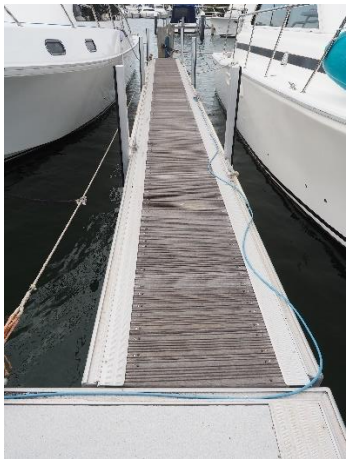
| Potential alternatives to plastic | Comments |
|---|---|
| <p>Timber (general)</p> <p><i>Wooden pile removed at Aquarama Marina to be replaced with steel pile and polyethylene sleeve (top) and wooden jetty to be replaced (middle) and side boat access jetty (bottom) at Swan Yacht Club.</i></p> | <ul style="list-style-type: none"> <li>• Resource shortages (not a long-term sustainable alternative).</li> <li>• Requires ongoing maintenance and repair.</li> <li>• Observed as being replaced at some locations (e.g. Swan Yacht club is replacing a fixed wooden jetty with plastic floating jetty in 2023; wooden piles from 1985 at Aquarama have almost all been replaced). Aquarama Marina GM comments: switched to plastic chaffers eight - 10 years ago because timber was difficult to source. Timber pylons obsolete now so they use steel pen piles covered with HDPE black plastic sleeve.</li> </ul> |

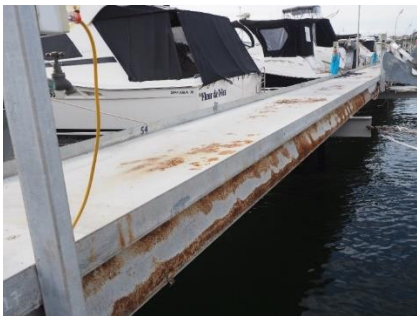
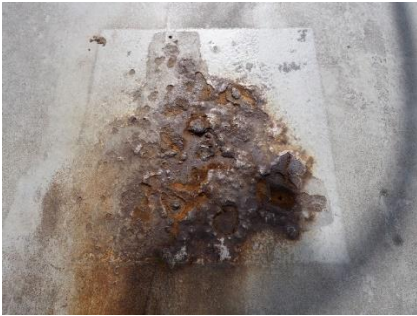
| <p>Metal (steel)</p> <p><i>Steel jetty built in 1985 that needs replacing at Aquarama Marina.</i></p> | <ul style="list-style-type: none"> <li>• Long lasting when maintained but can rust over time.</li> <li>• Energy intensive to manufacture.</li> <li>• Probably not feasible to use for marine infrastructure but can potentially be used for edge protection.</li> </ul> |

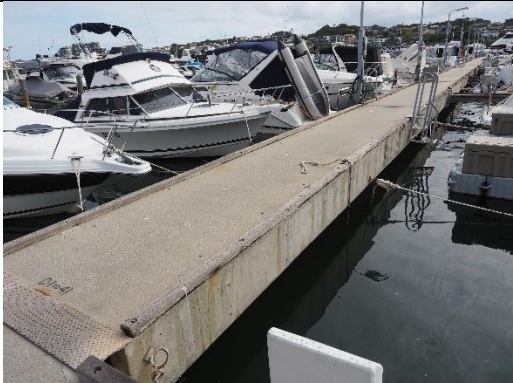
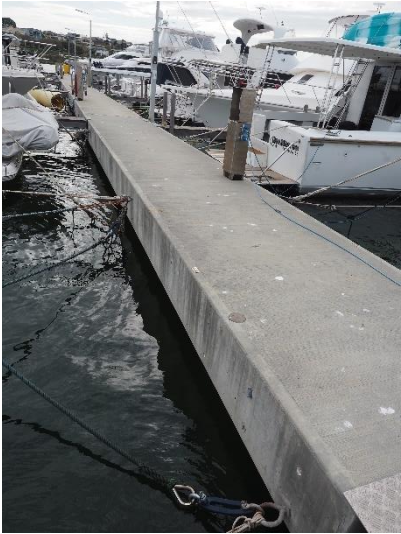
| <p>Concrete jetty at Aquarama Marina (top) and Swan Yacht Club (bottom)</p> | <ul style="list-style-type: none"> <li>• Concrete is the recommended material from multiple yacht club managers.</li> <li>• Negligible signs of degradation after a 25+ year service life. Low maintenance.</li> <li>• High embodied carbon but this may be offset by an increased service life, reduced maintenance cost and eliminating the possibility of plastic fragments ending up in the Swan and Canning rivers.</li> <li>• Concrete float example (<a href="https://www.poralu.com/en/products/">https://www.poralu.com/en/products/</a>). The construction of a concrete dock float meets concrete standards IN 206-1. They are encapsulated and reinforced by a layer of galvanized steel, ensuring optimal protection and resistance regardless of site conditions. They are filled with high-density expanded polystyrene foam which ensures their unsinkability.</li> </ul> |
